# RPA & Associates LLC

| JOB | DATE |
|---|---|
| 719 Gildersleeve Street, Santa Fe, NM 87505 – MAIN HOUSE | 07/02/2026 |

## RPA & ASSOCIATES, LLC | WINDOW & DOOR CONDITION AND INTEGRITY CODES

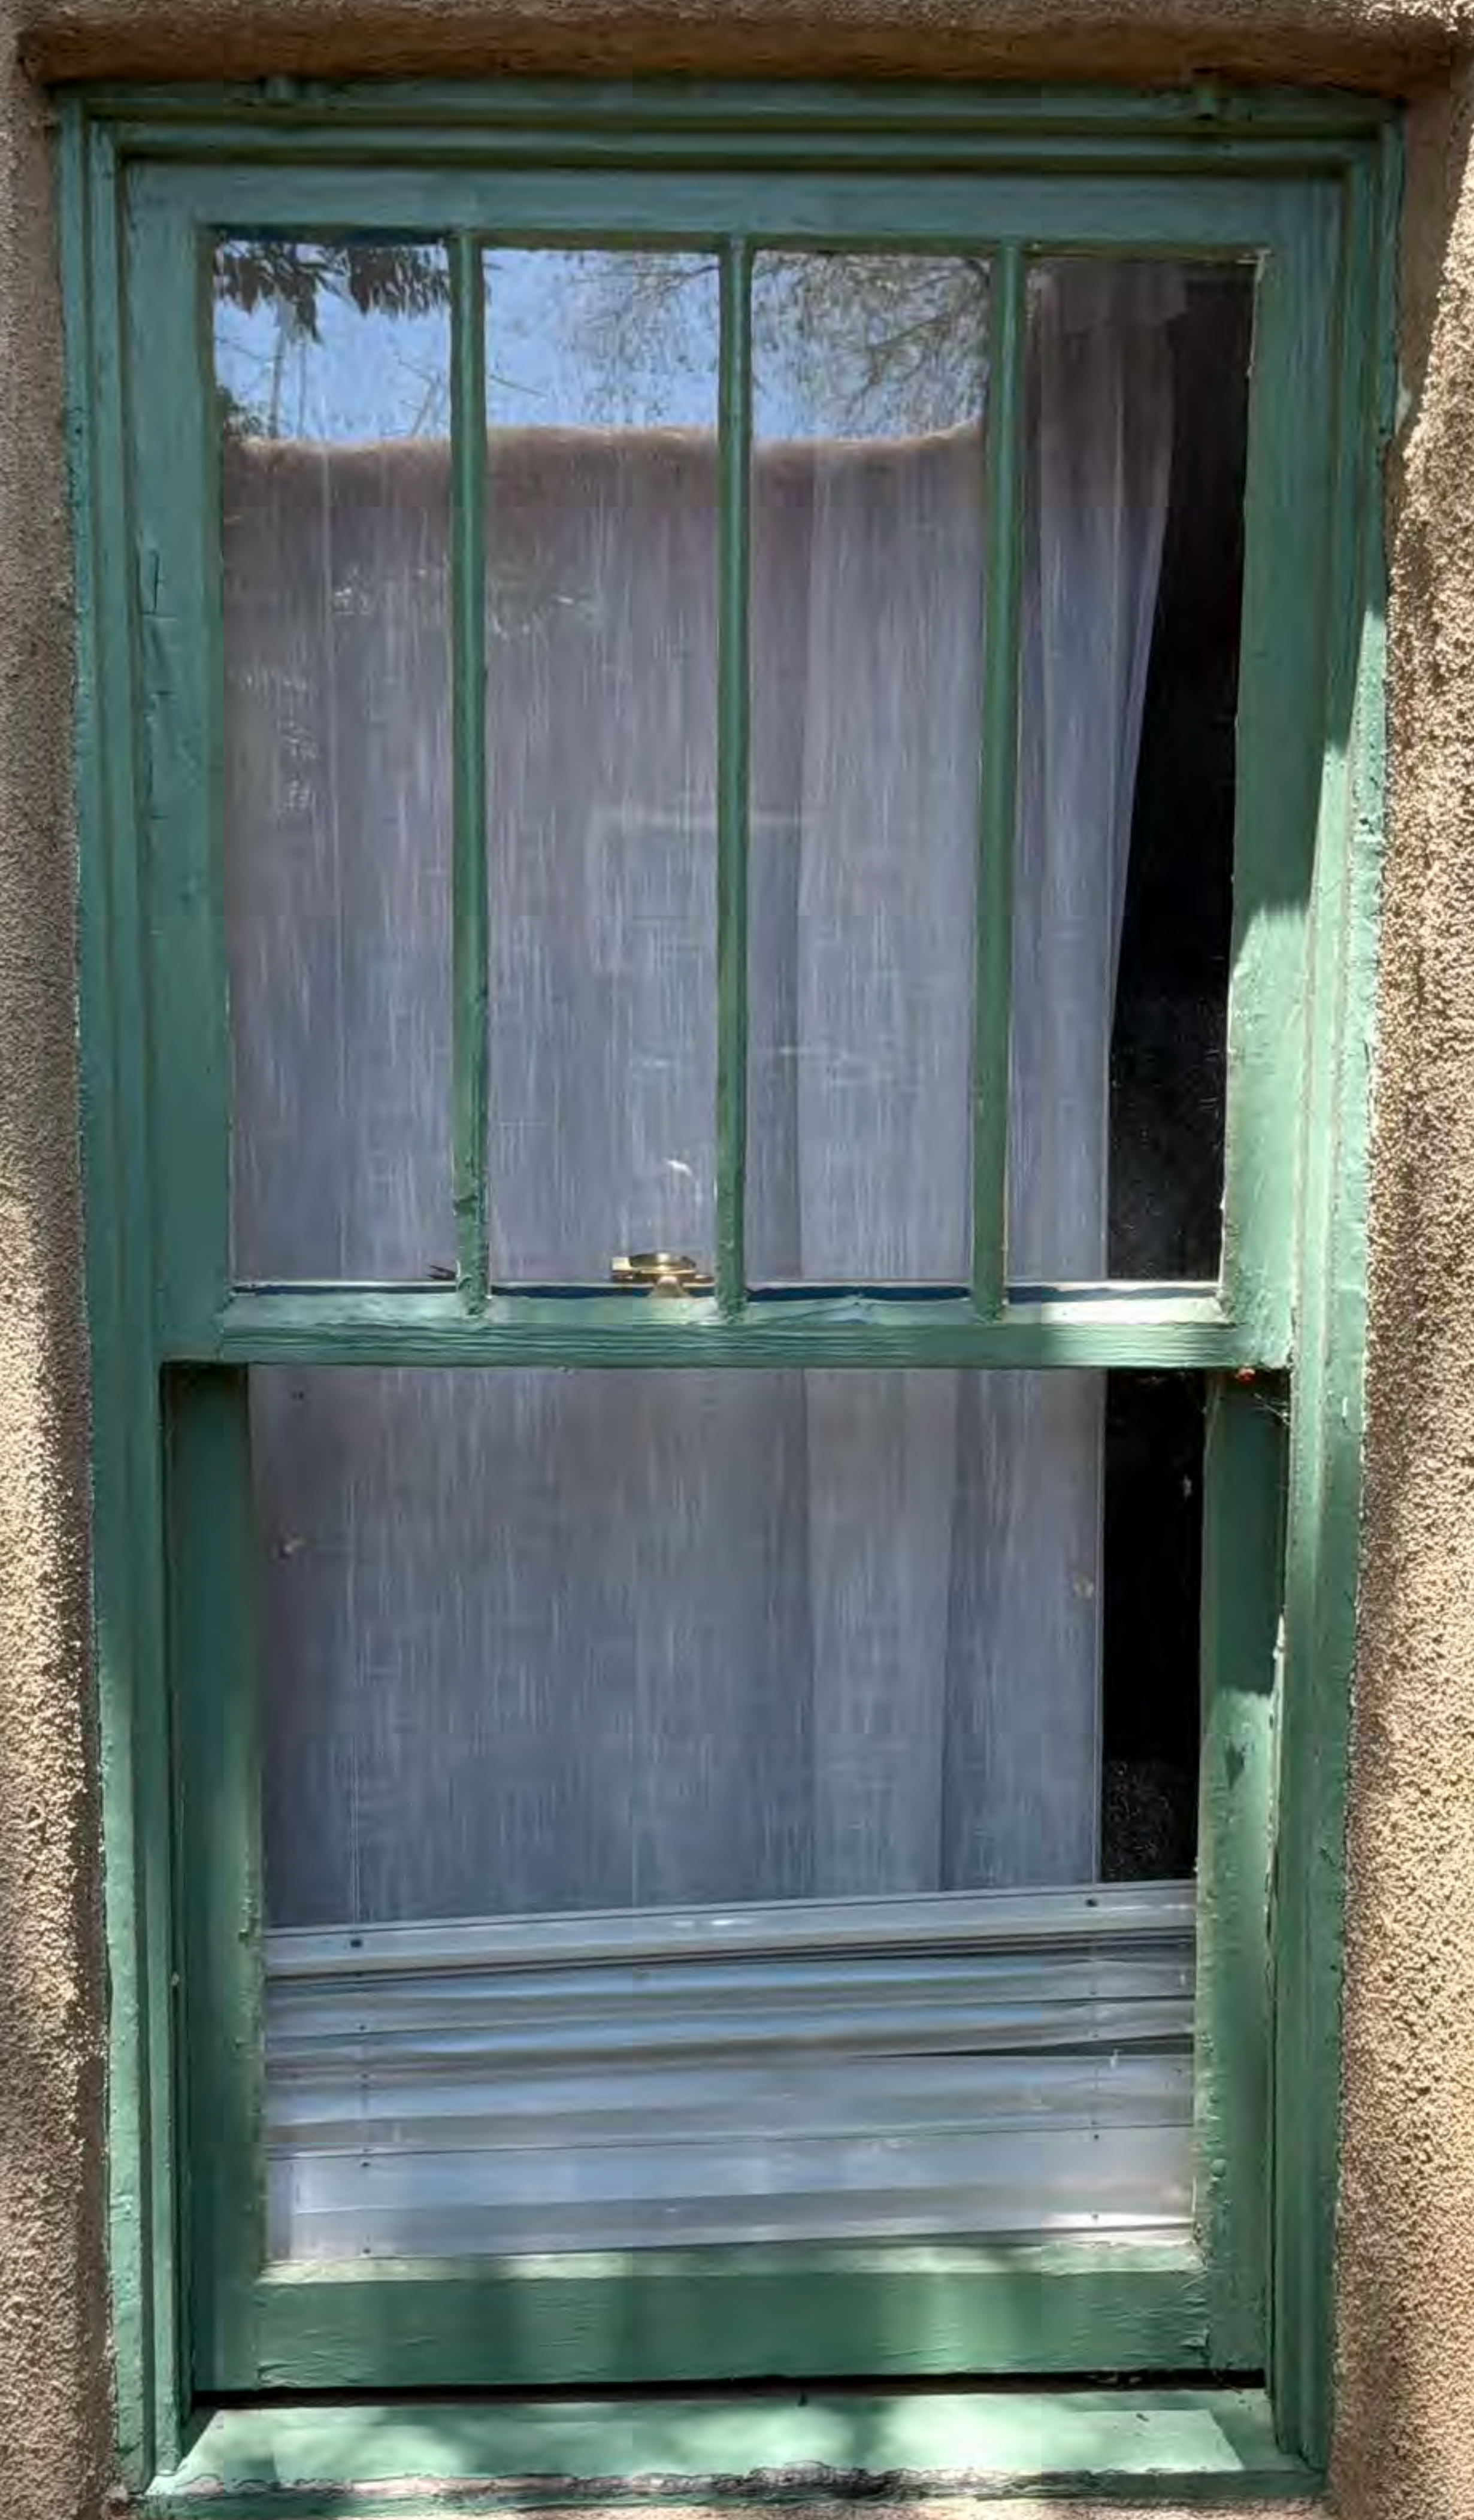
South  
Elevation  
Window A.

Windows A, B, C, and H are historic and restorable however the units do have considerable rot.

| LABEL | WINDOW & DOOR DESCRIPTION | CONDITION & INTEGRITY CODE | HISTORIC/NON-HISTORIC - AGE |
|---|---|---|---|
| A | 30" x 56" DOUBLE HUNG 4W1H/1-LT ALL WOOD | F | <b>HISTORIC</b> - LEFT SIDE OF TOP SASH, SILL & BOTTOM SASH ROTTED BEYOND 40 % |

If the windows and doors are replaced, they should be replaced in “like and kind” of the historic windows that are existing. With divided lights, four (4) verticals on top and one (1) light on the bottom, either in all wood or clad/wood to match the existing color. Windows such as Marvin or Kolbe will meet these requirements.

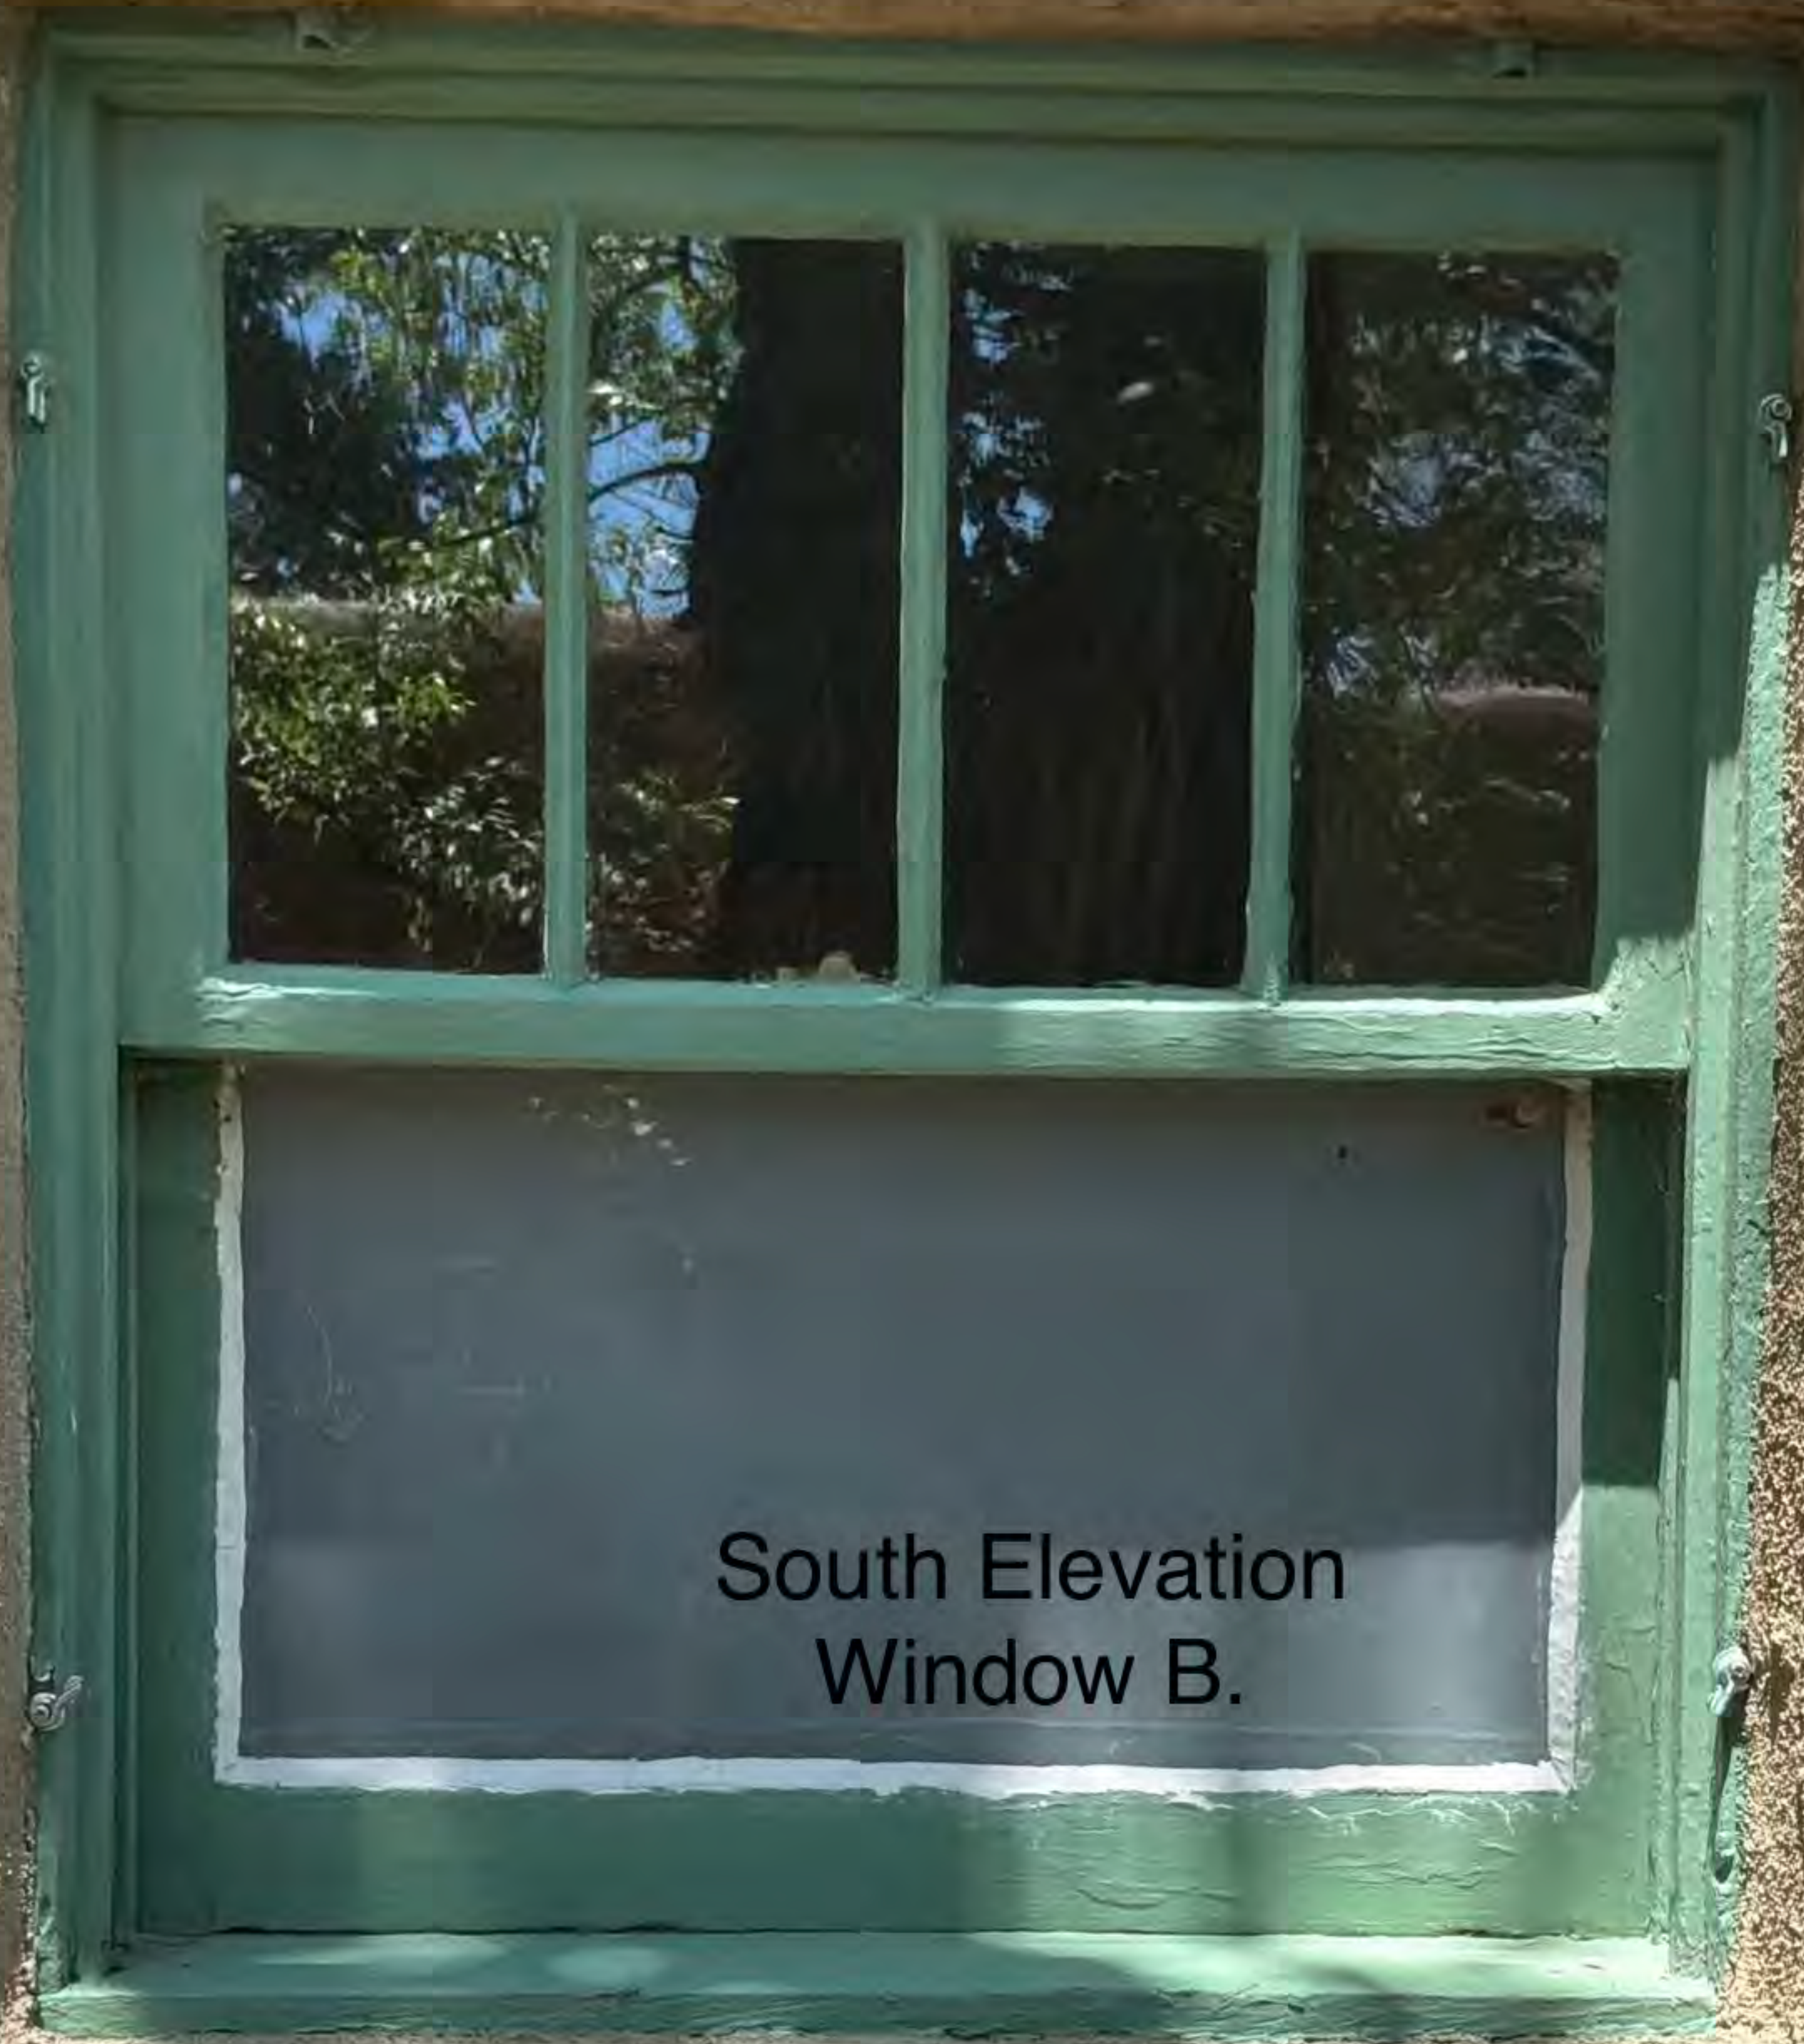
South Elevation  
Window B.

| LABEL | WINDOW & DOOR DESCRIPTION | CONDITION & INTEGRITY CODE | HISTORIC/NON-HISTORIC - AGE |
|---|---|---|---|
| B | 30" x 56" DOUBLE HUNG 4W1H/1-LT ALL WOOD | F | <b>HISTORIC</b> - SILL & BOTTOM RAIL OF TOP & BOTTOM SASH ROTTED BEYOND 40 % |

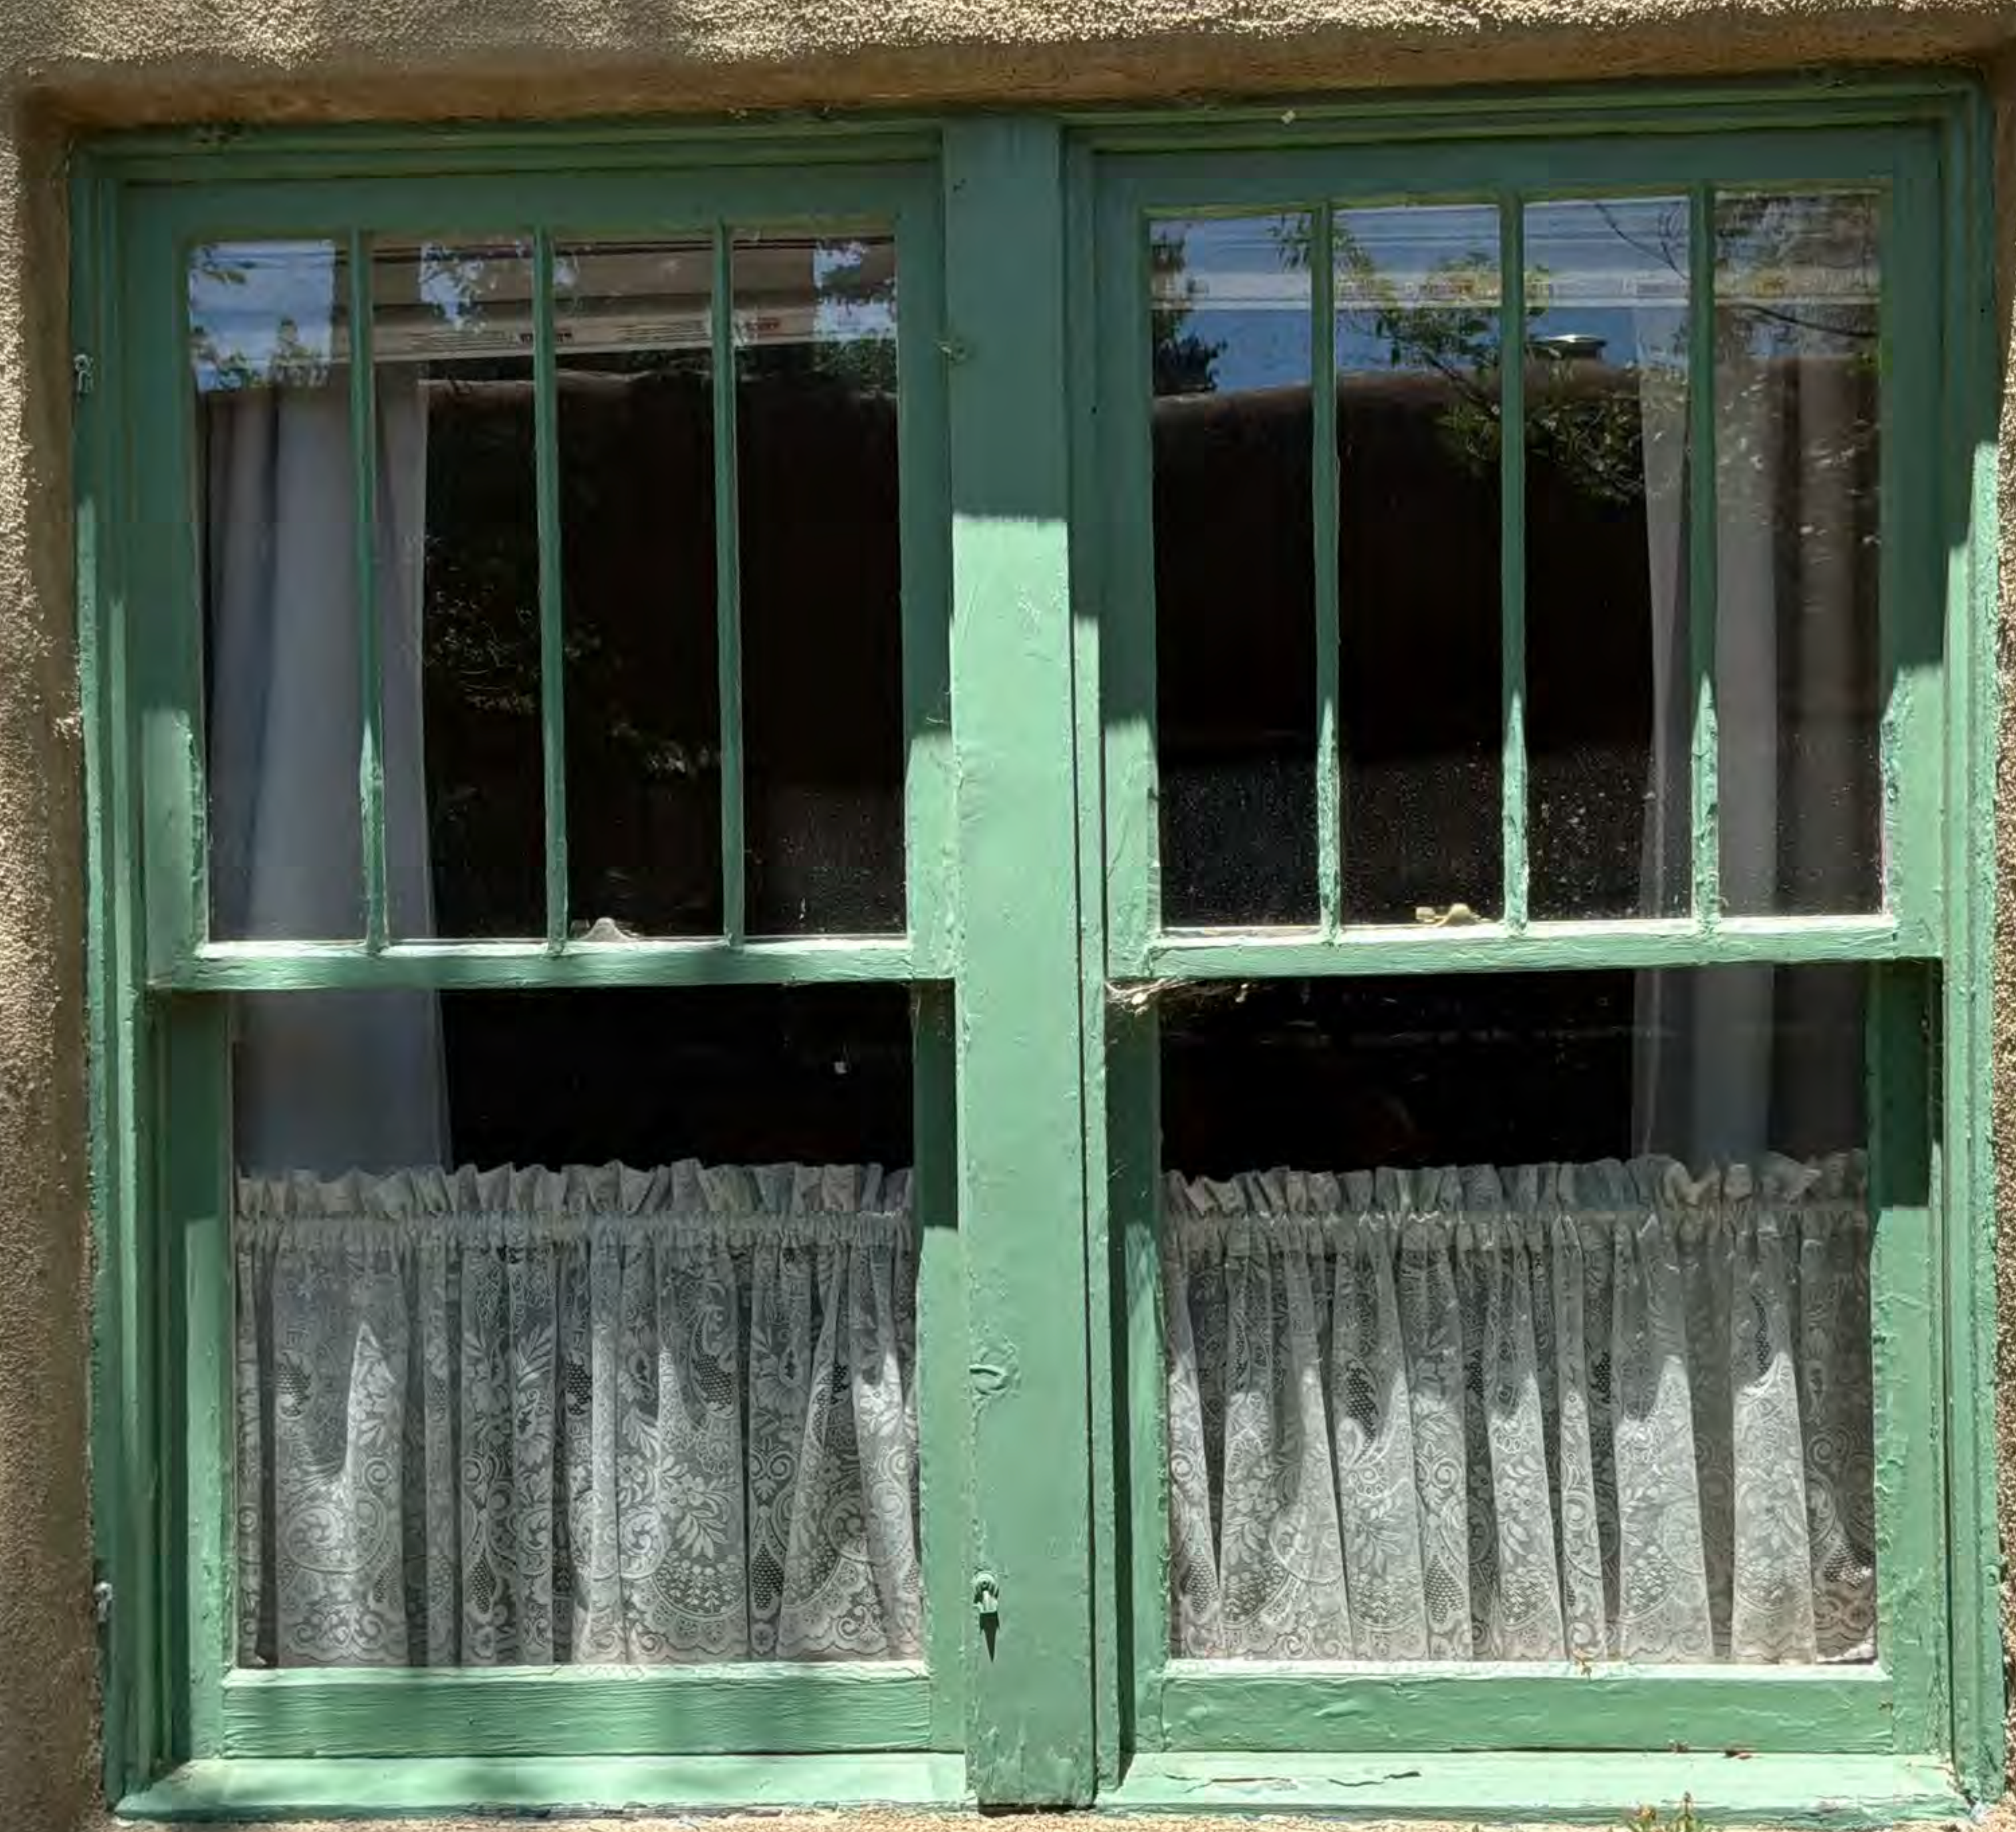
South  
Elevation  
Window C.

| LABEL | WINDOW & DOOR DESCRIPTION | CONDITION & INTEGRITY CODE | HISTORIC/NON-HISTORIC - AGE |
|---|---|---|---|
| C | 60" x 56" TWIN DOUBLE HUNG 4W1H/1-LT ALL WOOD (2-28") | F | <b>HISTORIC</b> - BOTTOM RAILS & LEFT SIDE STILES ON LEFT WINDOW & RIGHT-SIDE STILE ON RIGHT WINDOW ROTTED BEYOND 40%, EXTERIOR MULL COVER IS ALSO ROTTED BEYOND 40% |

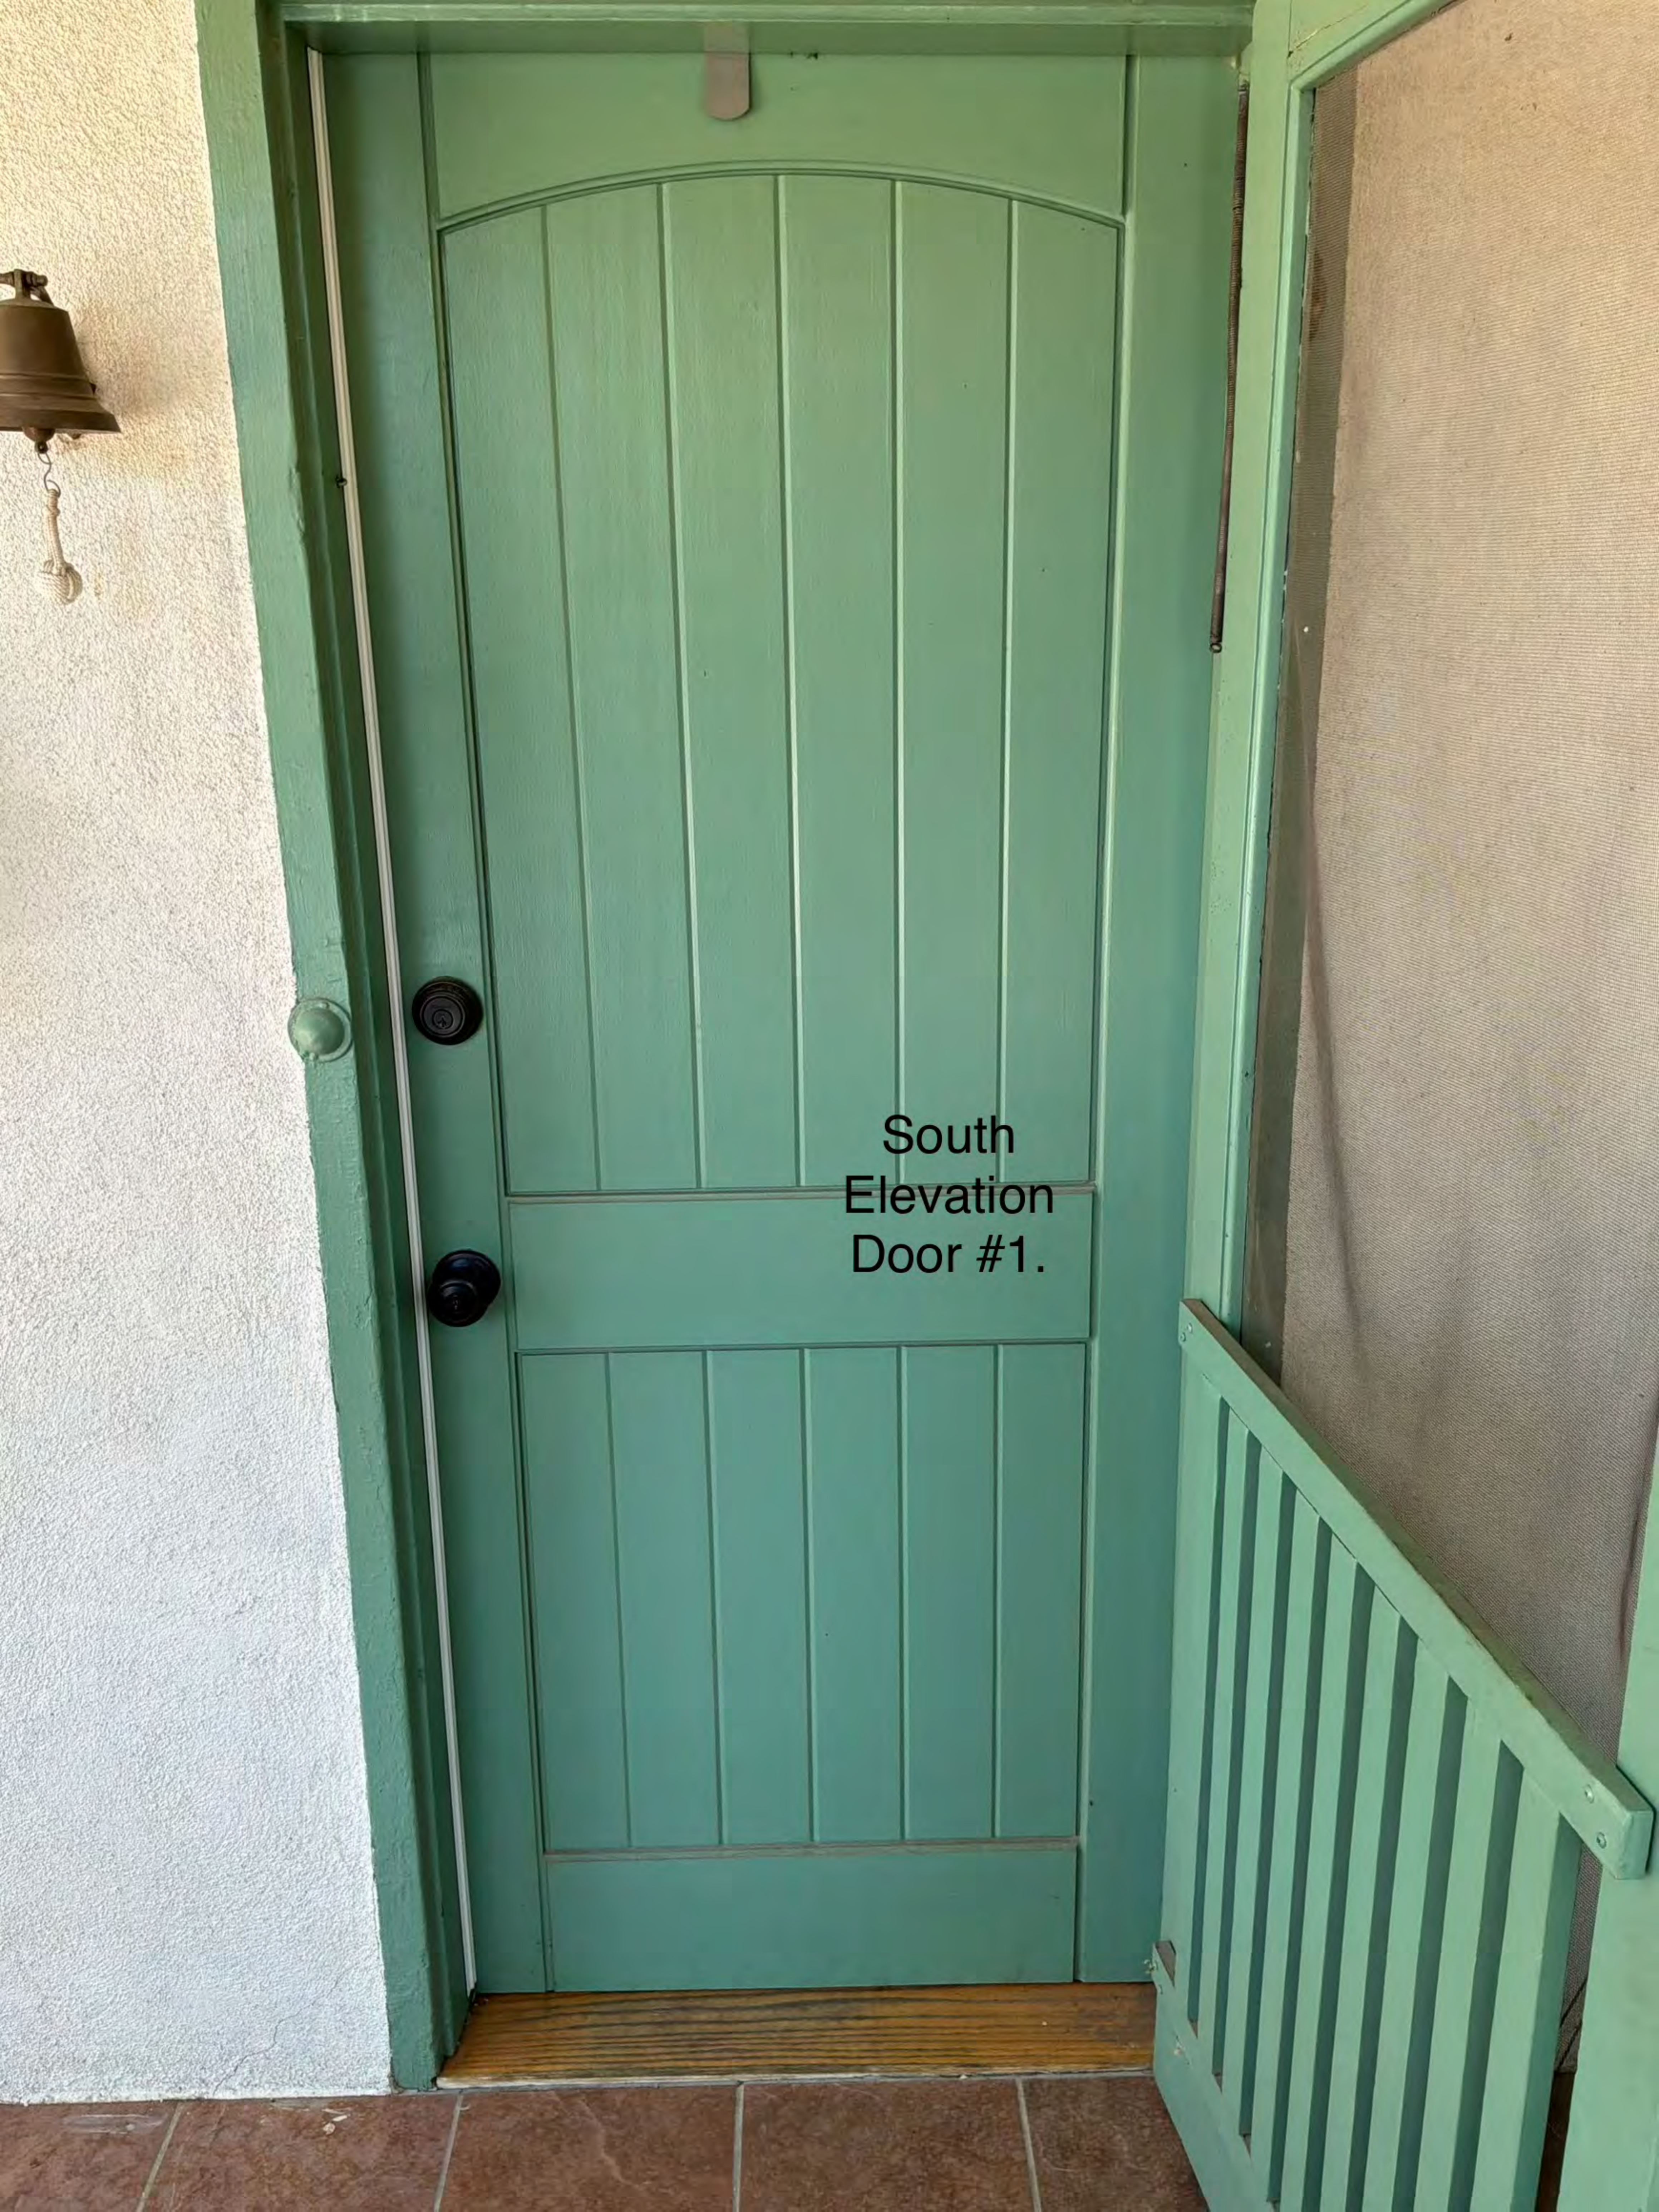
South  
Elevation  
Door #1.

Doors 1 and 2 are non-historic.

| LABEL | WINDOW & DOOR DESCRIPTION | CONDITION & INTEGRITY CODE | HISTORIC/NON-HISTORIC - AGE |
|---|---|---|---|
| DR #1 | 32" x 80" RH INSWING ARCH TOP V-GROOVE ALL WOOD DOOR | S | <b>NON-HISTORIC</b> - SIMPSON DOOR (2011) |

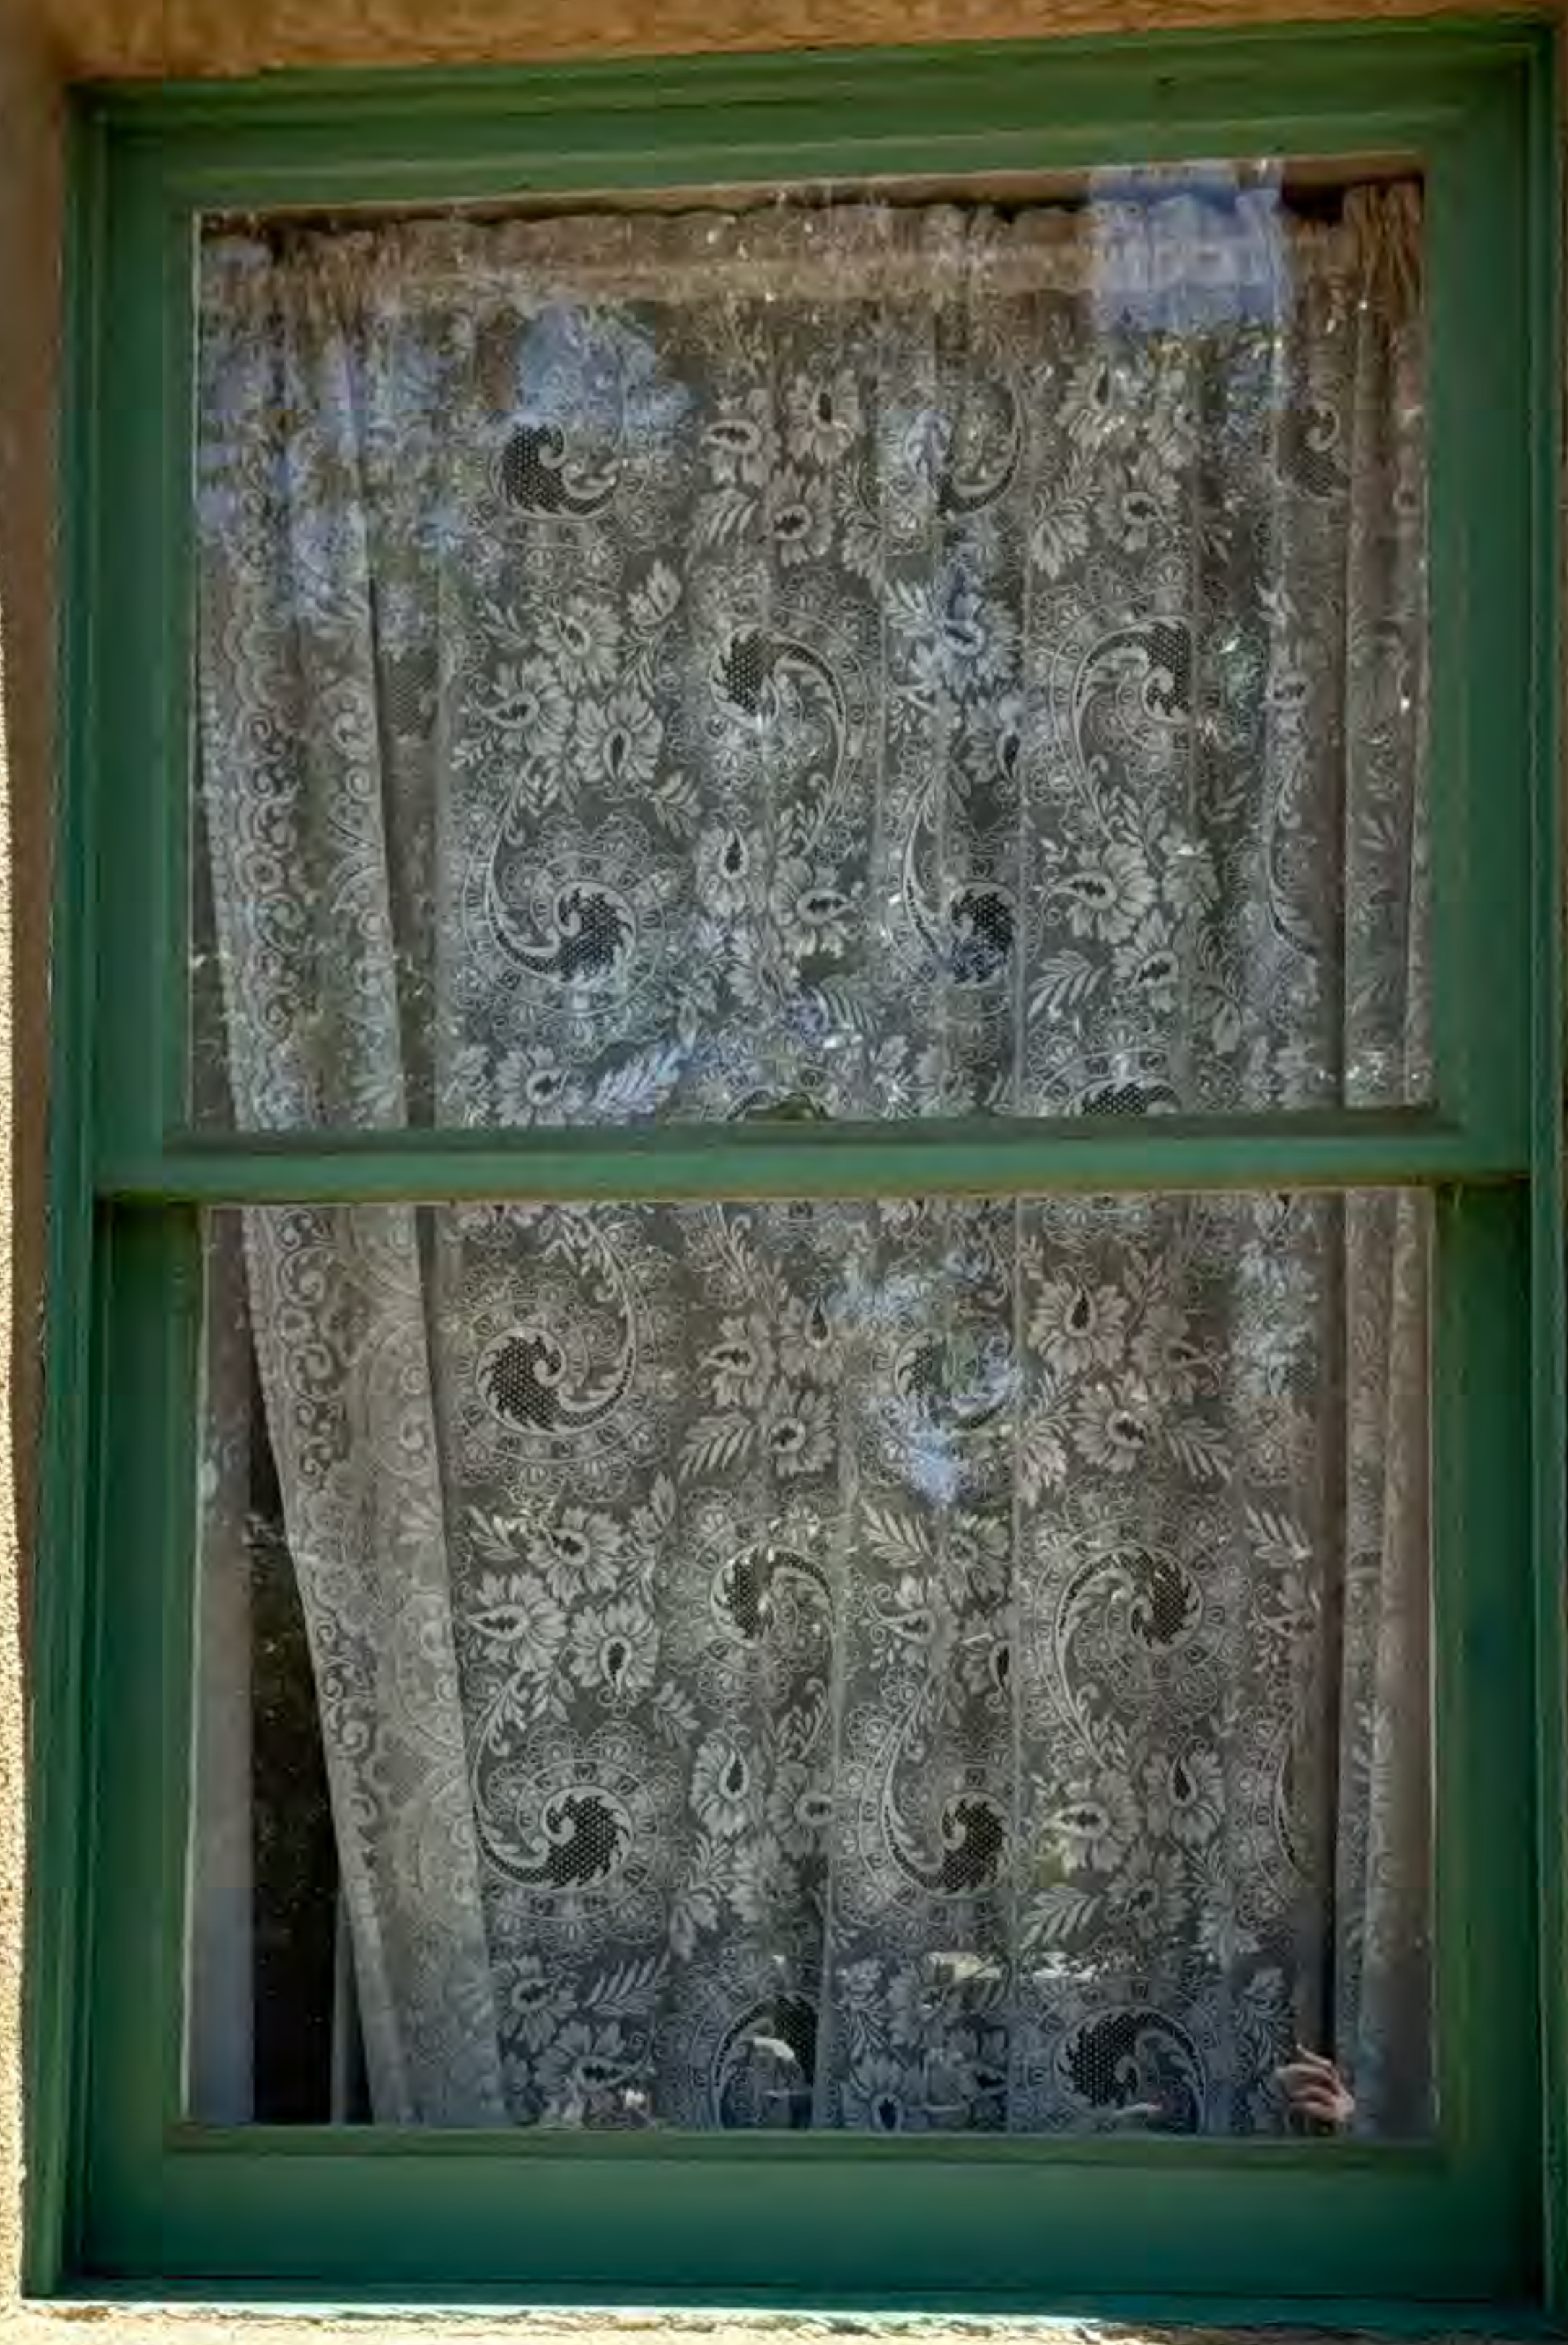
West Elevation  
Window D.

| LABEL | WINDOW & DOOR DESCRIPTION | CONDITION & INTEGRITY CODE | HISTORIC/NON-HISTORIC - AGE |
|---|---|---|---|
| D | 36" x 56" DOUBLE HUNG 1/1 ALL WOOD | S | <b>NON-HISTORIC</b> - SASHES ARE NEWER MACHINED SASHES ROUTERED/SHAPER, NON-DIVIDED LIGHTS, STUCCO SHOWS SIZE OF ORIGINAL OPENING CHANGE (1984) |

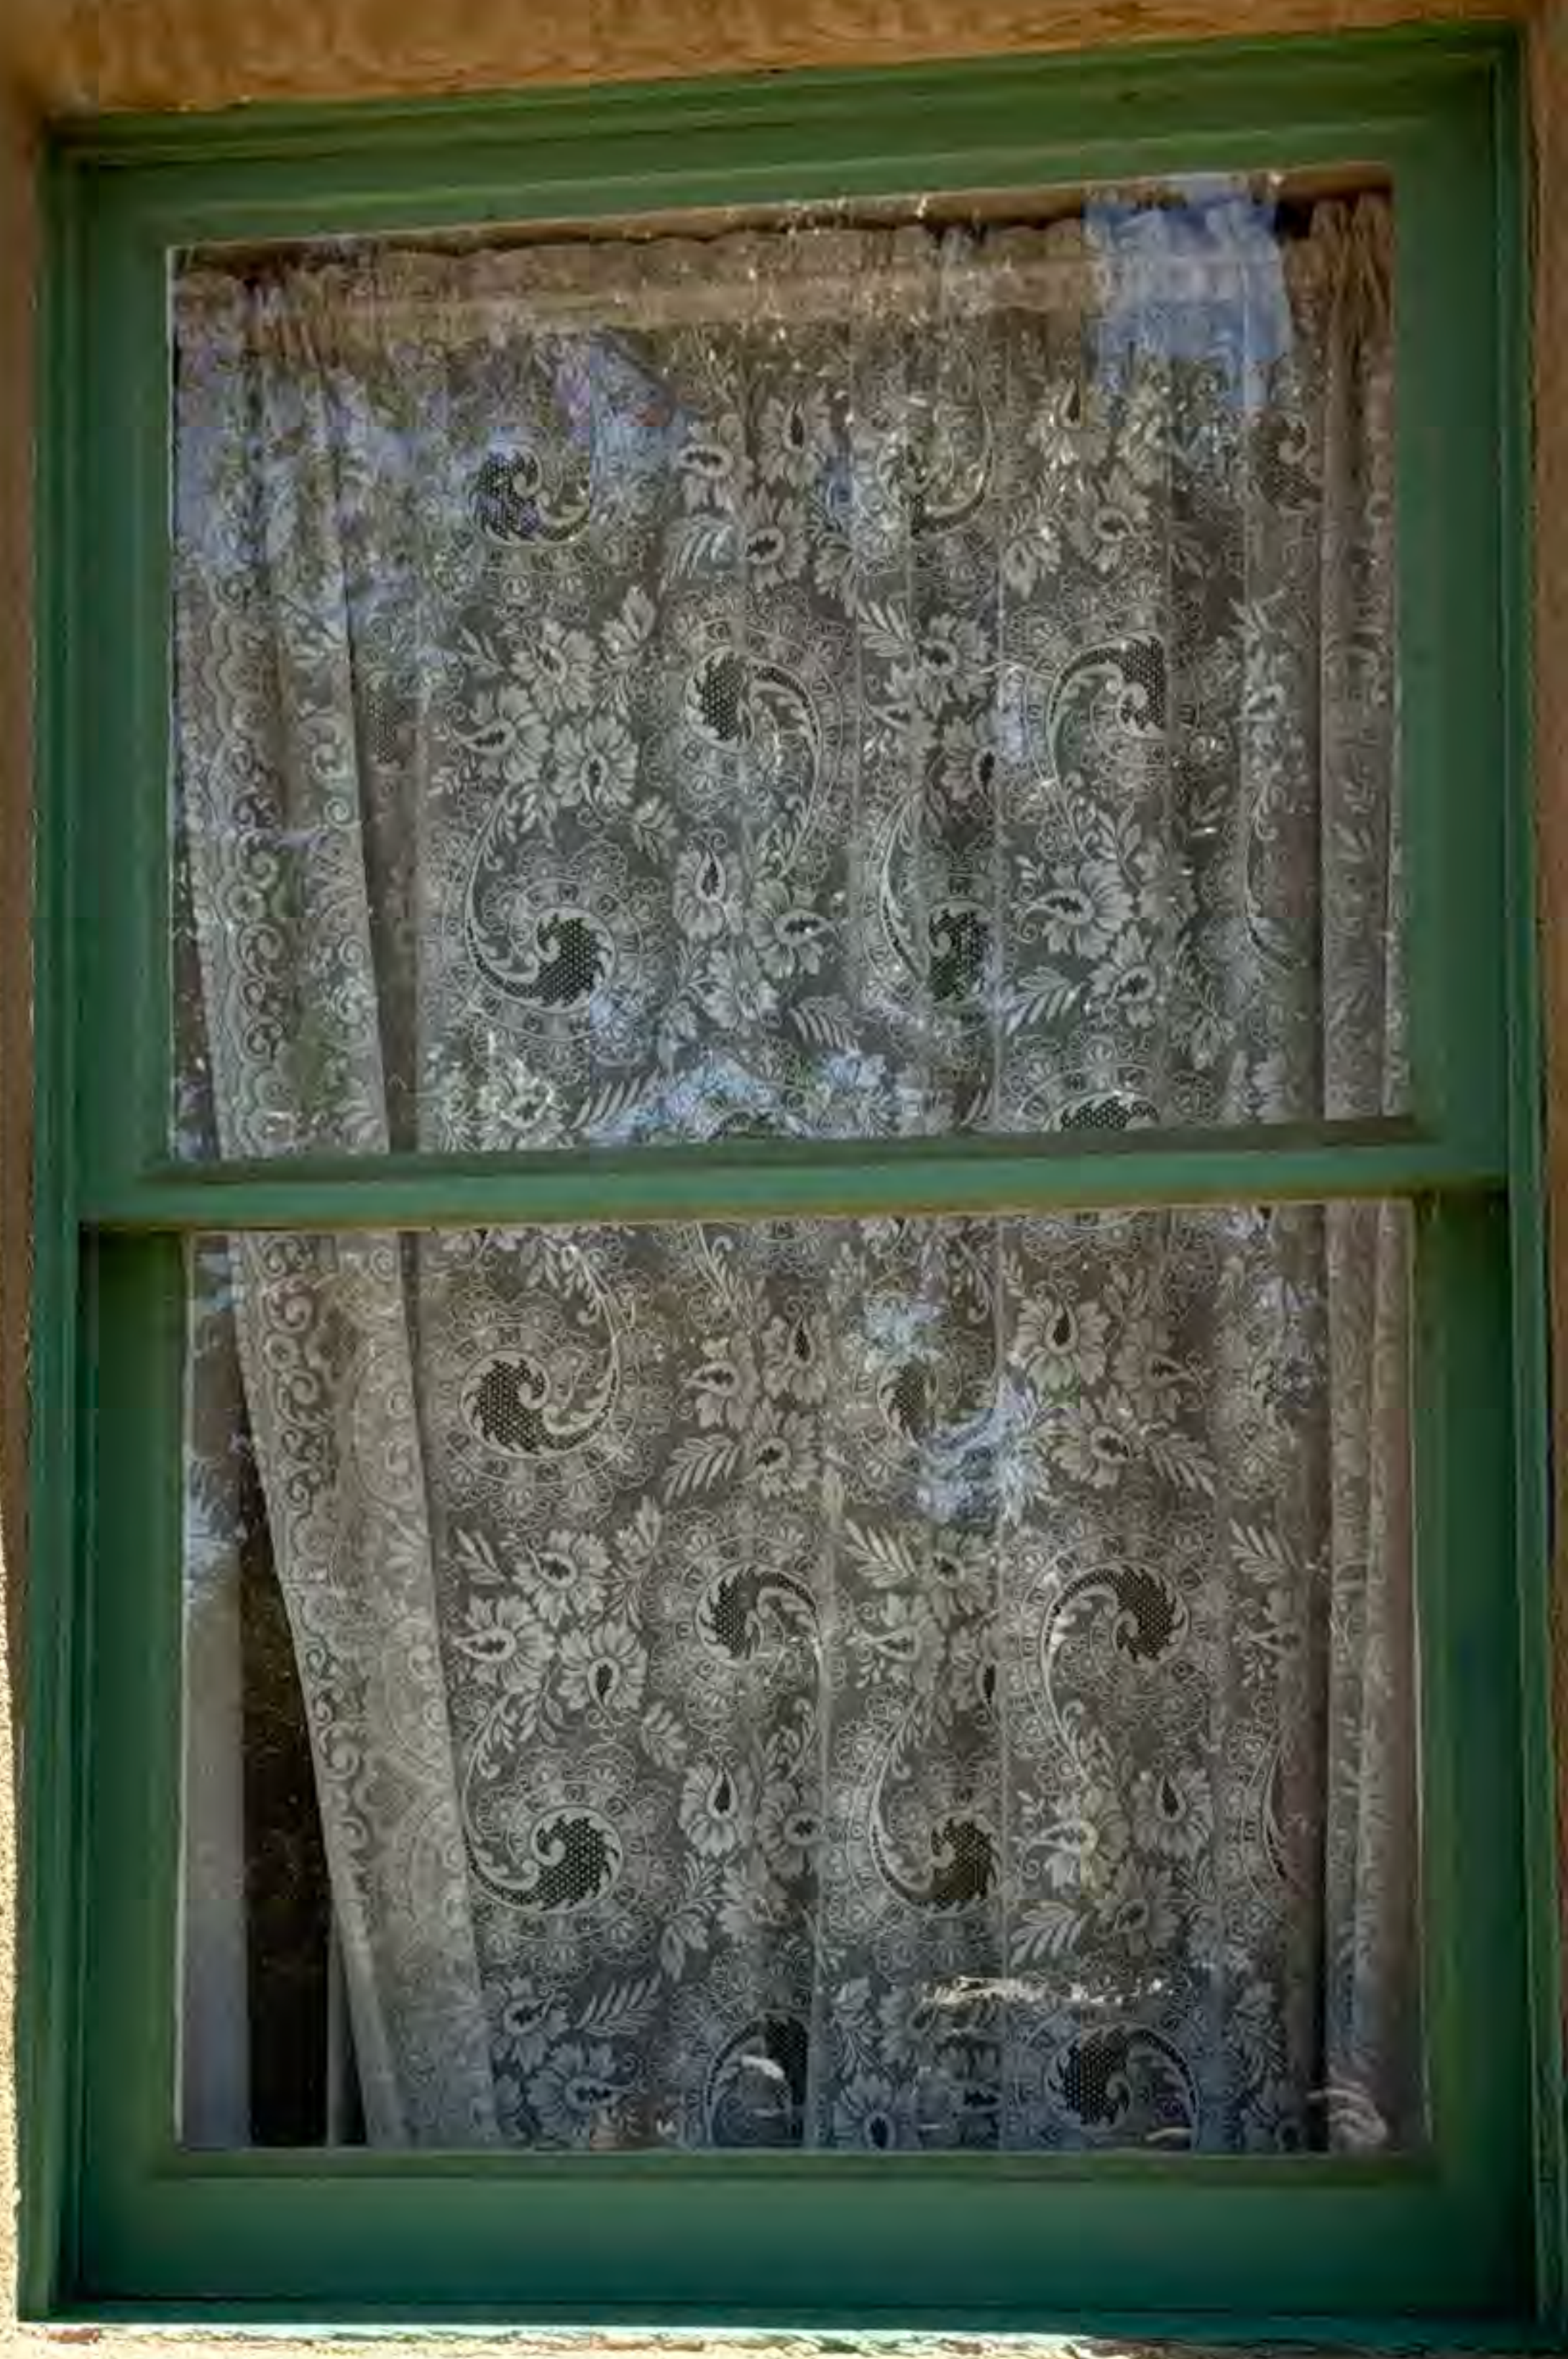
West Elevation  
Window E.

| LABEL | WINDOW & DOOR DESCRIPTION | CONDITION & INTEGRITY CODE | HISTORIC/NON-HISTORIC - AGE |
|---|---|---|---|
| E | 36" x 56" DOUBLE HUNG 1/1 ALL WOOD | S | <b>NON-HISTORIC</b> - SASHES ARE NEWER MACHINED SASHES ROUTERED/SHAPER, NON-DIVIDED LIGHTS, STUCCO SHOWS SIZE OF ORIGINAL OPENING CHANGE (1984) |
