# RPA & Associates LLC

| JOB | DATE |
|---|---|
| 719 Gildersleeve Street, Santa Fe, NM 87505 – MAIN HOUSE | 07/02/2026 |

## RPA & ASSOCIATES, LLC | WINDOW & DOOR CONDITION AND INTEGRITY CODES

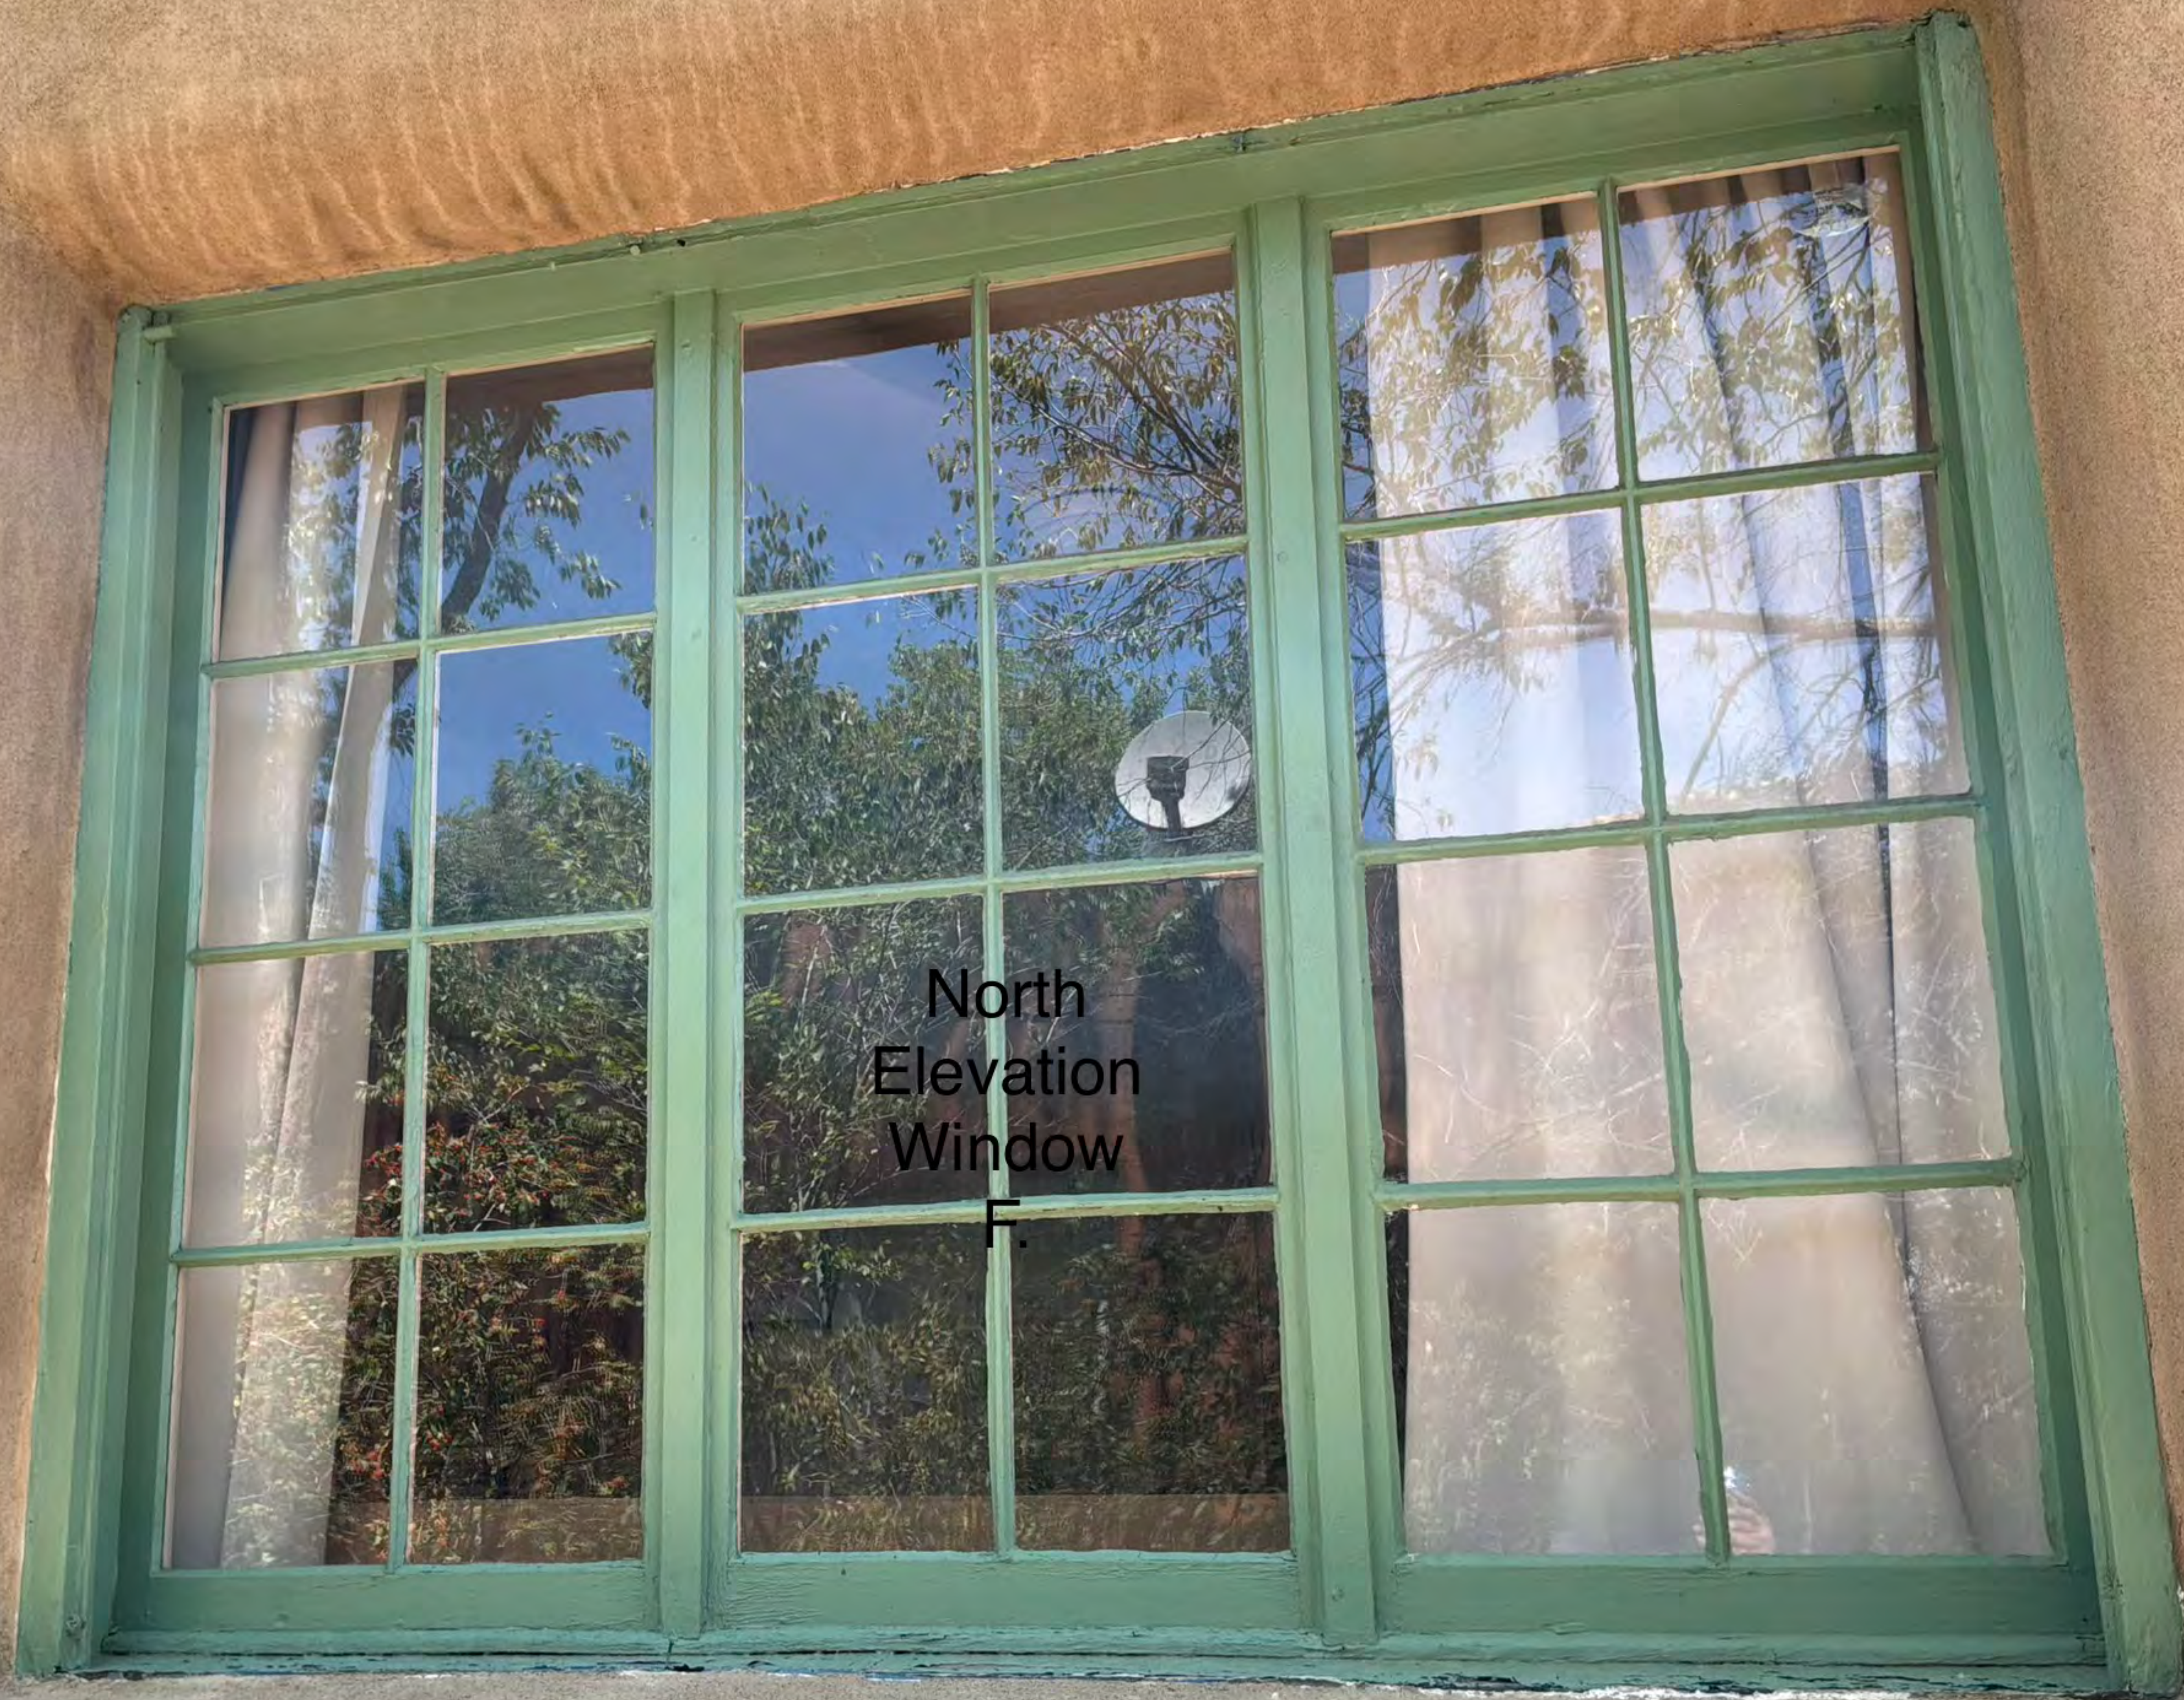
North  
Elevation  
Window  
F.

| LABEL | WINDOW & DOOR DESCRIPTION | CONDITION & INTEGRITY CODE | HISTORIC/NON-HISTORIC - AGE |
|---|---|---|---|
| F | 68" x 54" TRIPLE ALL STATS 2W4H ALL WOOD | U | <b>NON-HISTORIC</b> - SILL ROTTED & BURIED IN STUCCO ALLOWING WATER TO LEAK INTO THE WALL, WINDOW UNIT WAS A ORINGINALLY A TRIPLE DOUBLE HUNG, NON 3 BARNSASHES FROM 1980's IN THE PLACE OF THE DOUBLE HUNGS |

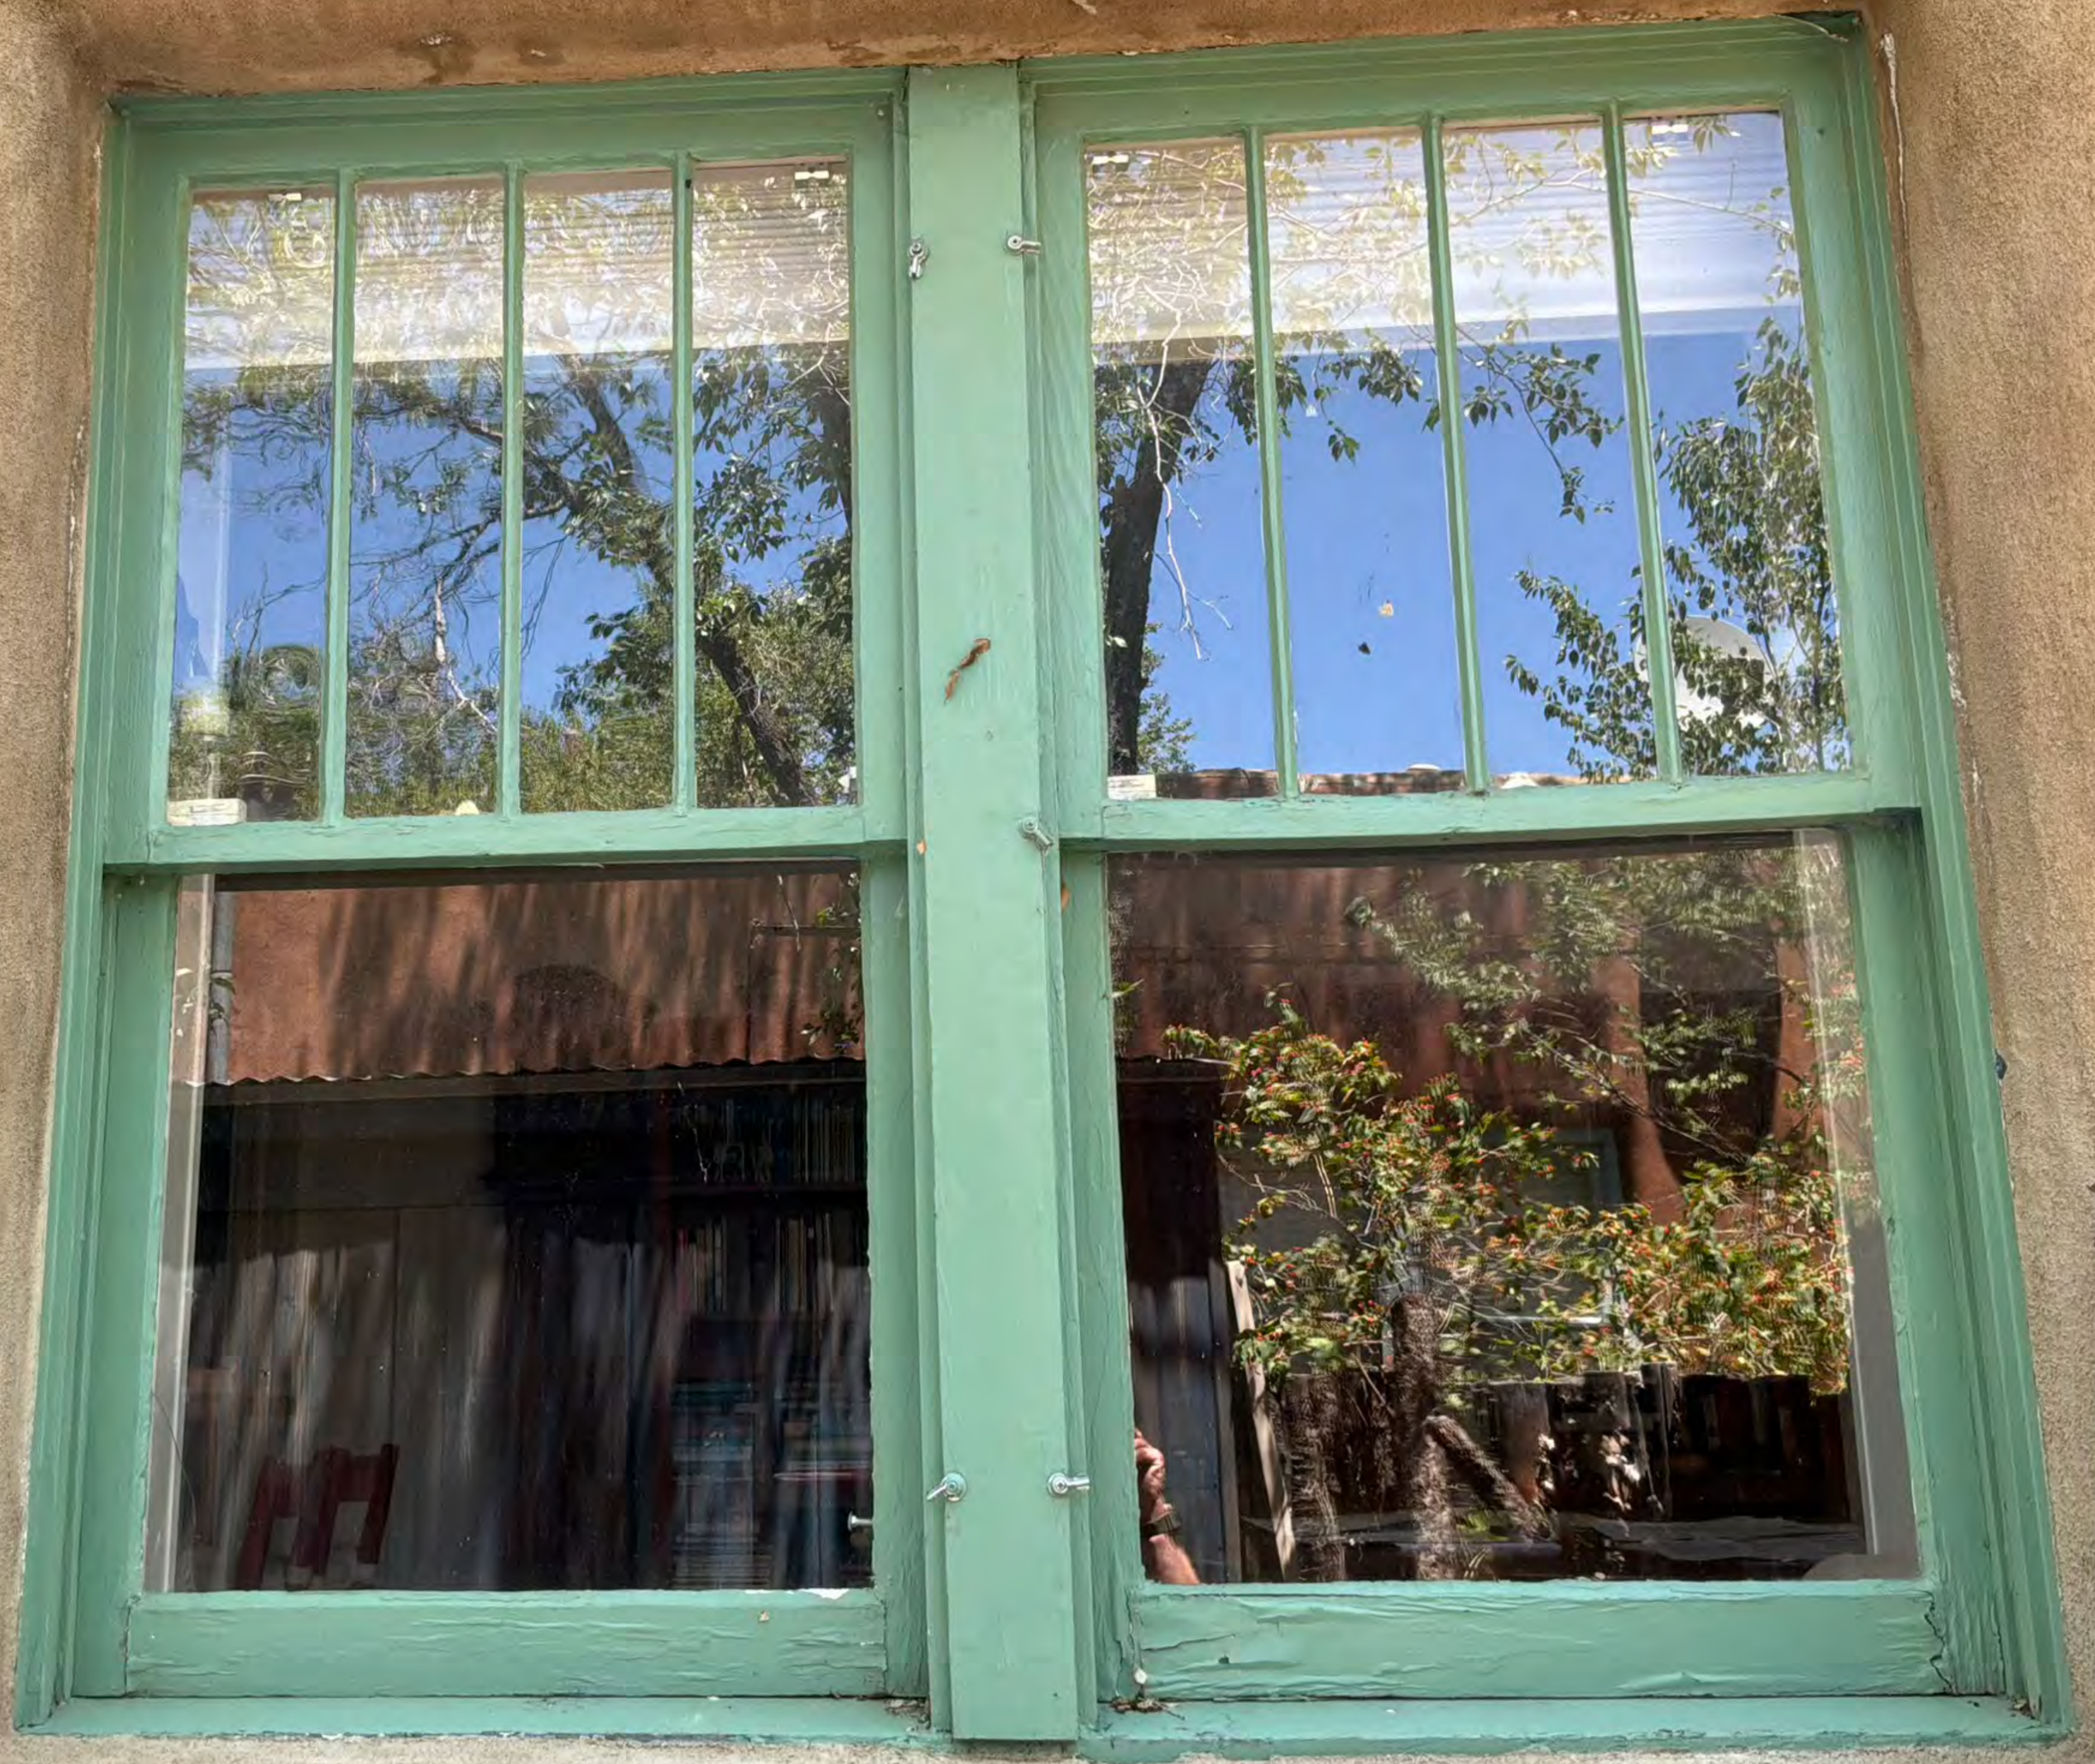
North  
Elevation  
Window G.

Windows G and L are historic however unrestorable.

| LABEL | WINDOW & DOOR DESCRIPTION | CONDITION & INTEGRITY CODE | HISTORIC/NON-HISTORIC - AGE |
|---|---|---|---|
| G | 60" x 56" TWIN DOUBLE HUNG 4W1H/1-LT ALL WOOD (2-28") | U | <b>HISTORIC</b> - SILLS, BOTTOM RAILS OF BOTTOM SASHES, & SIDE JAMBS GOING UP 12" ON EACH SIDE ROTTED BEYOND 40%, SHOWING SIGNS OF WATER LEAKING INTO THE WALL |

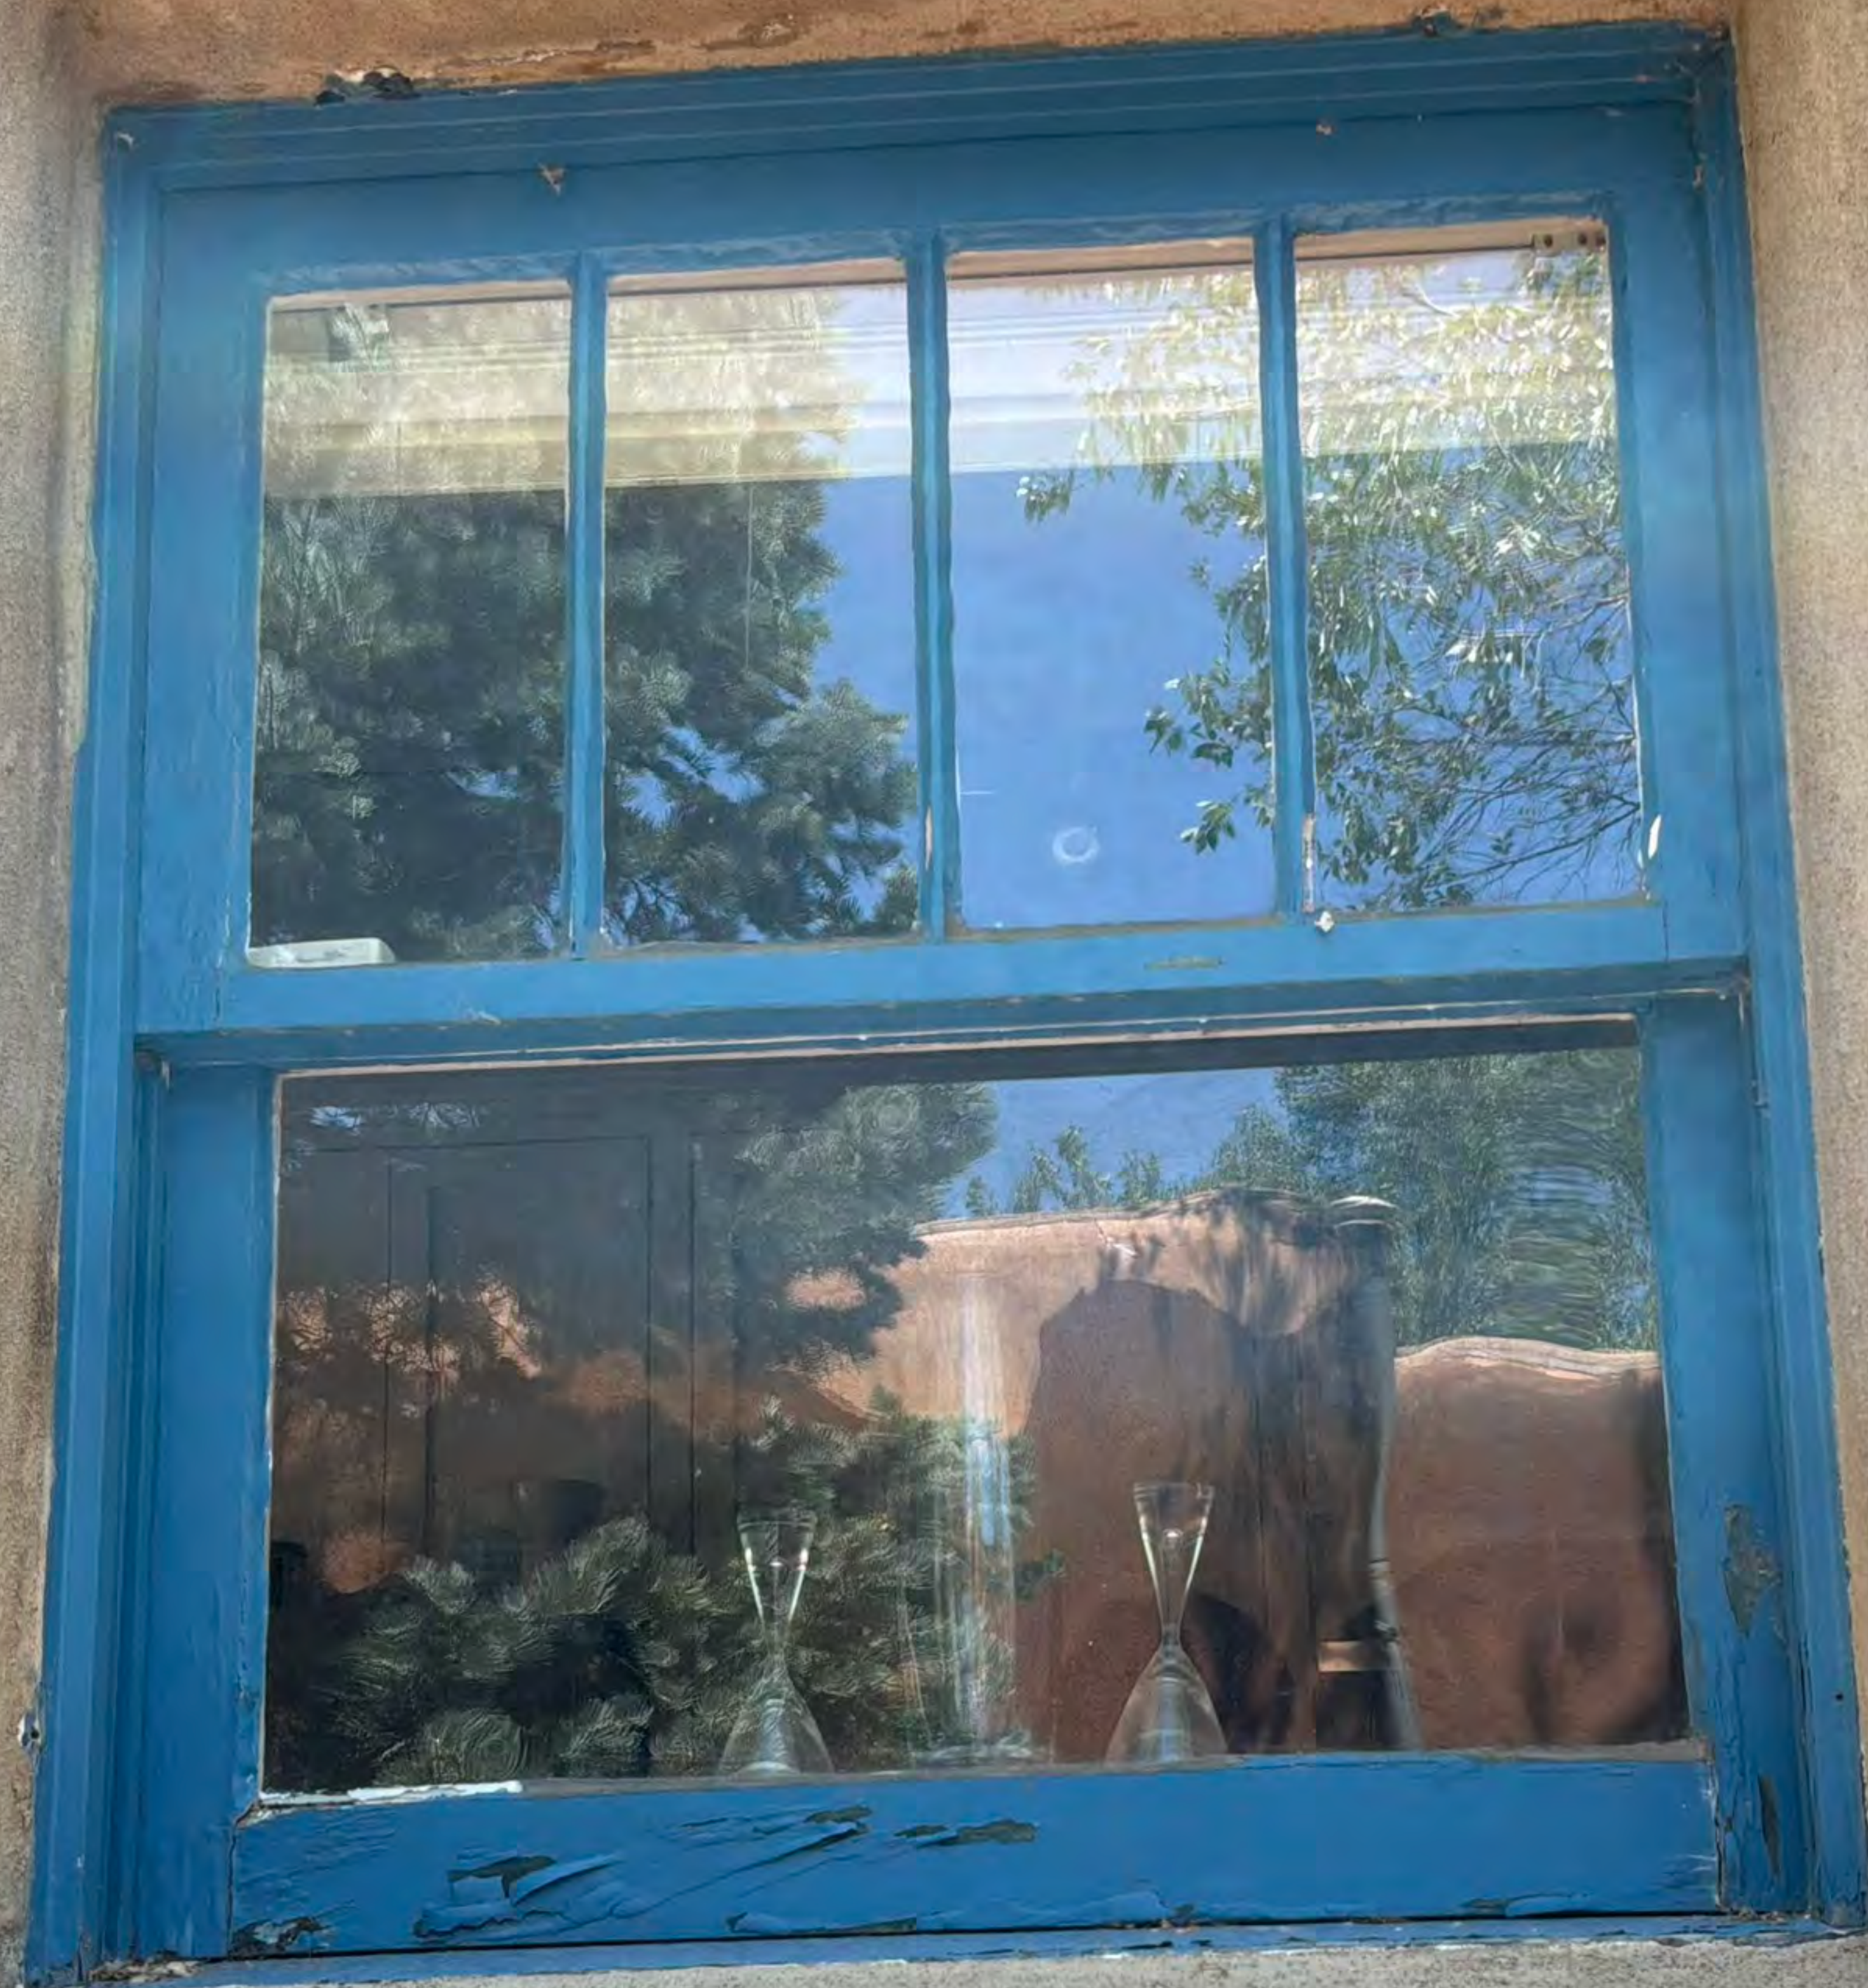
North Elevation  
Window H.

Windows A, B, C, and H are historic and restorable however the units do have considerable rot.

| LABEL | WINDOW & DOOR DESCRIPTION | CONDITION & INTEGRITY CODE | HISTORIC/NON-HISTORIC - AGE |
|---|---|---|---|
| H | 30" x 36" DOUBLE HUNG 4W1H/1-LT ALL WOOD | F | <b>HISTORIC</b> |

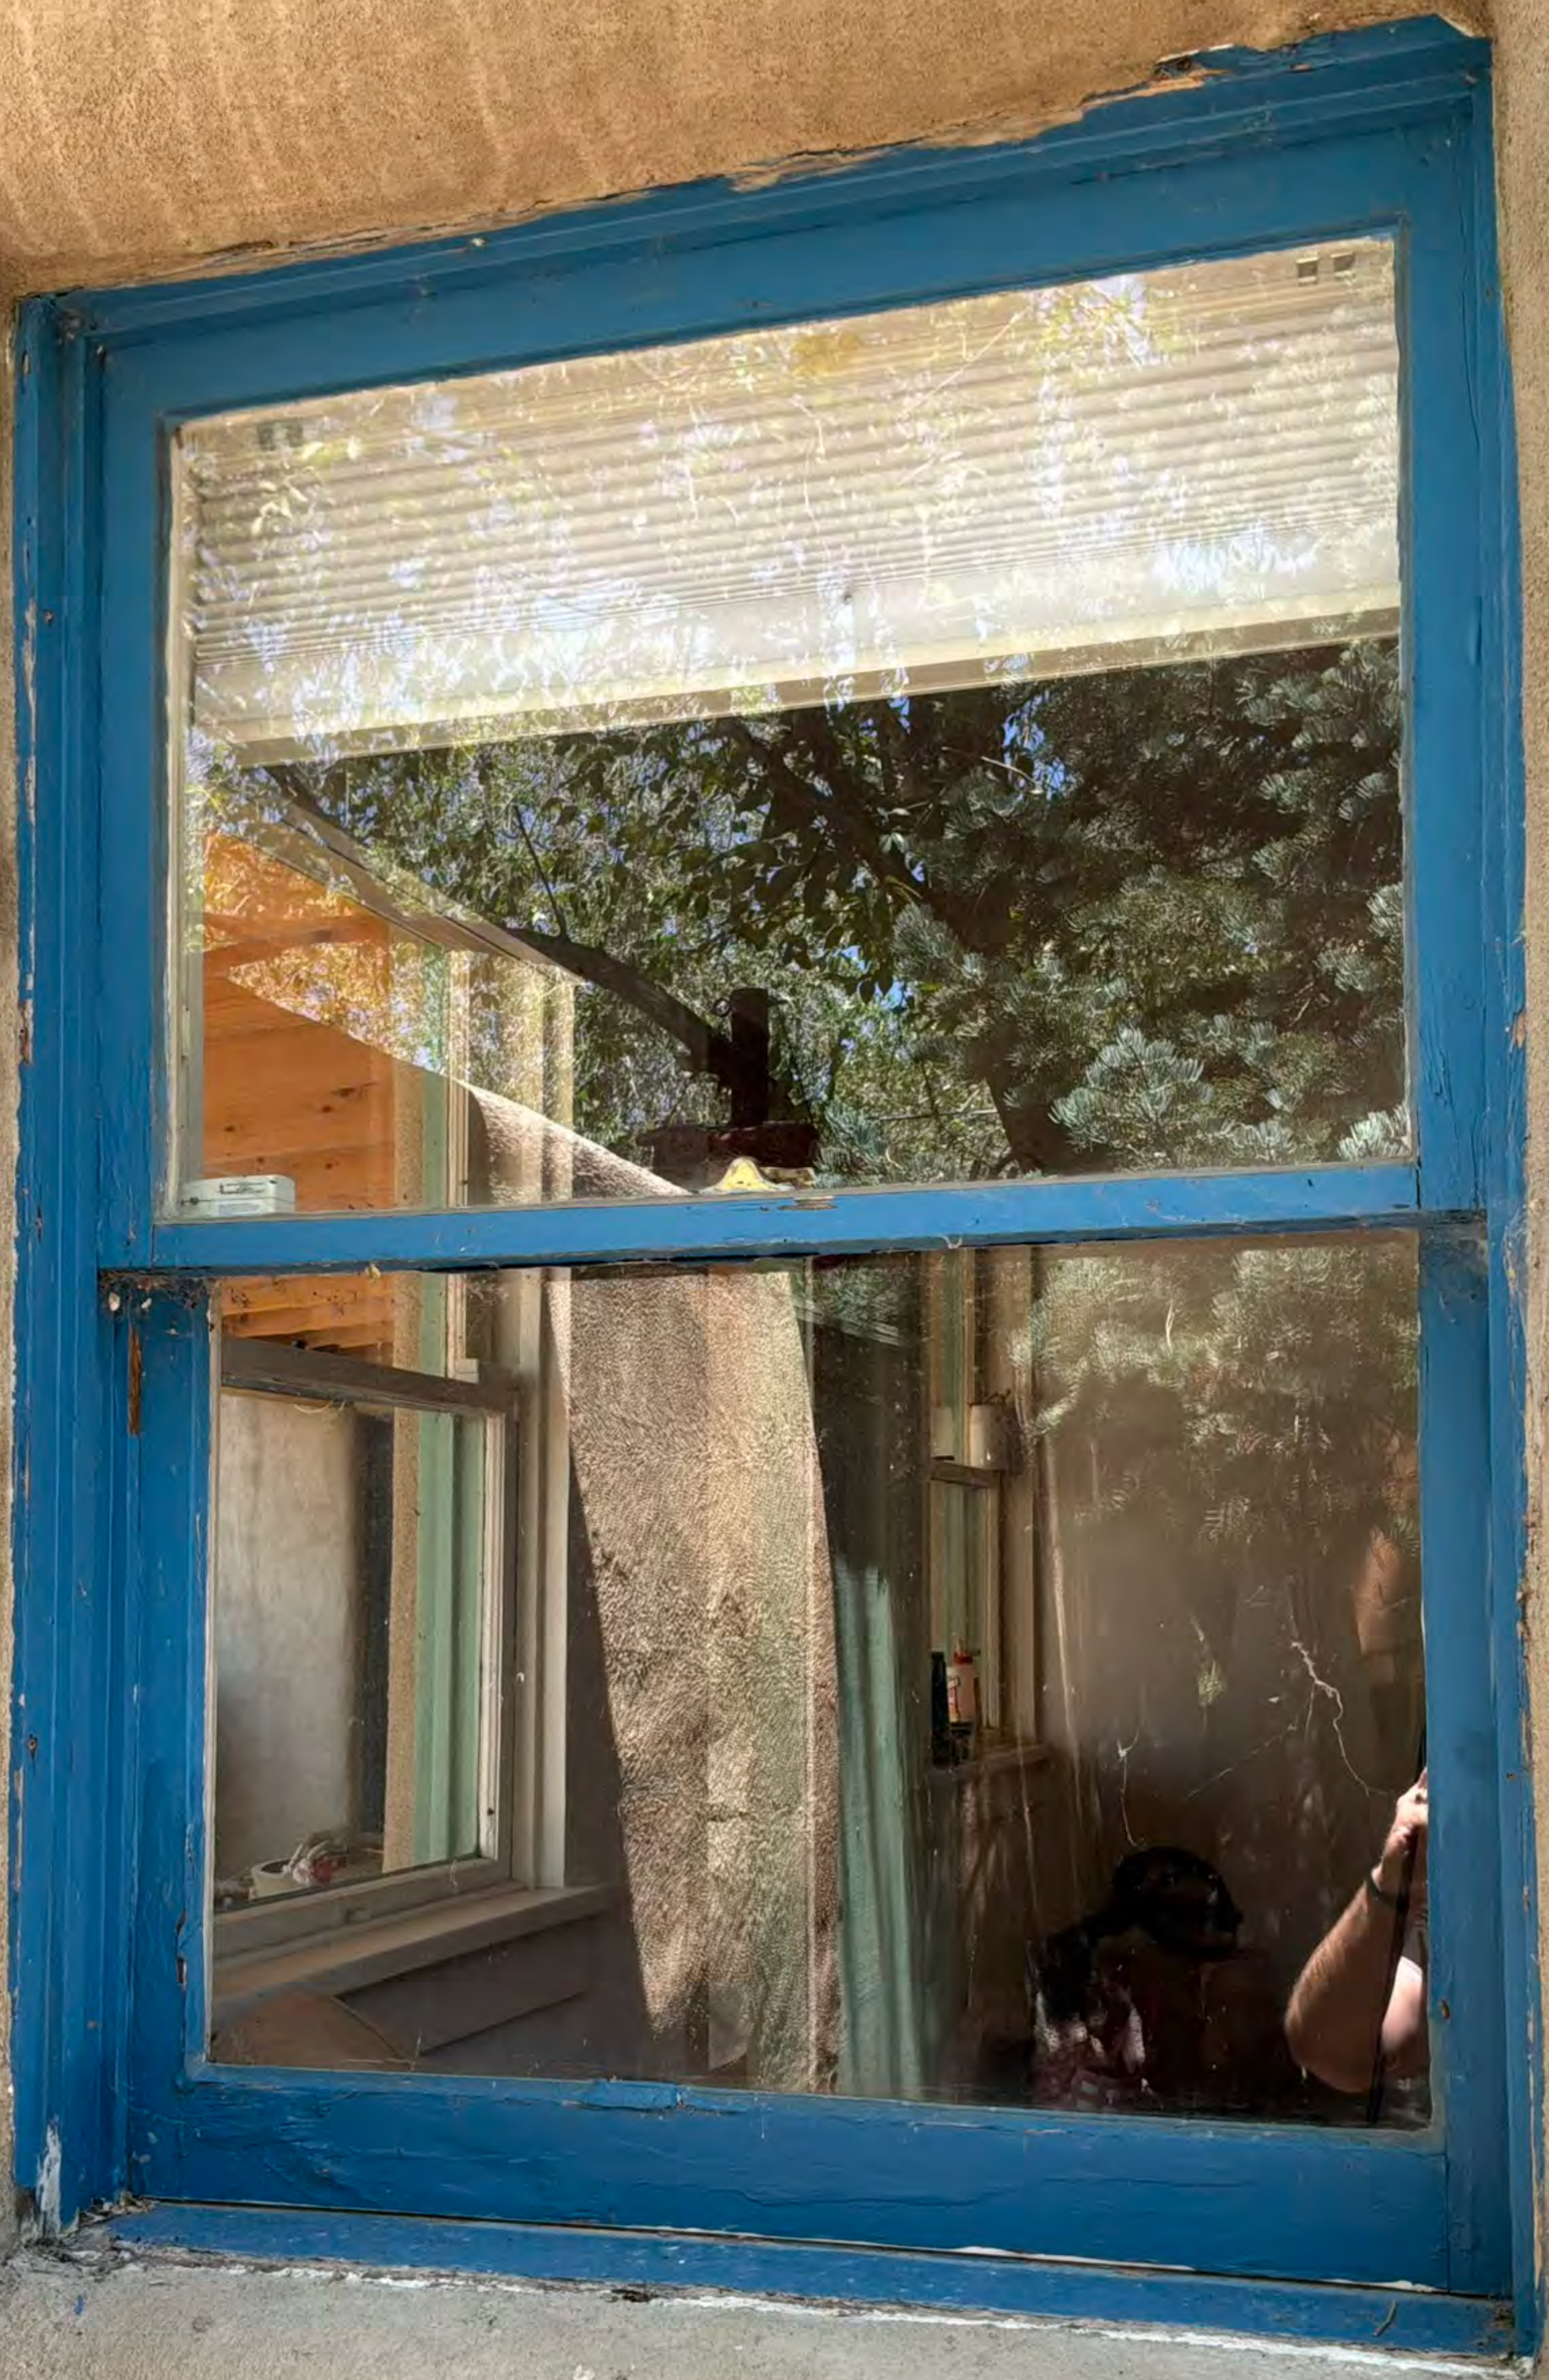
North Elevation  
Window I.

| LABEL | WINDOW & DOOR DESCRIPTION | CONDITION & INTEGRITY CODE | HISTORIC/NON-HISTORIC - AGE |
|---|---|---|---|
| I | 36" x 48" DOUBLE HUNG 1/1 1-LT ALL WOOD | U | <b>NON-HISTORIC</b> - SILL, BOTTOM RAIL OF BOTTOM SASH, & SIDE JAMBS ROTTED BEYOND 40%, ALLOWING WATER TO LEAK INTO THE WALL, NO DIVIDED LIGHTS (1984) |

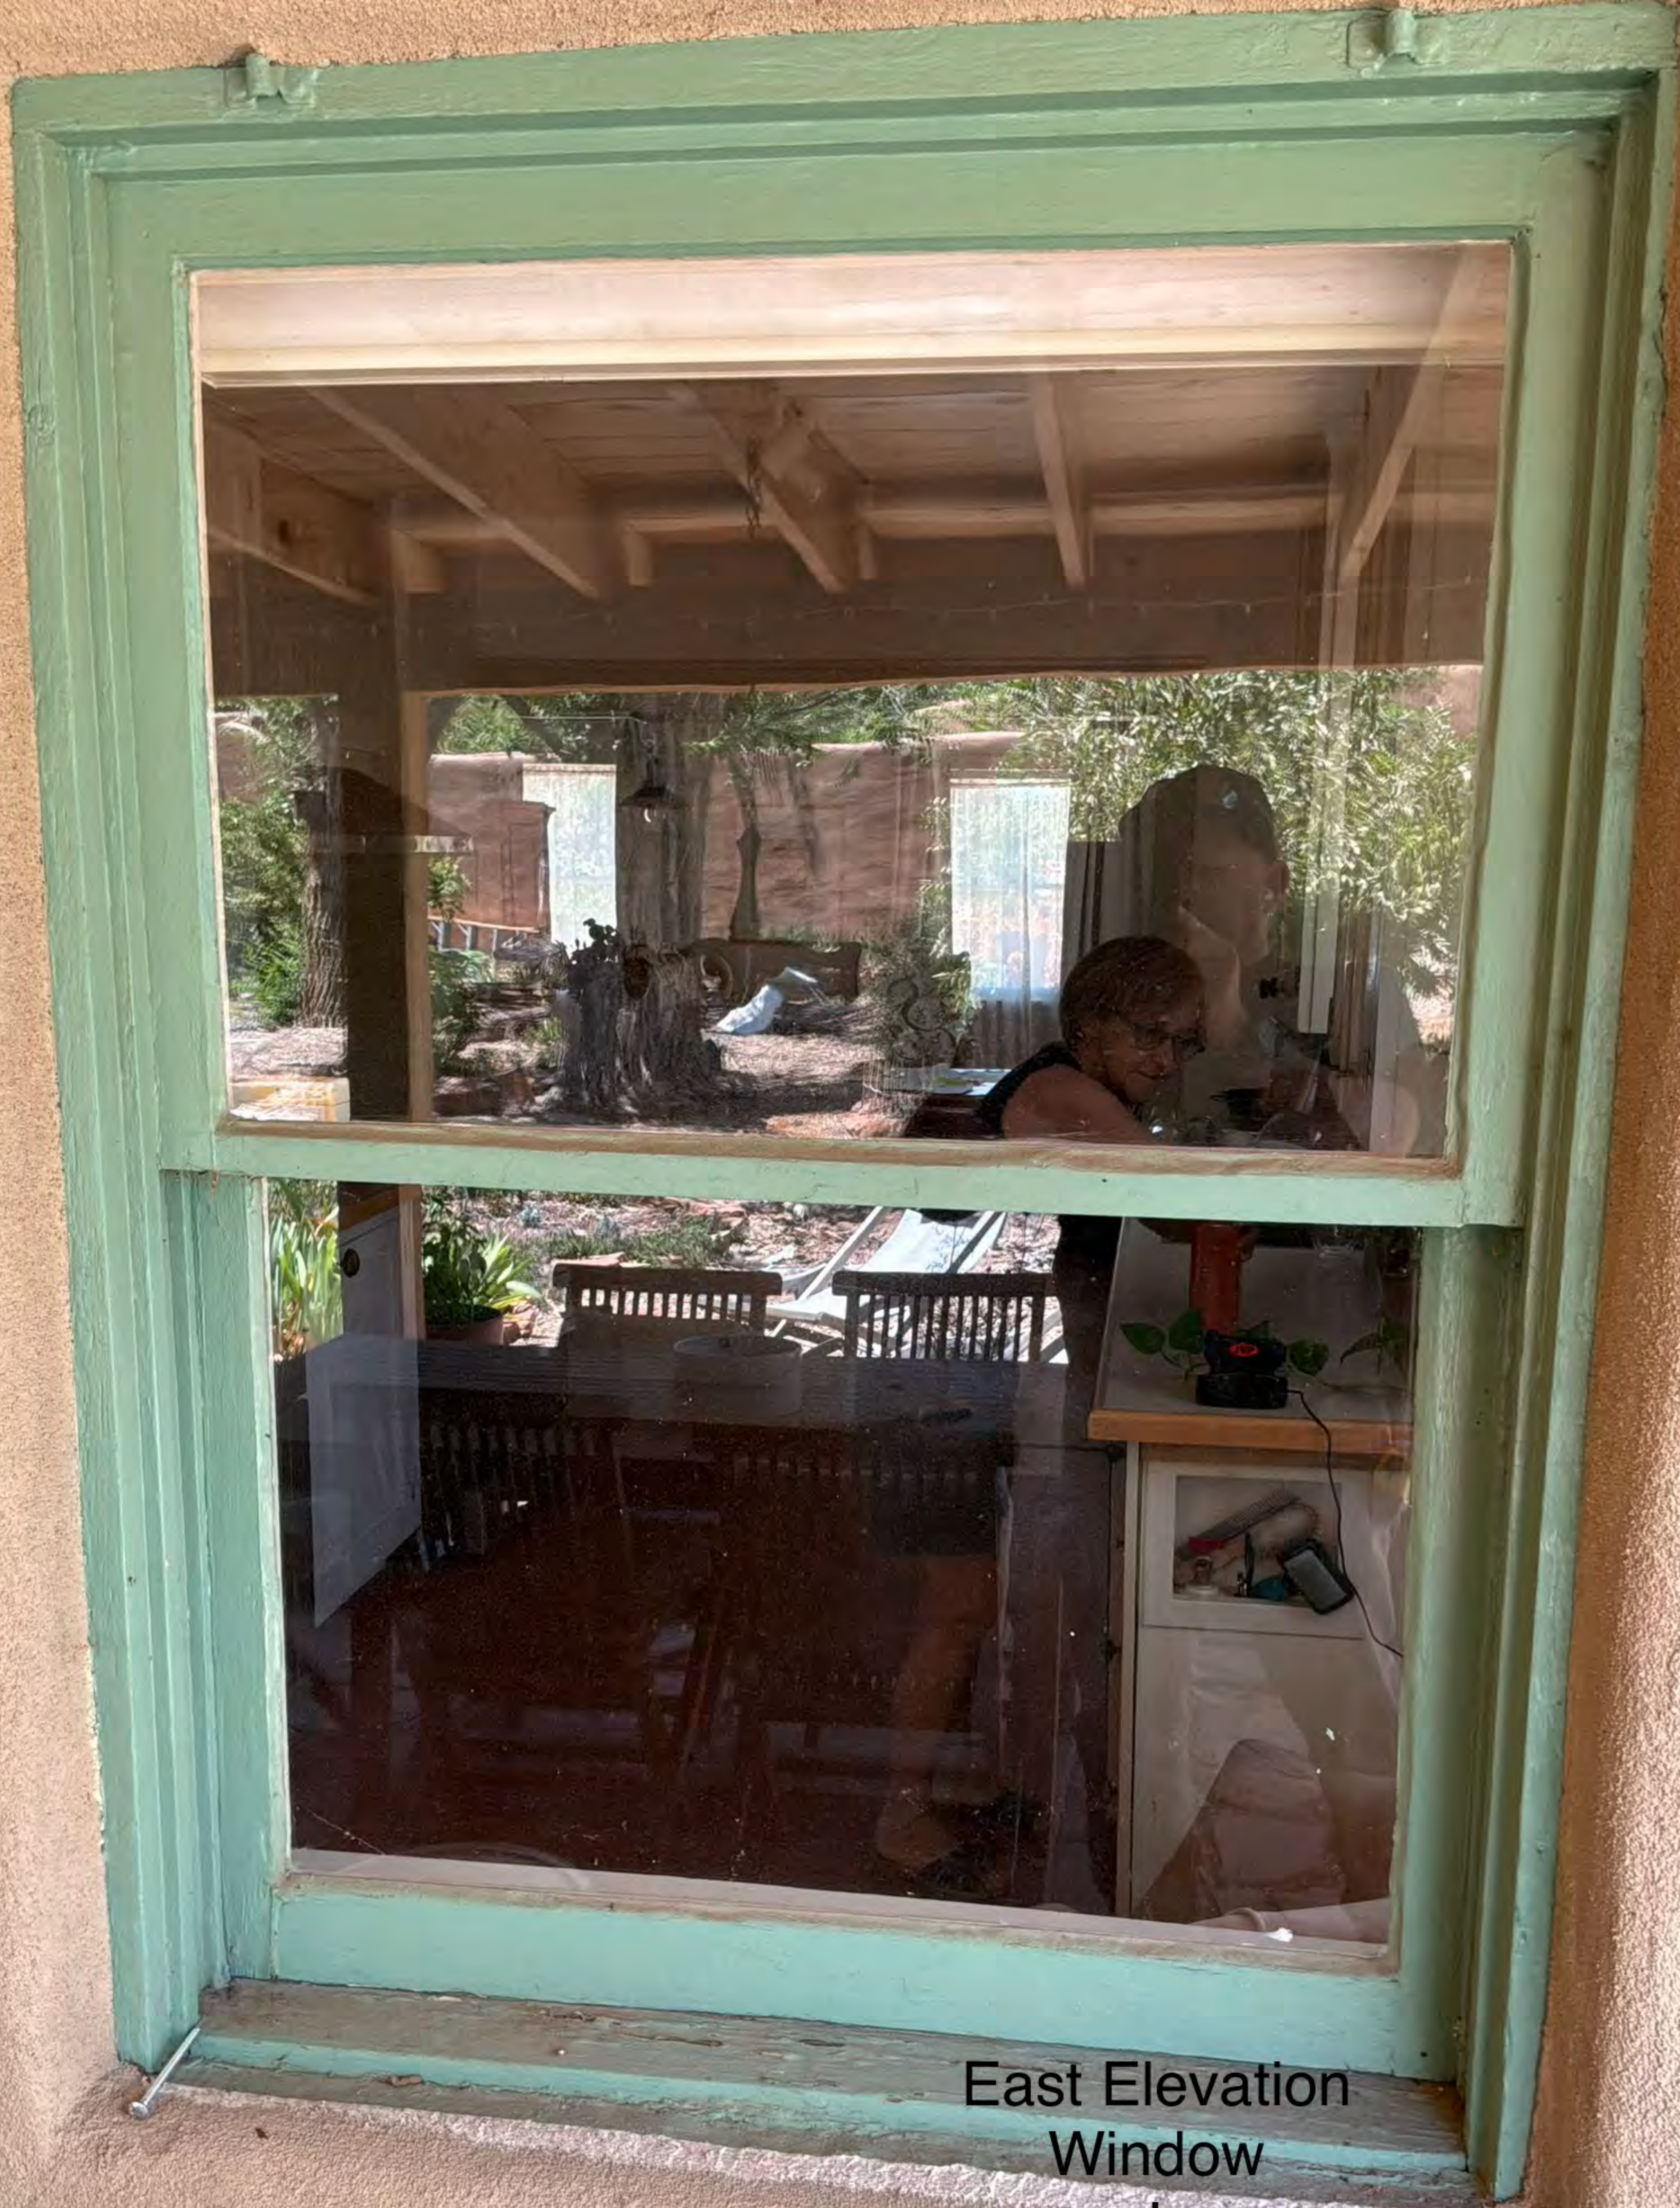
East Elevation  
Window  
J.

| LABEL | WINDOW & DOOR DESCRIPTION | CONDITION & INTEGRITY CODE | HISTORIC/NON-HISTORIC - AGE |
|---|---|---|---|
| J | 36" x 48" DOUBLE HUNG 1/1 1-LT ALL WOOD | F | <b>NON-HISTORIC</b> - NO DIVIDED LIGHTS (1984) |

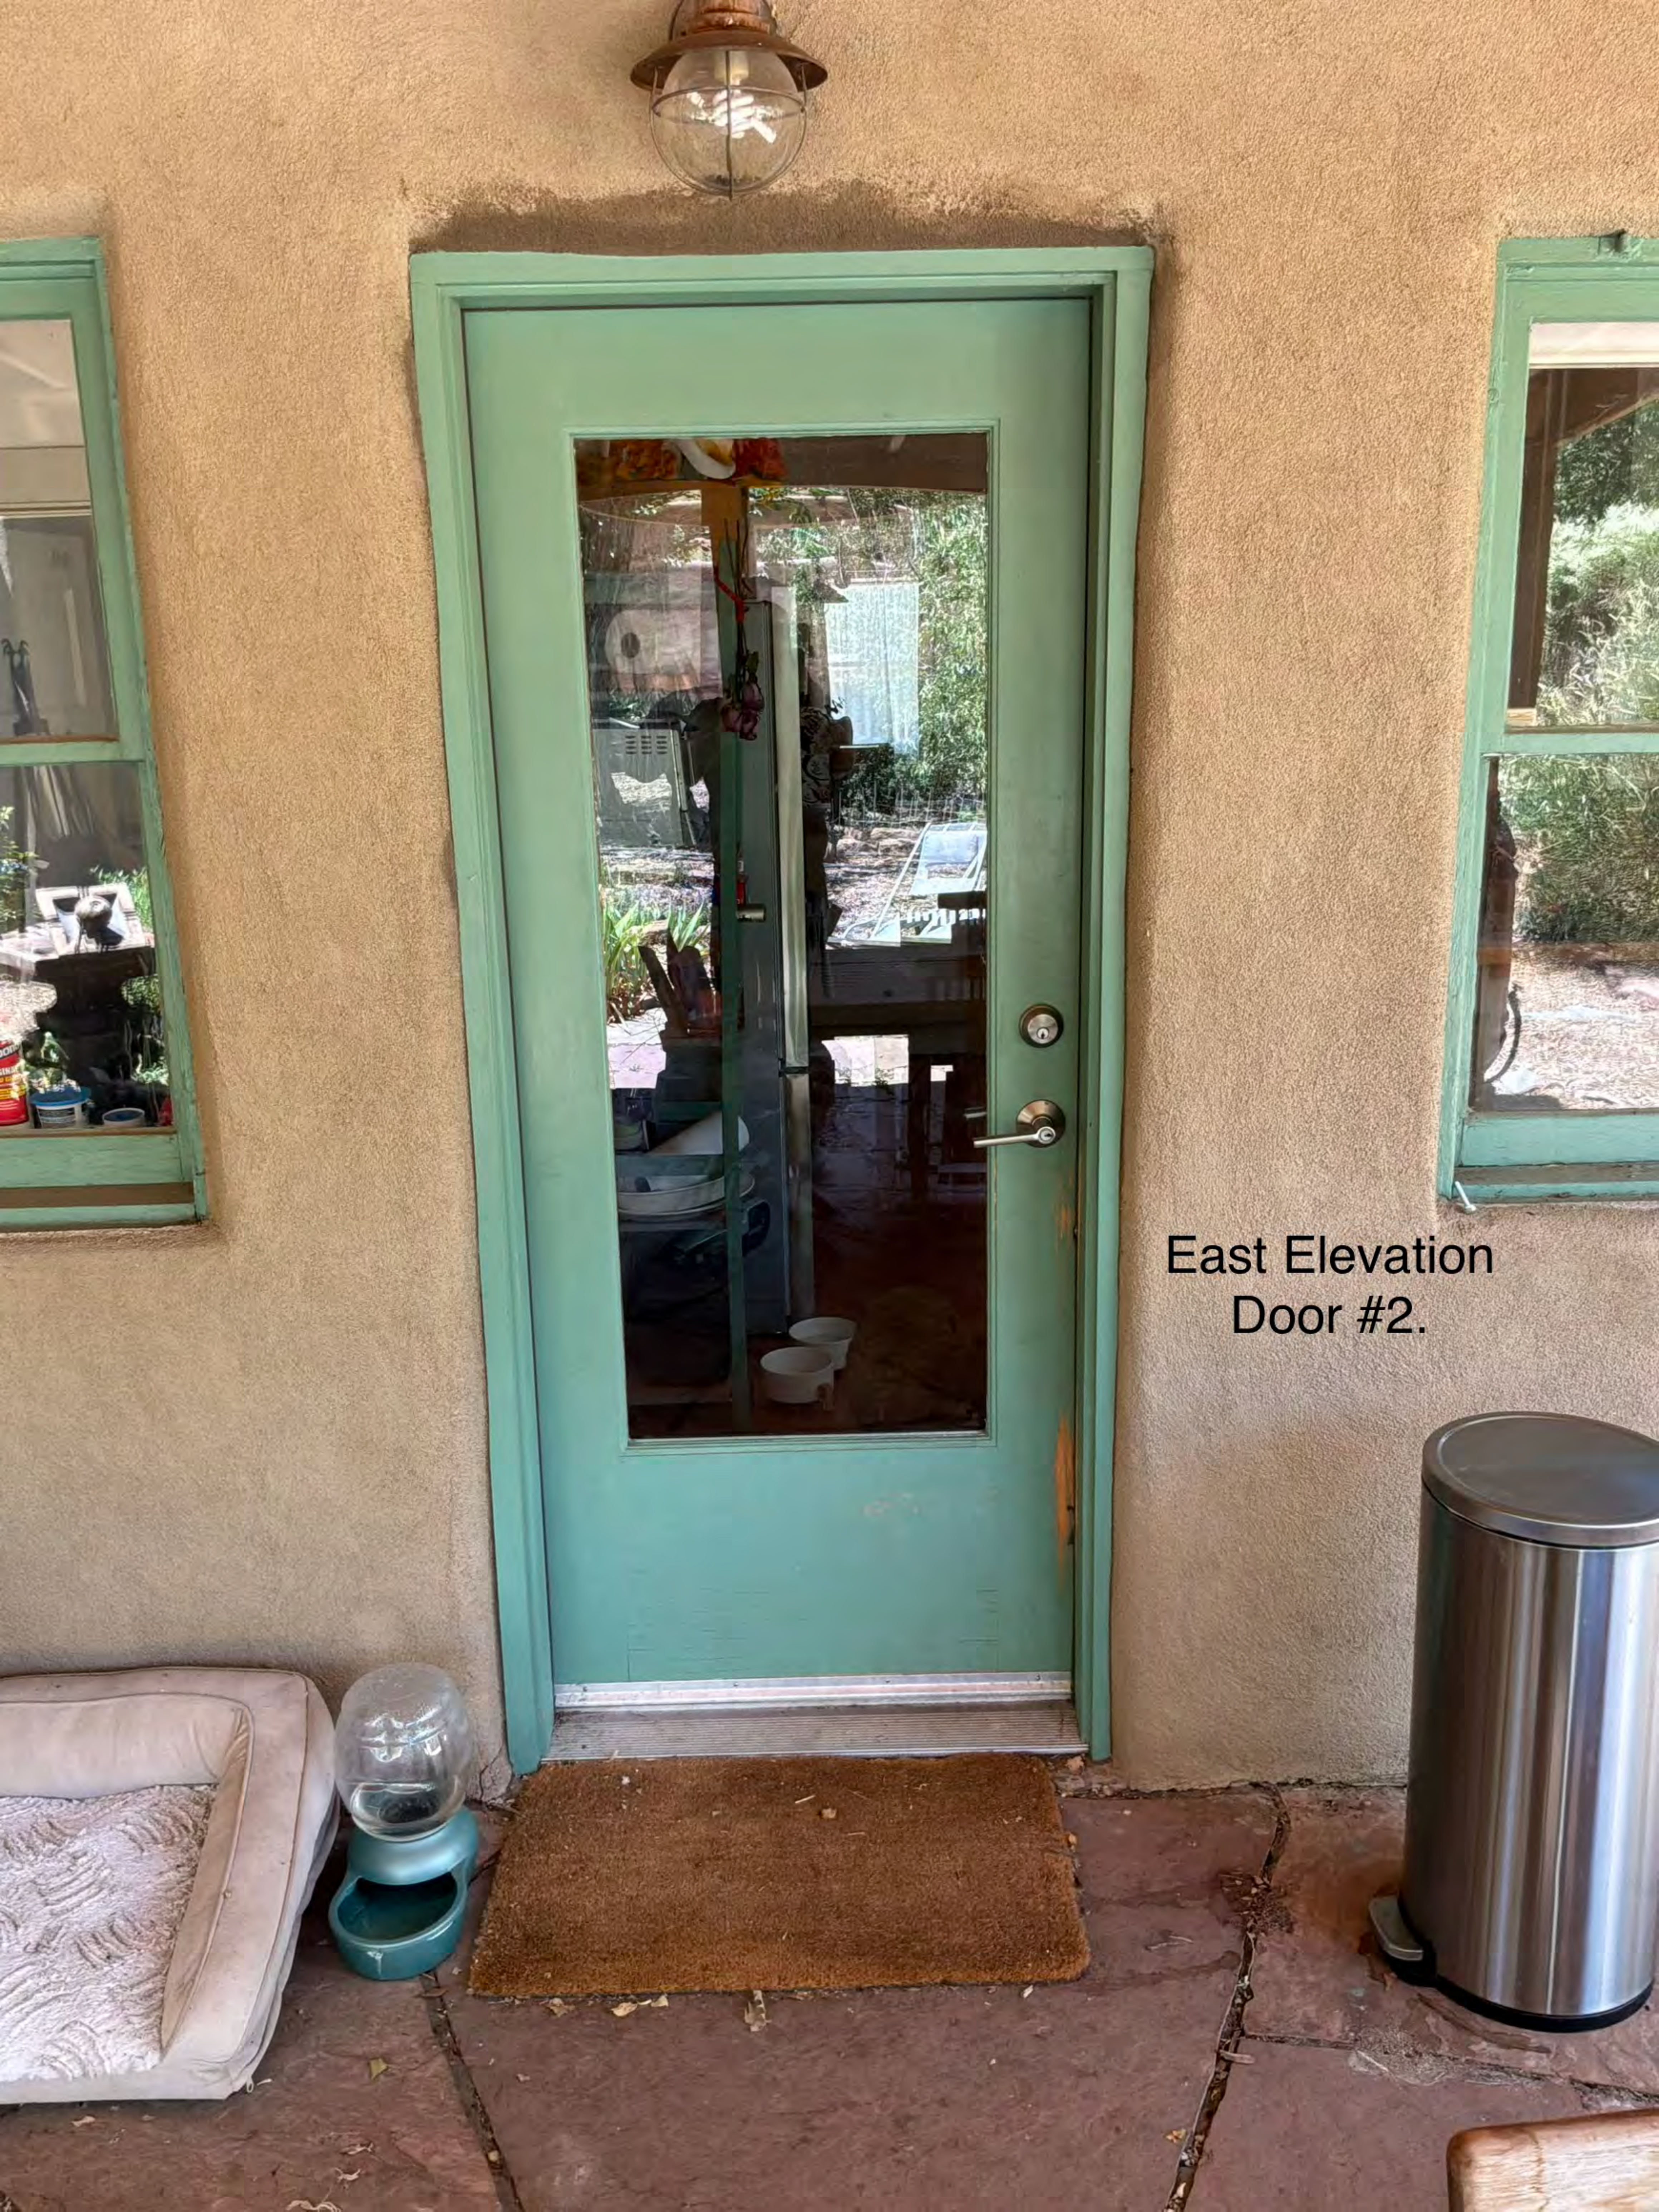
East Elevation  
Door #2.

Doors 1 and 2 are non-historic.

| LABEL | WINDOW & DOOR DESCRIPTION | CONDITION & INTEGRITY CODE | HISTORIC/NON-HISTORIC - AGE |
|---|---|---|---|
| DR #2 | 32" x 80" LH INSWING 1-LT ALL WOOD DOOR 18" BOTTOM RAIL | S | <b>NON-HISTORIC</b> - SIMPSON DOOR (2013) |
