# RPA & Associates LLC

| JOB | DATE |
|---|---|
| 719 Gildersleeve Street, Santa Fe, NM 87505 – MAIN HOUSE | 07/02/2026 |

## RPA & ASSOCIATES, LLC | WINDOW & DOOR CONDITION AND INTEGRITY CODES

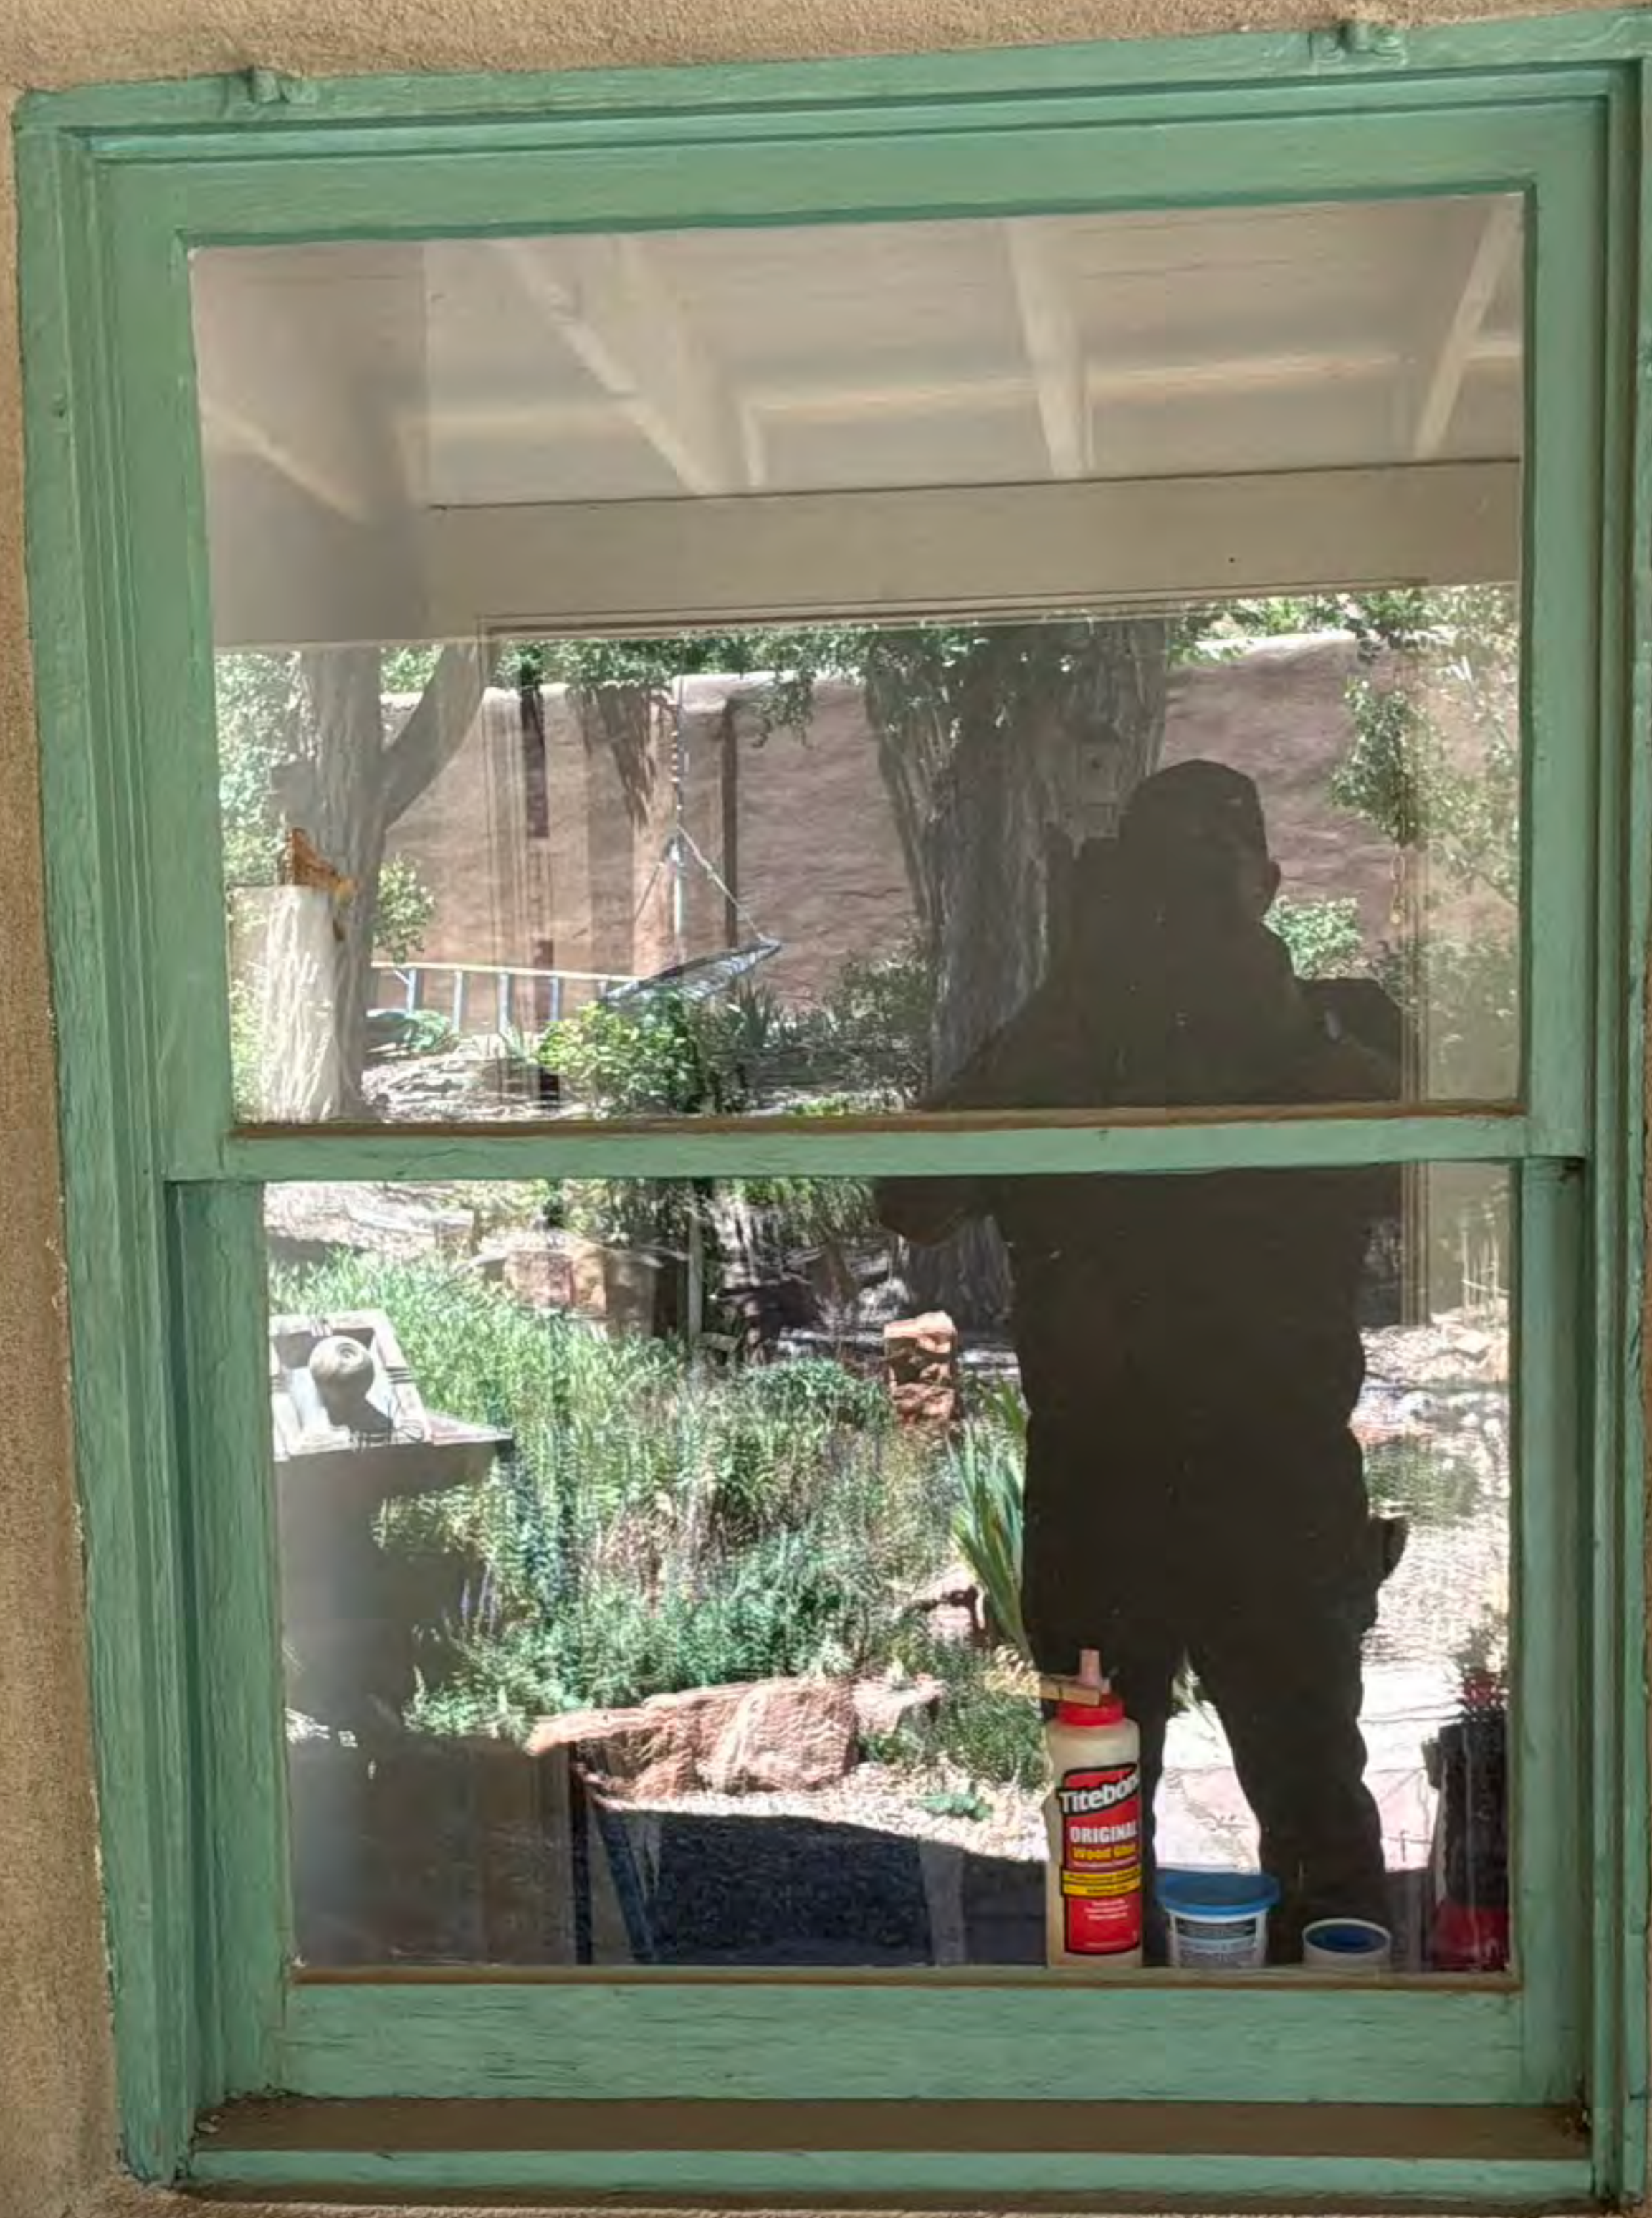
East Elevation  
Window  
K.

| LABEL | WINDOW & DOOR DESCRIPTION | CONDITION & INTEGRITY CODE | HISTORIC/NON-HISTORIC - AGE |
|---|---|---|---|
| K | 36" x 48" DOUBLE HUNG 1/1 1-LT | F | <b>NON-HISTORIC</b> - NO DIVIDED LIGHTS (1984) |

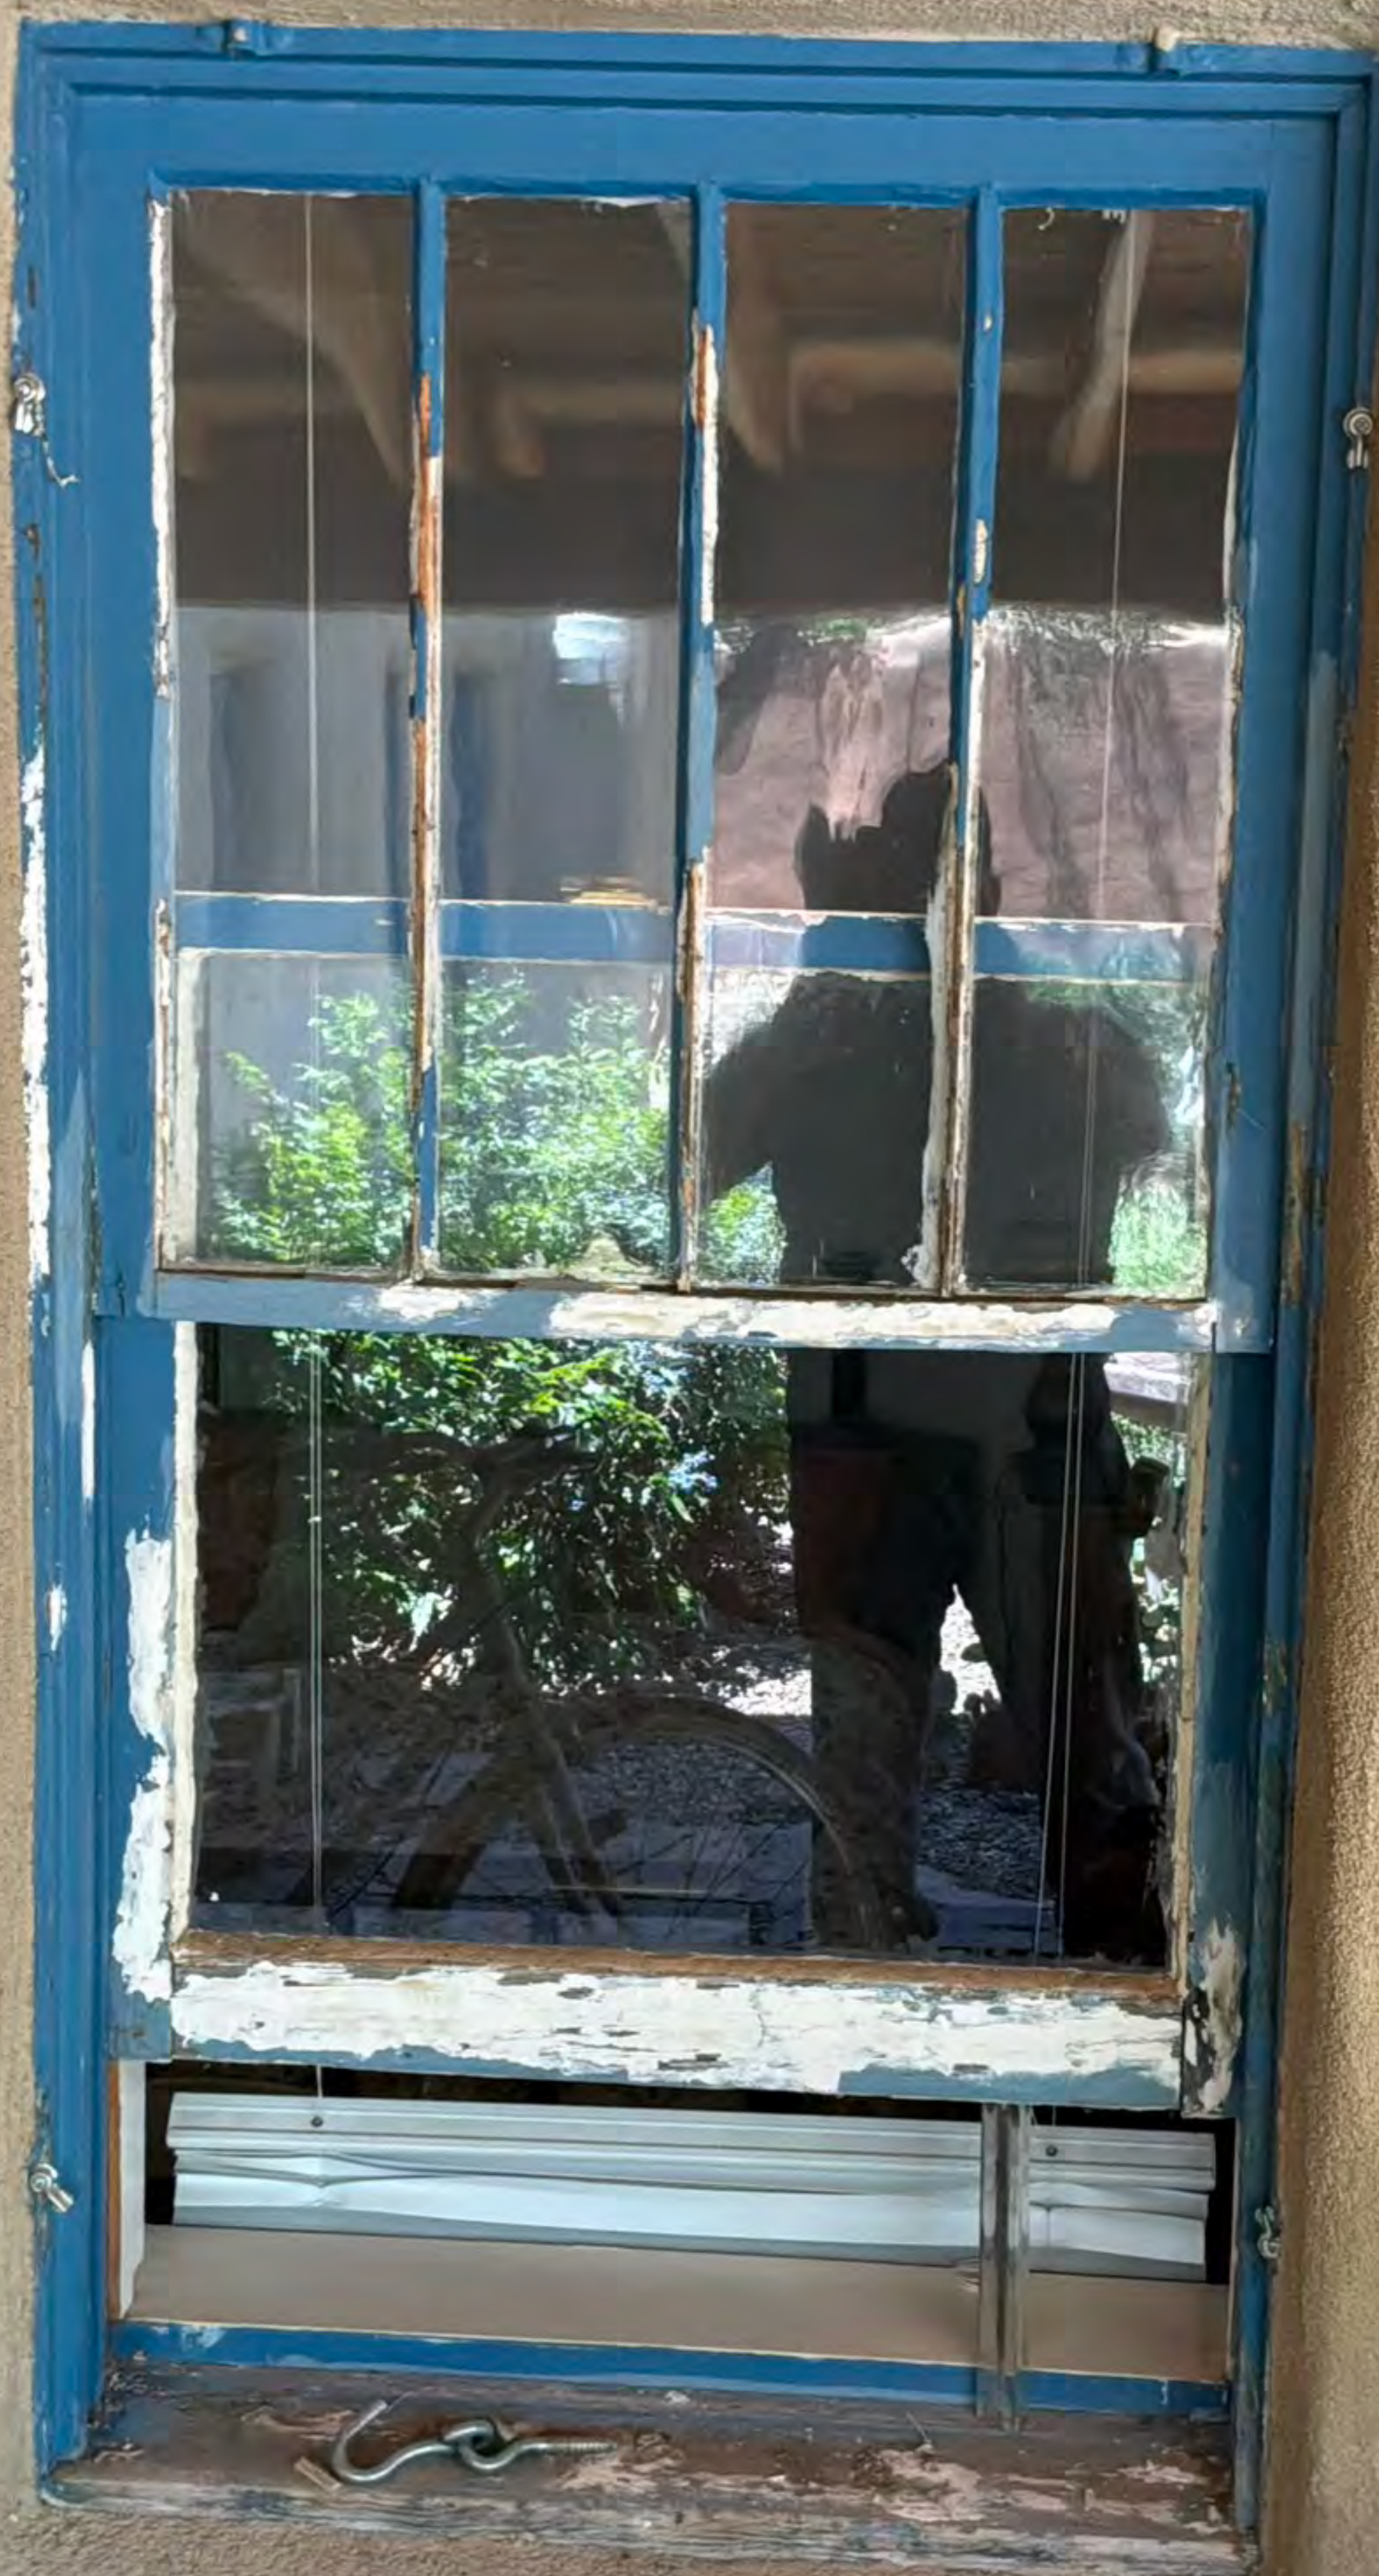
East  
Elevation  
Window L.

Windows G and L are historic however unrestorable.

| LABEL | WINDOW & DOOR DESCRIPTION | CONDITION & INTEGRITY CODE | HISTORIC/NON-HISTORIC - AGE |
|---|---|---|---|
| L | 28" x 56" DOUBLE HUNG 4W1H/1-LT ALL WOOD | U | <b>HISTORIC</b> - WINDOW UNIT HAS OVER 40% ROT & BONDO ON BOTH SASHES & JAMBS |

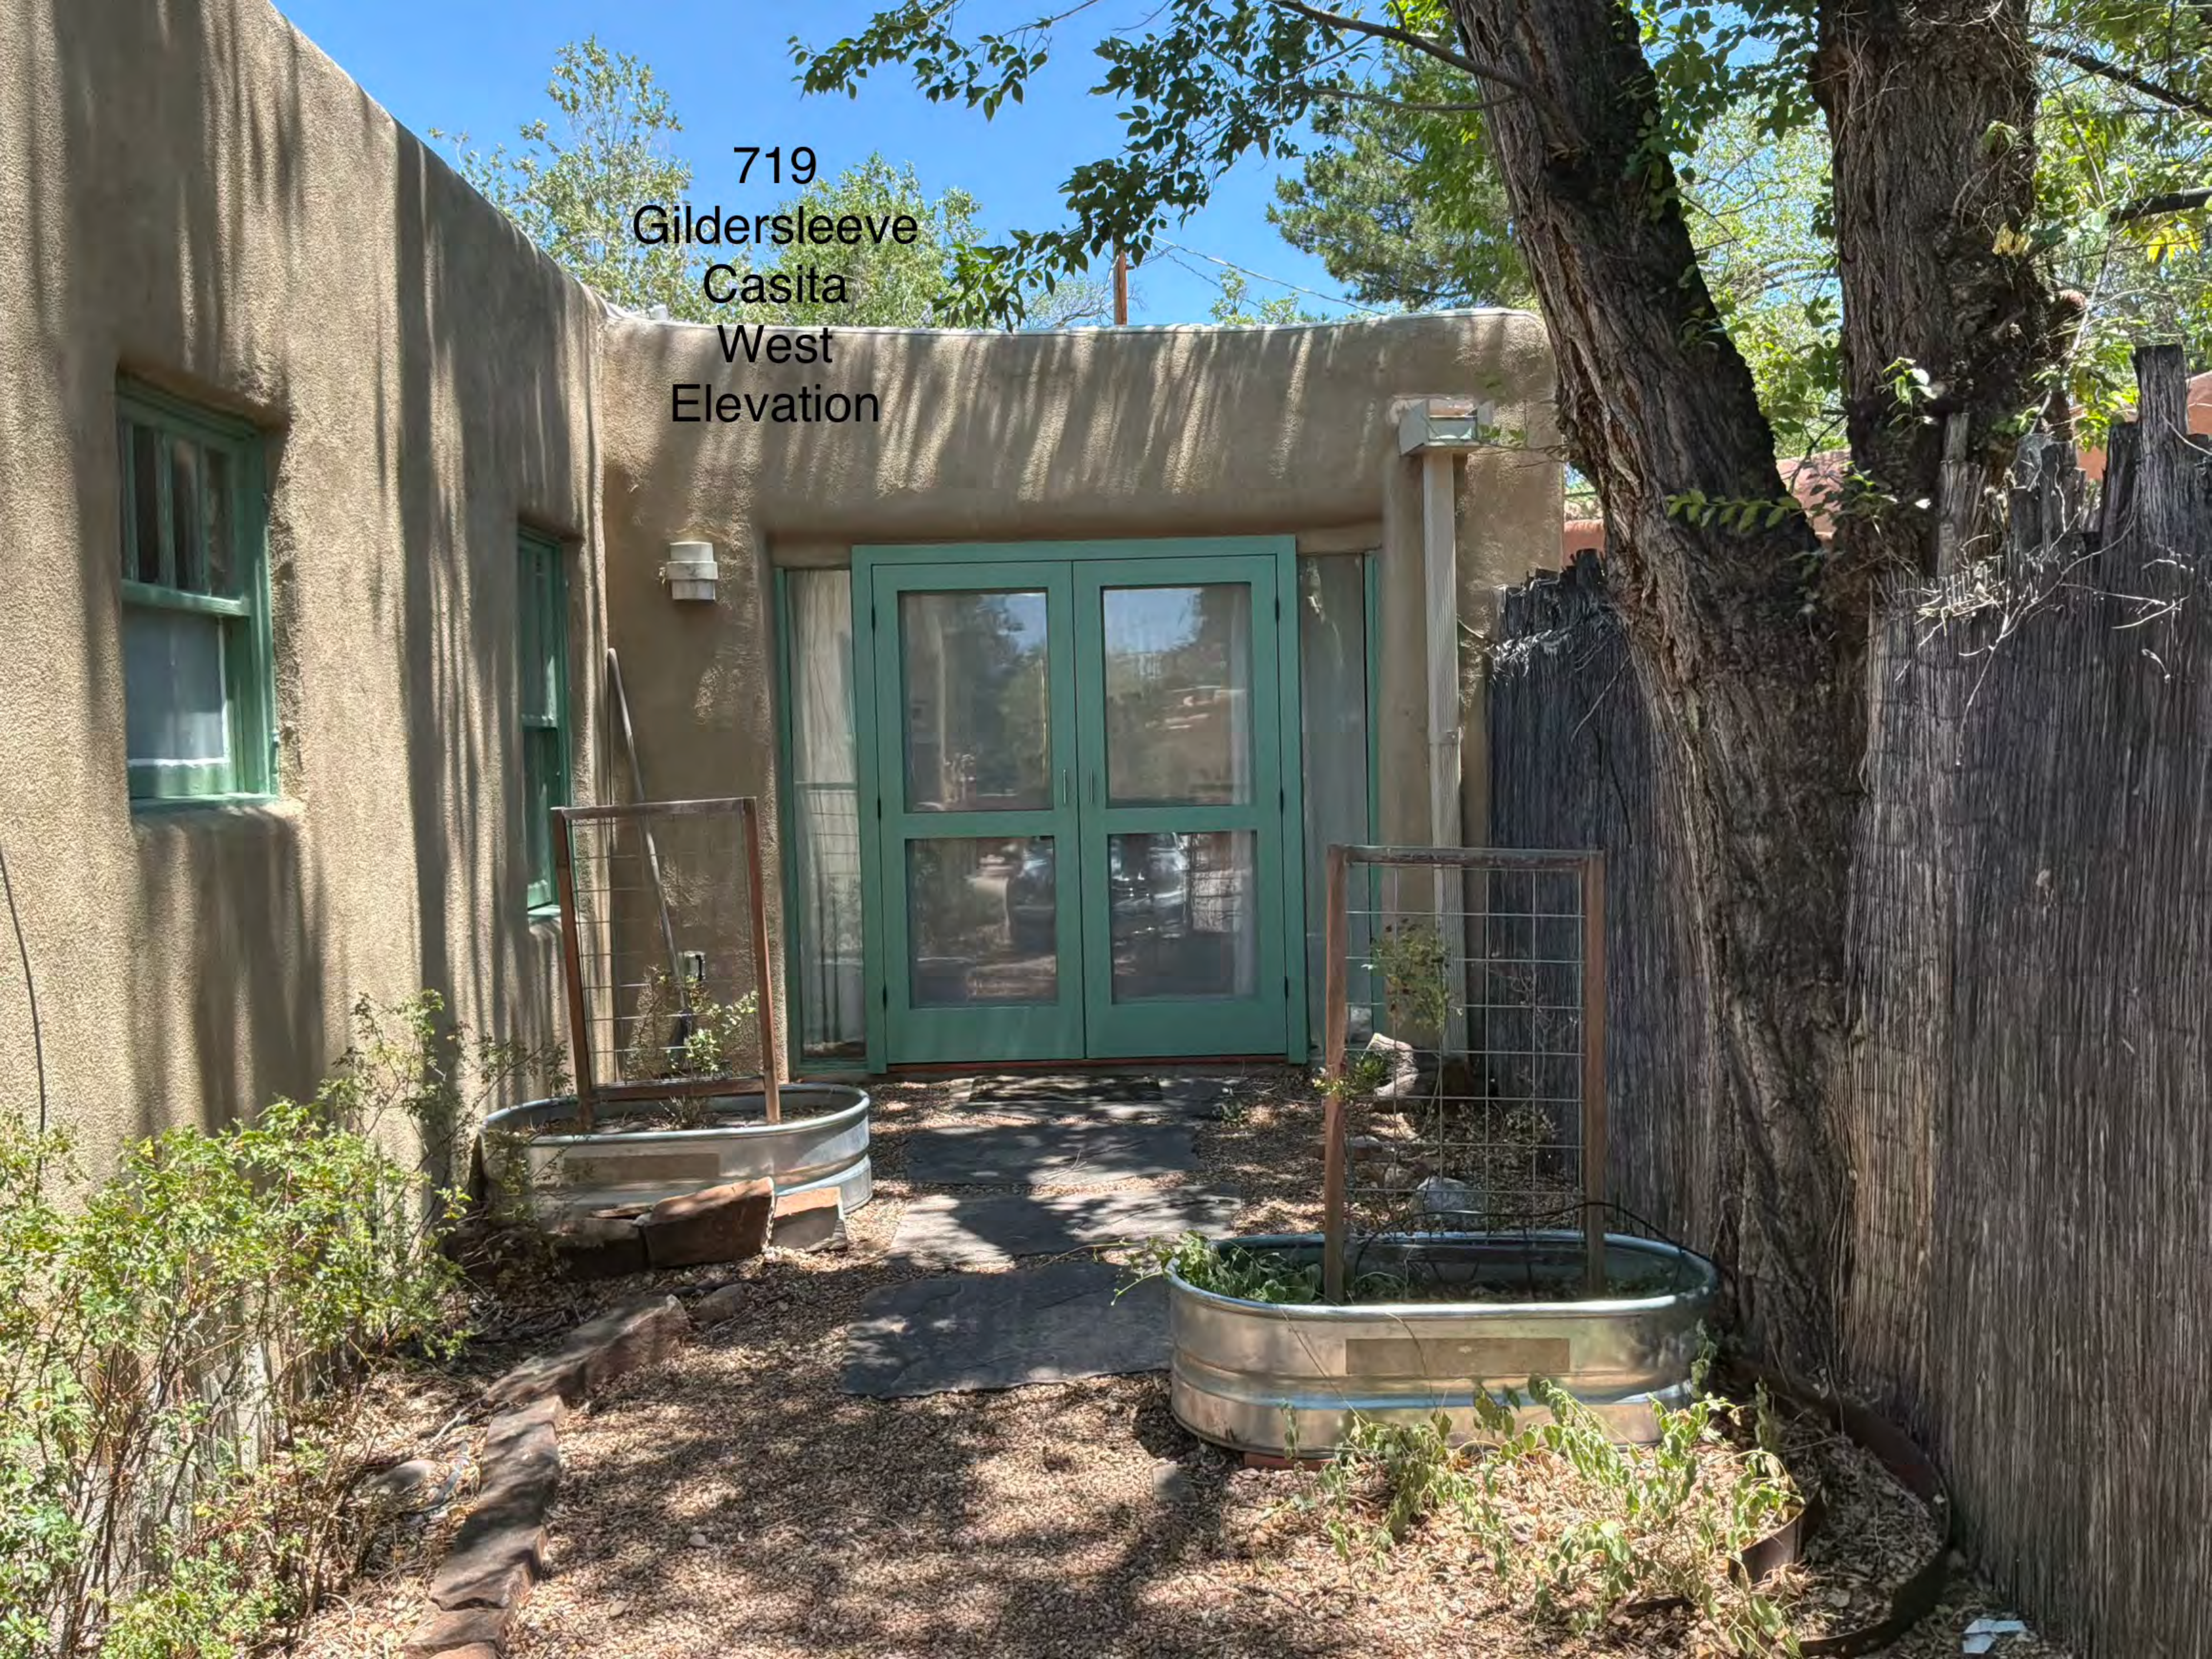
South  
Elevation  
Casita  
Window  
CA

| LABEL | WINDOW & DOOR DESCRIPTION | CONDITION & INTEGRITY CODE | HISTORIC/NON-HISTORIC – AGE |
|---|---|---|---|
| C-A | 80" x 23" TWIN FIXED 5W1H ALL WOOD (2-40") | U | <b>NON-HISTORIC</b> – TWO (2) DOUBLE HUNG SASHES STOPPED IN OVER 40% ROTTED HEAD & JAMB SILL THAT IS COVERED IN GALVANIZED METAL (1984) |

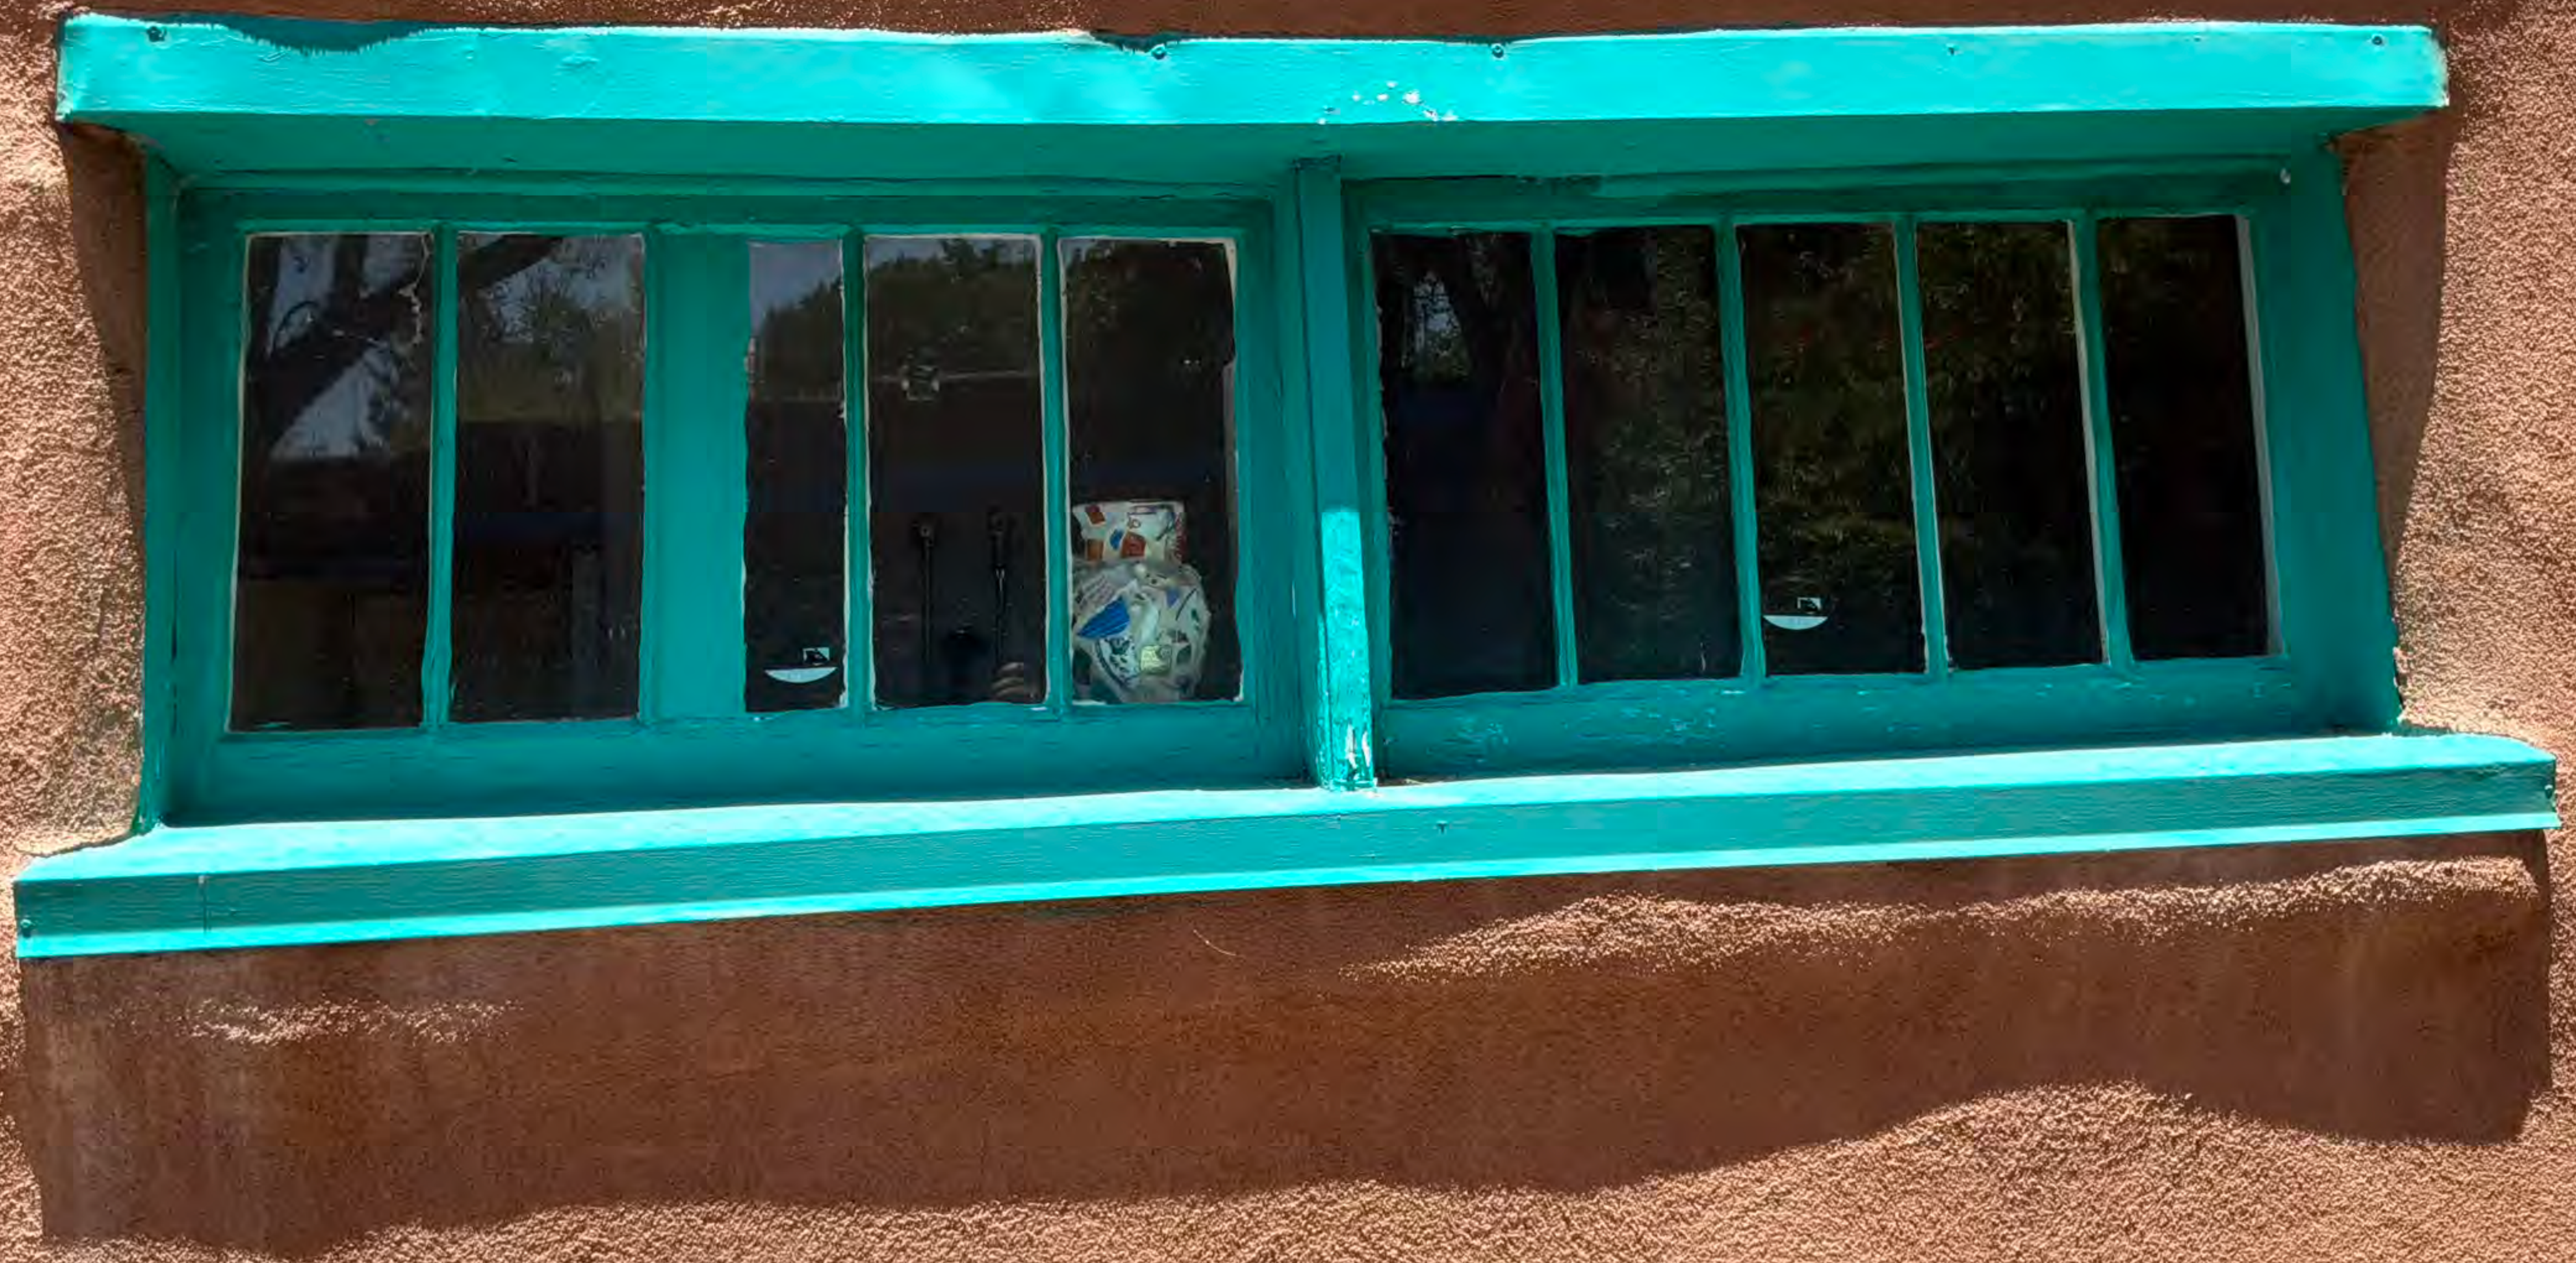
West  
Elevation  
Casita Door #  
C-1

| LABEL | WINDOW & DOOR DESCRIPTION | CONDITION & INTEGRITY CODE | HISTORIC/NON-HISTORIC – AGE |
|---|---|---|---|
| DR #C-1 | 95" x 84" LH INSWING ALL WOOD DOOR<br>SIDE LIGHT TRIPLE/FRENCH DOOR/SIDELIGHT<br>1-LT FULL GLASS<br>15"/64" (2-32")/15" | F | <b>NON-HISTORIC</b> – SIMPSON DOOR (2011) |

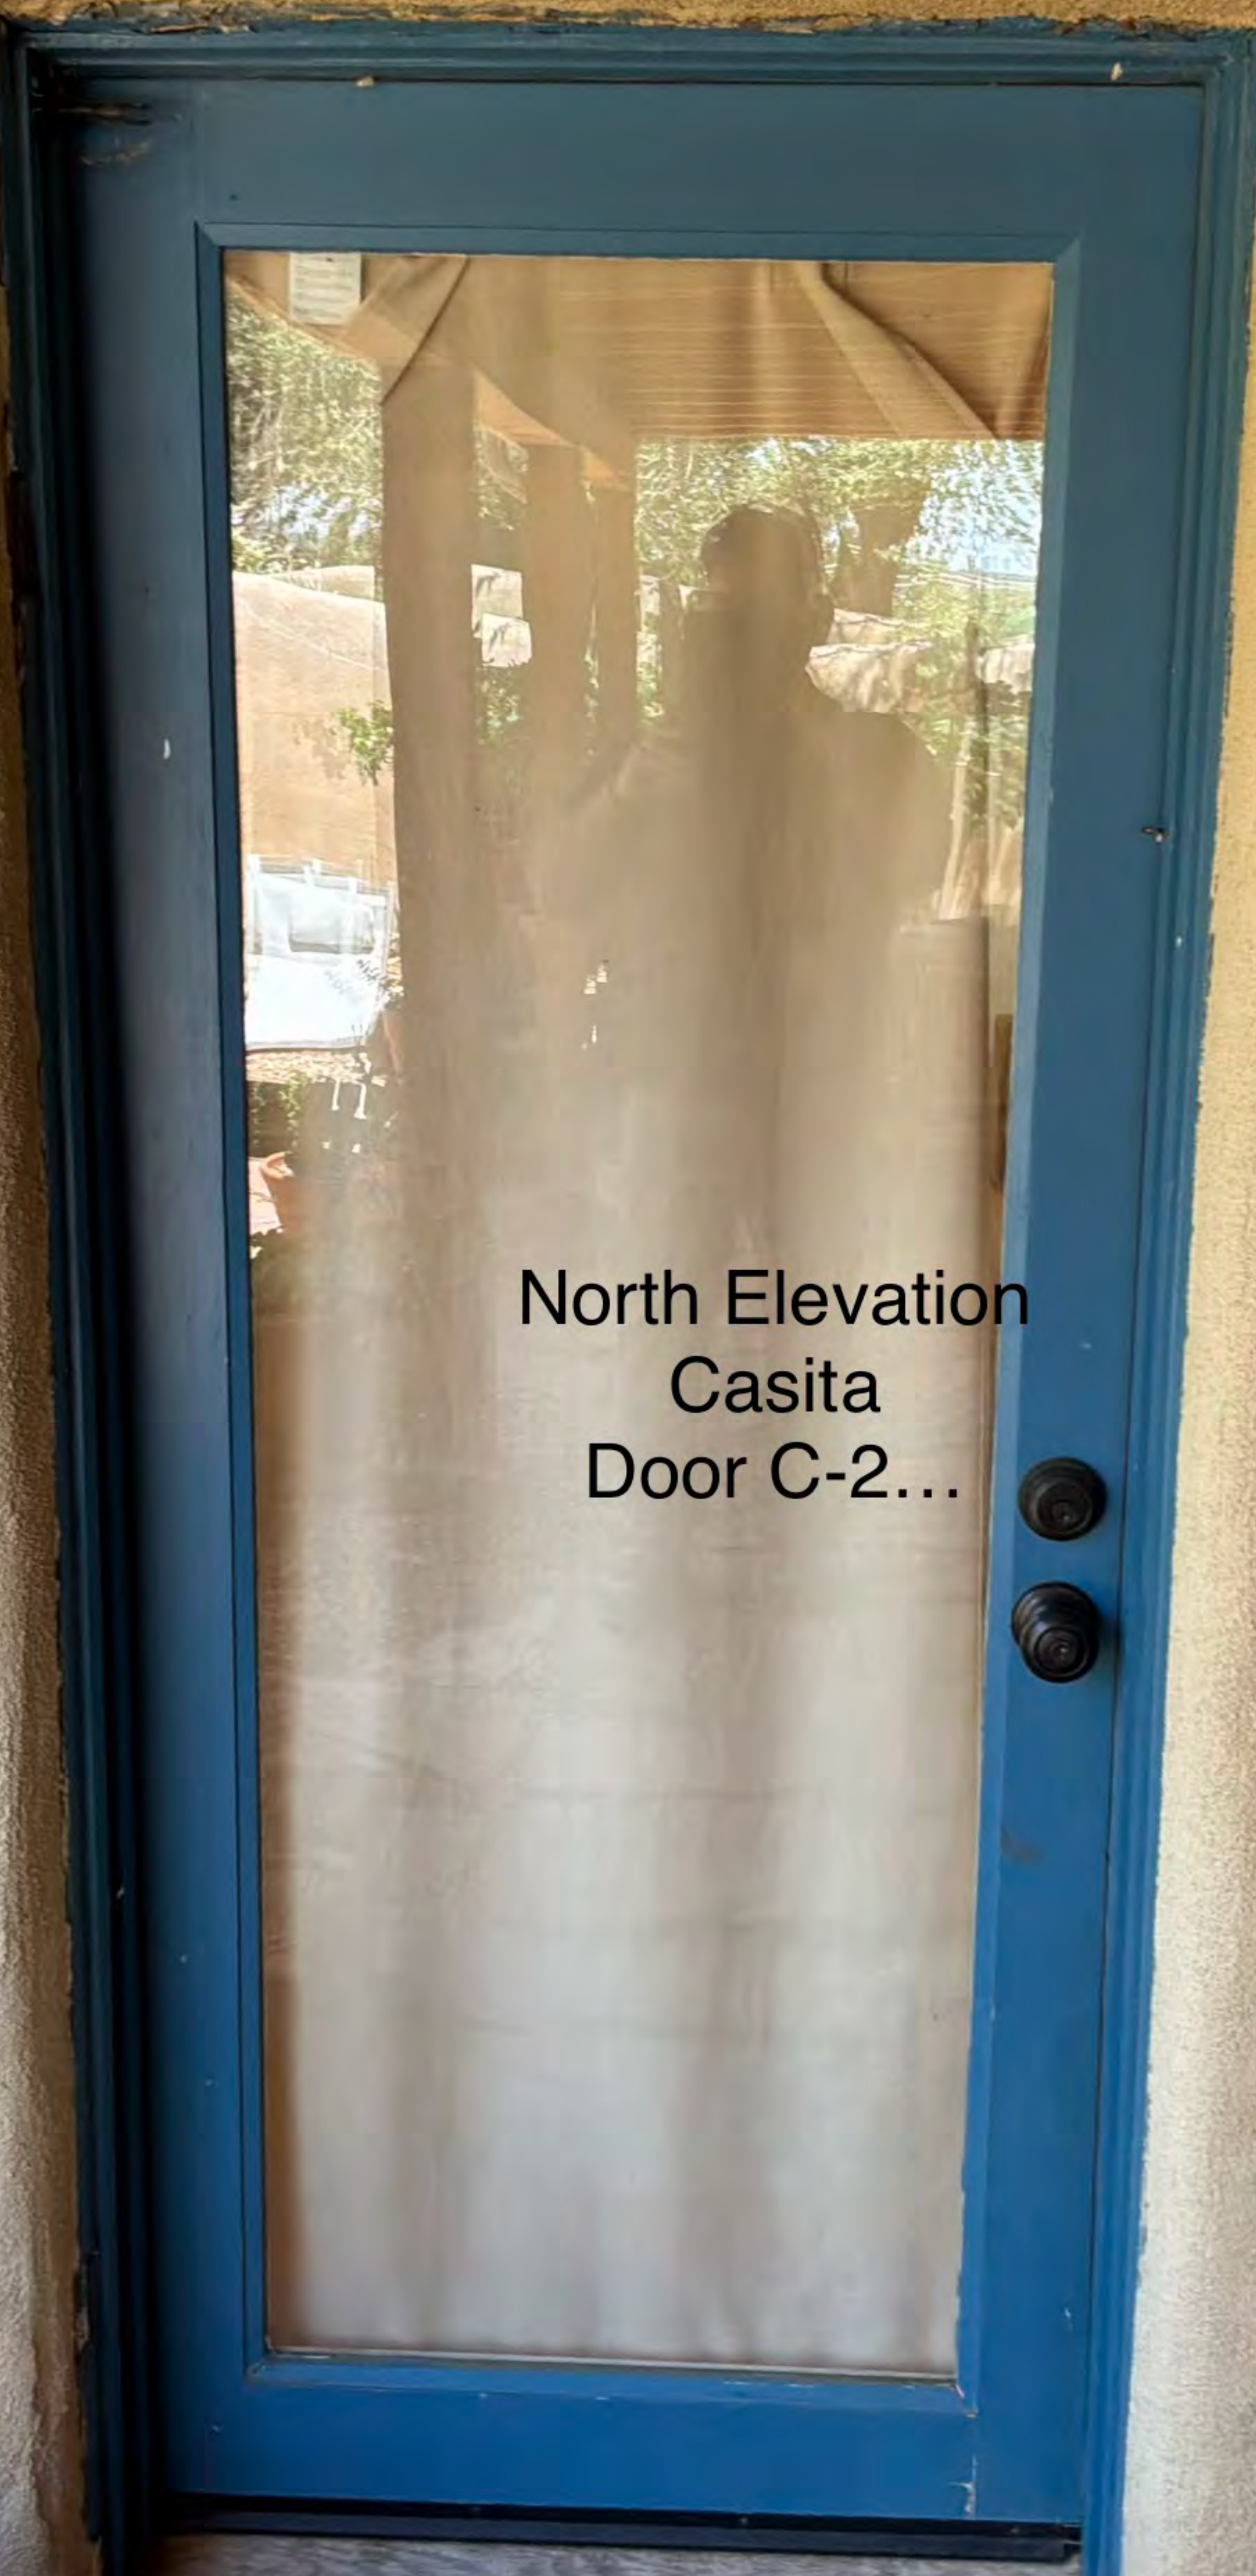
North Elevation  
Casita  
Door C-2...

| LABEL | WINDOW & DOOR DESCRIPTION | CONDITION & INTEGRITY CODE | HISTORIC/NON-HISTORIC – AGE |
|---|---|---|---|
| DR #C-2 | 32" x 78" LH INSWING ALL WOOD DOOR<br>FULL LIGHT, CUT DOWN BOTTOM RAIL<br>INSULATED GLASS | F | <b>NON-HISTORIC</b> – (1988) |

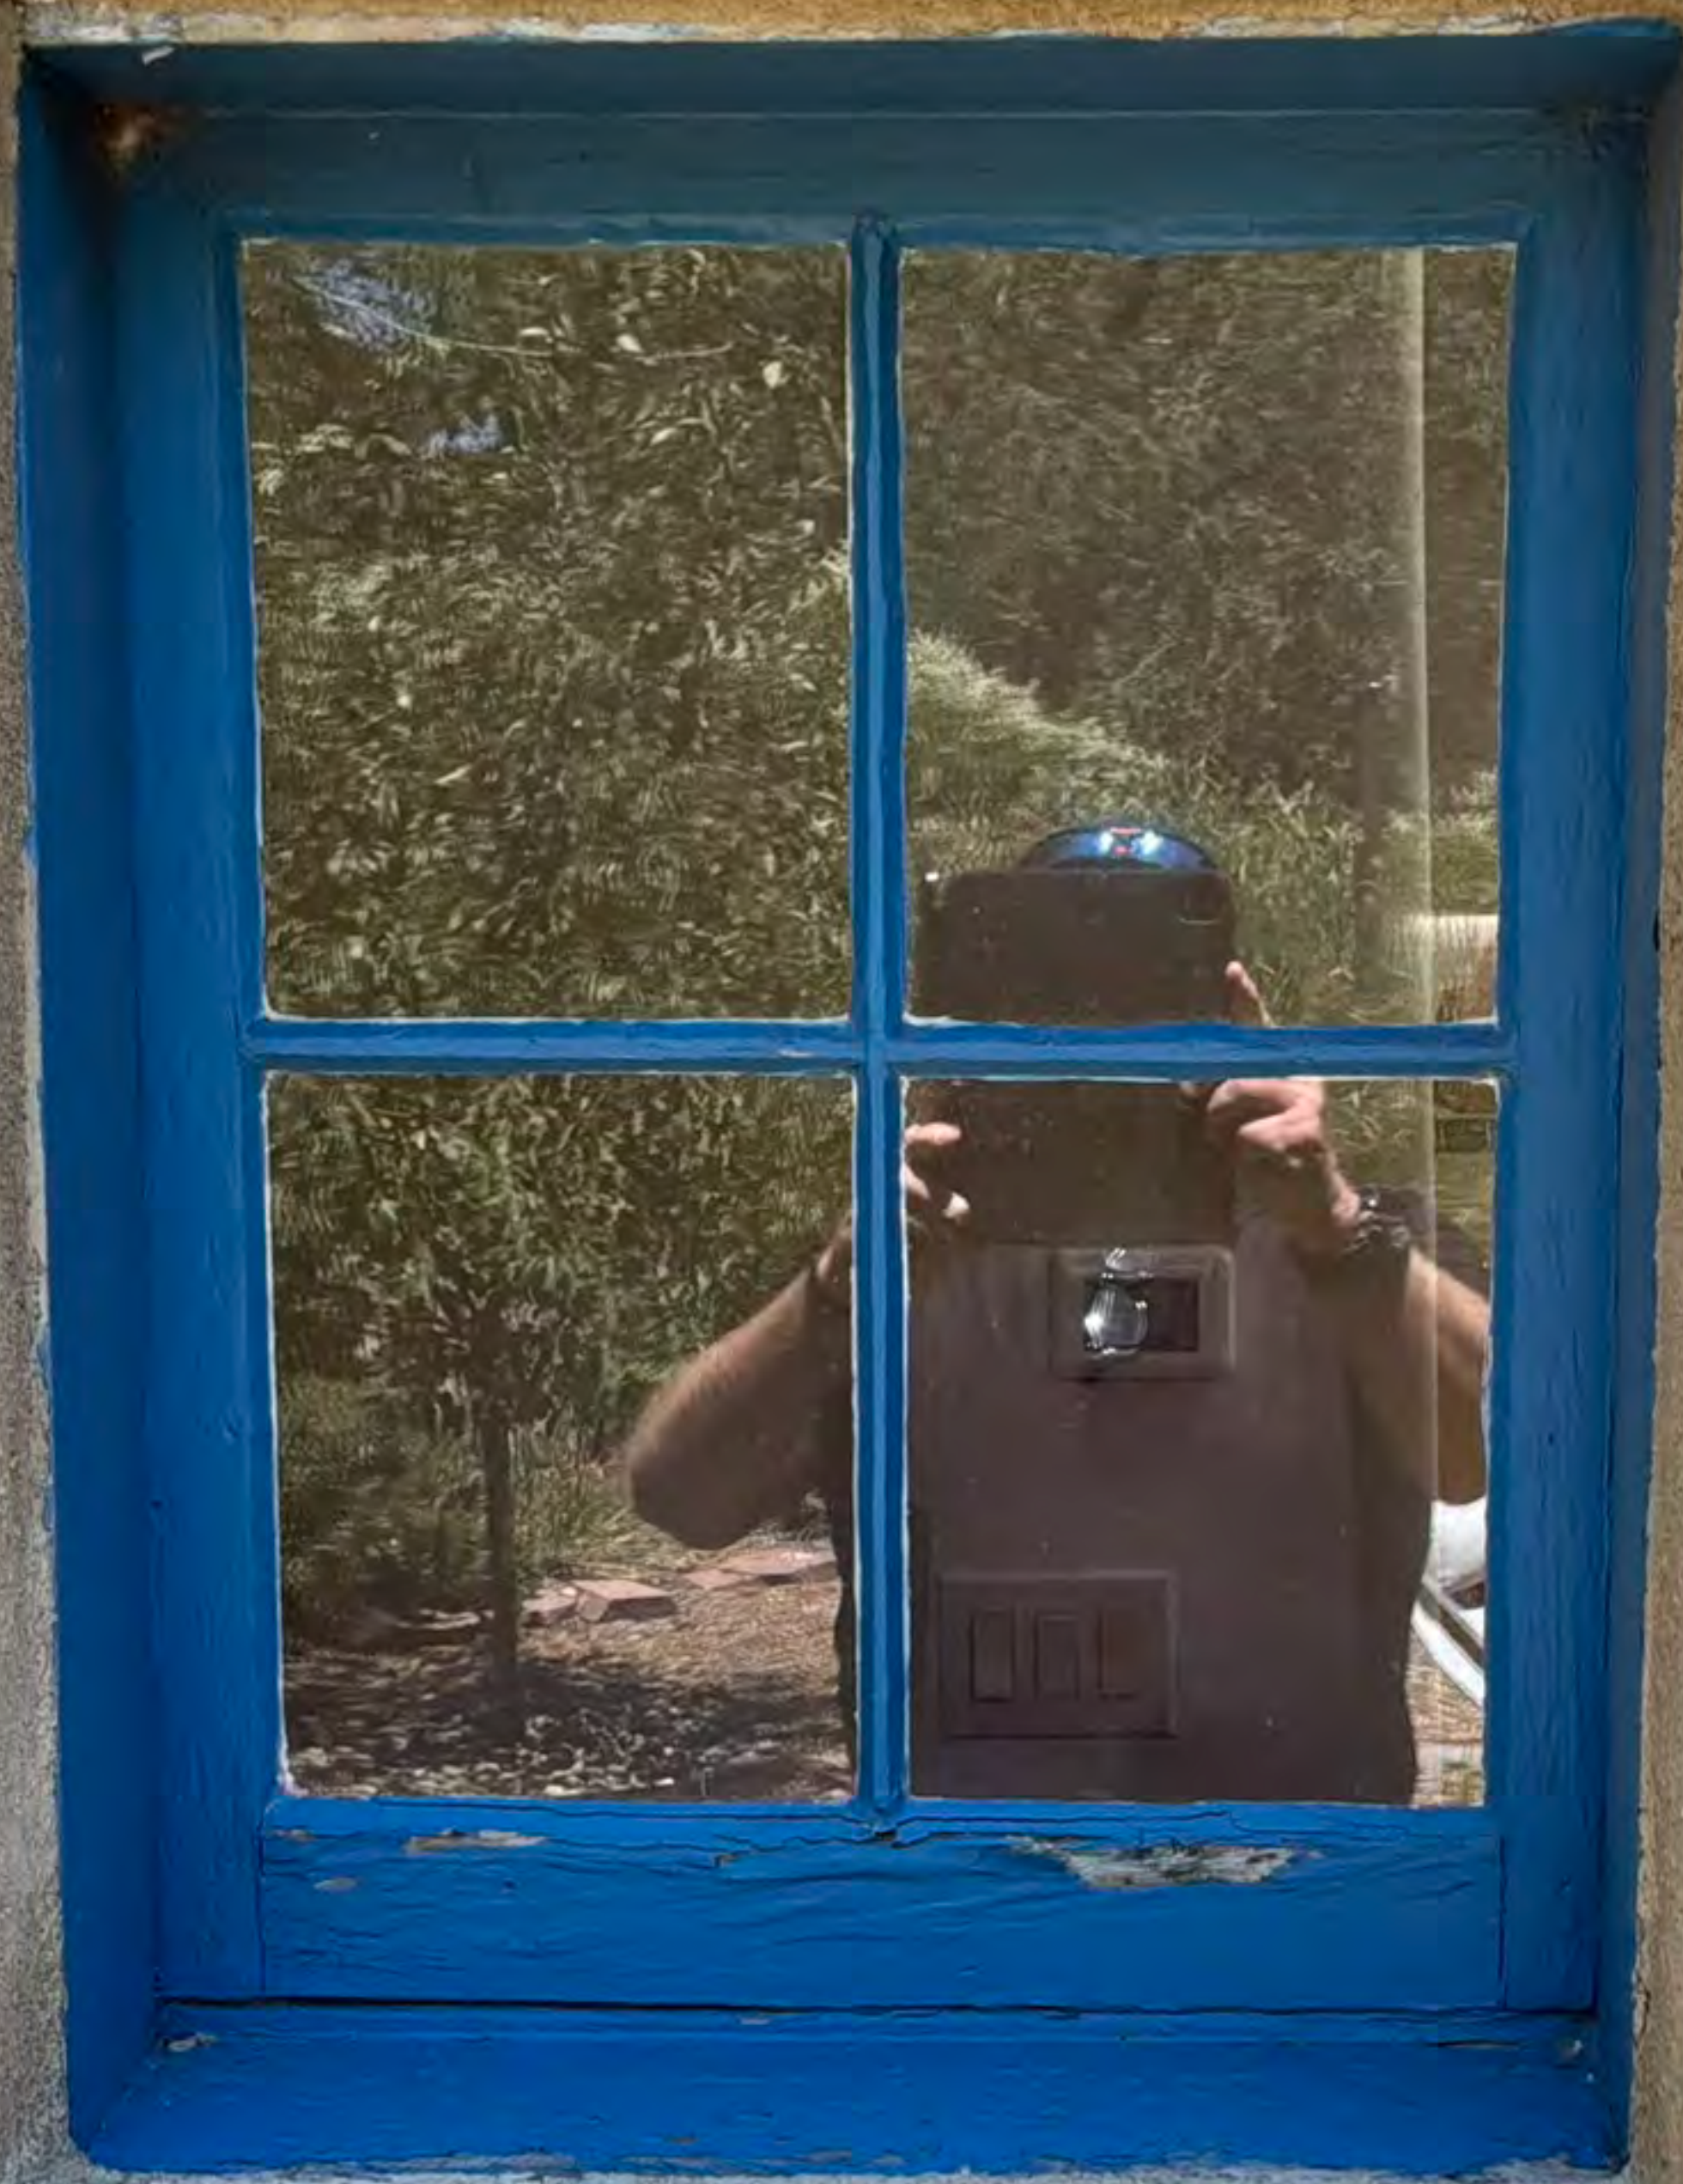
North Elevation  
Casita  
Window C-B.

| LABEL | WINDOW & DOOR DESCRIPTION | CONDITION & INTEGRITY CODE | HISTORIC/NON-HISTORIC – AGE |
|---|---|---|---|
| C-B | 19" x 25" FIXED INSWING STAT 2W2H ALL WOOD | F | <b>NON-HISTORIC</b> – BARN SASH (1988) |
