# RPA & Associates LLC

| JOB | DATE |
|---|---|
| 719 Gildersleeve Street, Santa Fe, NM 87505 – MAIN HOUSE | 07/02/2026 |

## RPA & ASSOCIATES, LLC | WINDOW & DOOR CONDITION AND INTEGRITY CODES

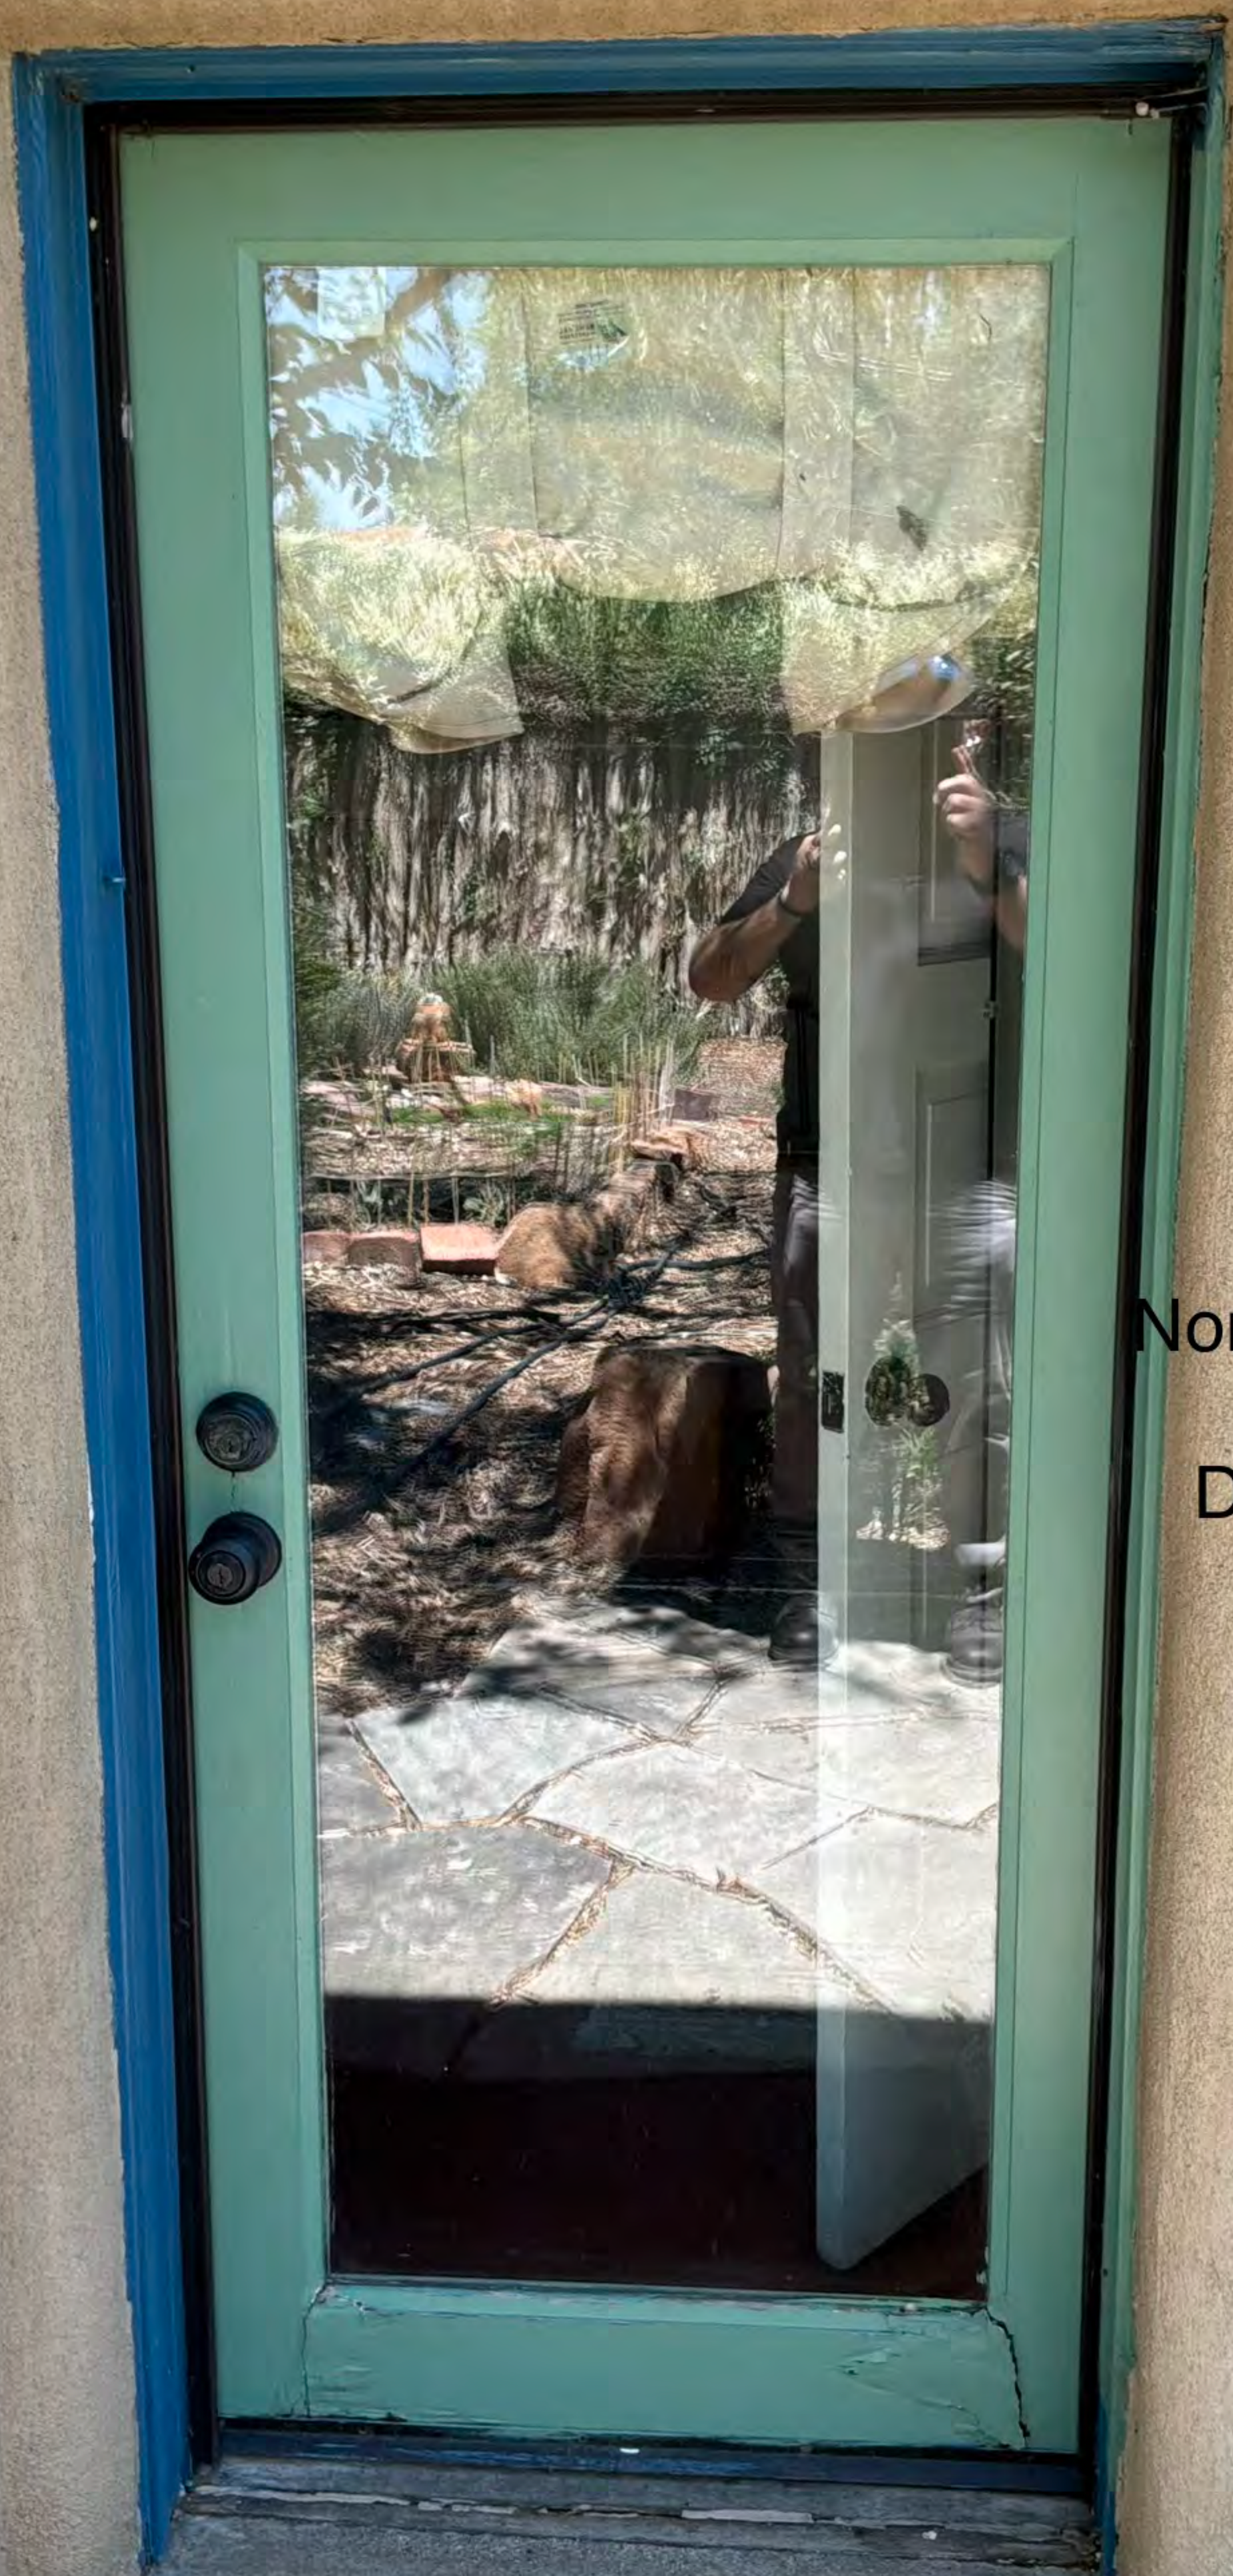
North Elevation  
Casita  
Door # C-3.

| LABEL | WINDOW & DOOR DESCRIPTION | CONDITION & INTEGRITY CODE | HISTORIC/NON-HISTORIC – AGE |
|---|---|---|---|
| DR #C-3 | 32" x 78" RH INSWING ALL WOOD DOOR<br>FULL LIGHT, CUT DOWN BOTTOM RAIL<br>INSULATED GLASS | U | <b>NON-HISTORIC</b> – ROTTED BOTTOM RAIL (1988) |

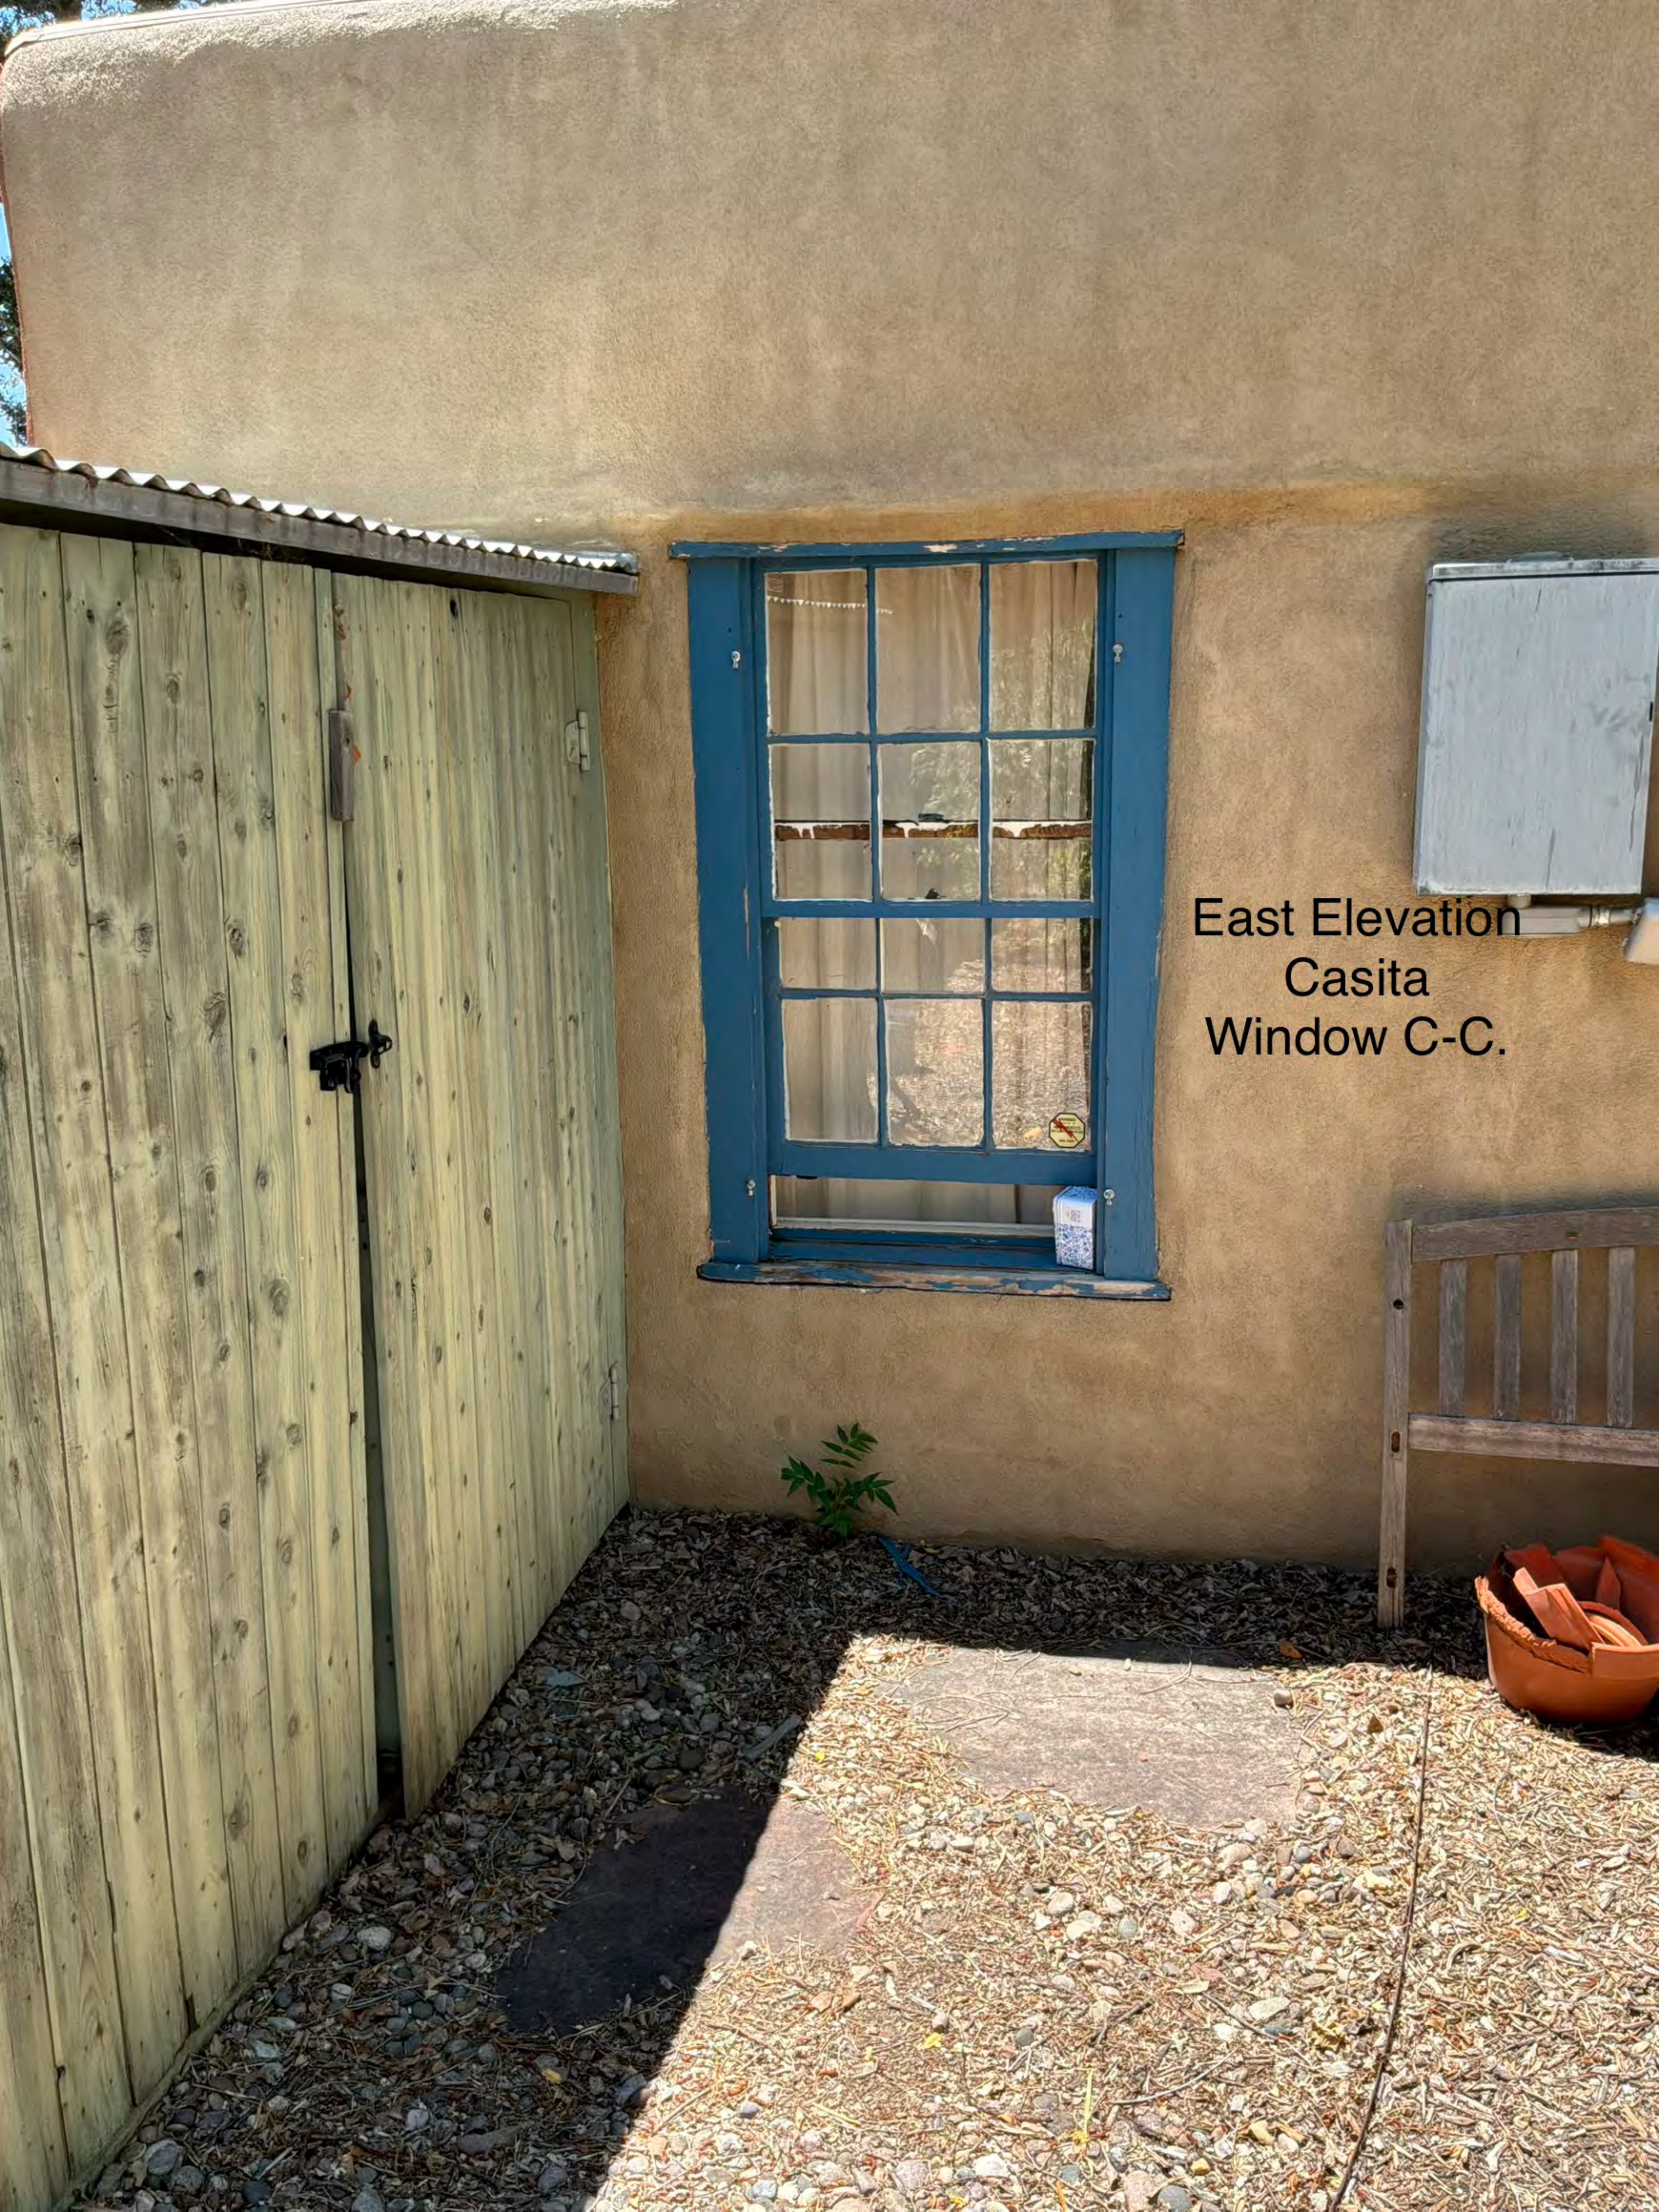
East Elevation  
Casita  
Window C-C.

| LABEL | WINDOW & DOOR DESCRIPTION | CONDITION & INTEGRITY CODE | HISTORIC/NON-HISTORIC – AGE |
|---|---|---|---|
| C-C | 29" x 56" DOUBLE HUNG 3W2H/3W2H ALL WOOD<br>3 ½" FLAT CASING EXTERIOR | U | <b>NON-HISTORIC</b> – WINDOW UNIT NOT FROM ORIGINAL ERA, LIGHT PATTERN DIFFERENT THAN THE REST OF THE HOUSE, EXTERIOR CASING HAS A DIFFERENT PROFILE |

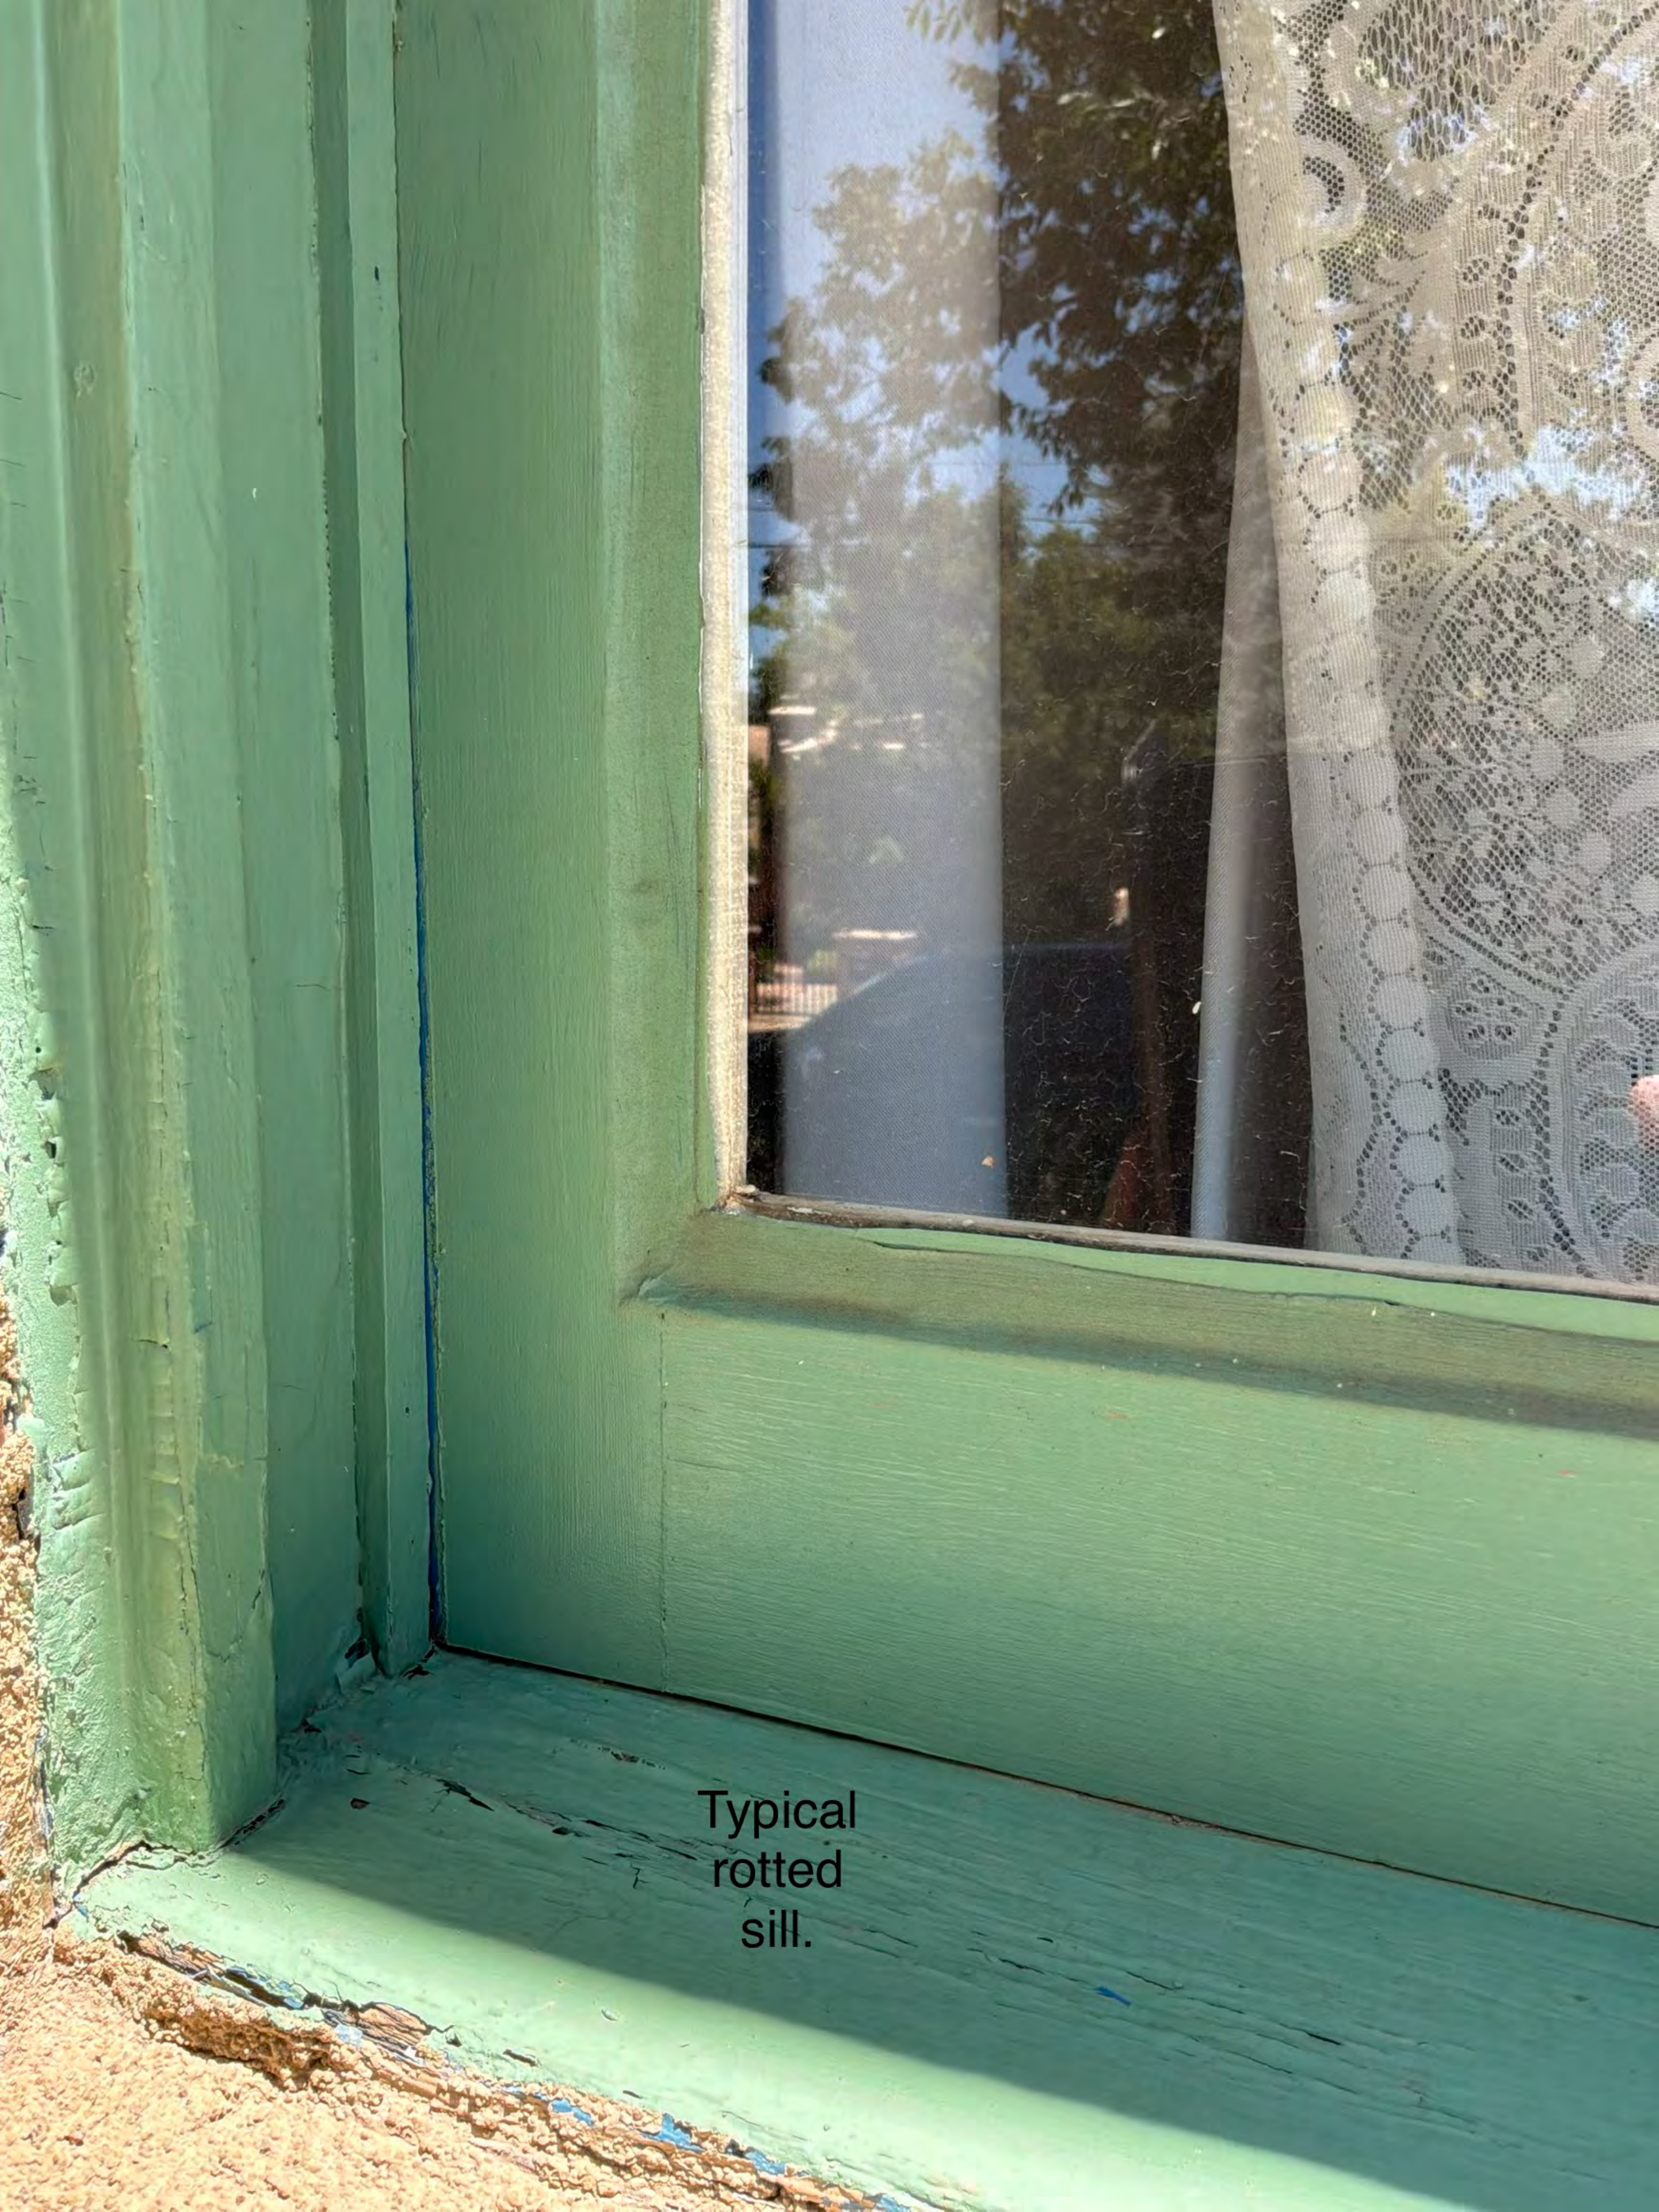
Typical  
rotted  
sill.
