# RPA & Associates, LLC.

| JOB | DATE |
|---|---|
| 104 Camino Mathias | 07/28/2026 |

## RPA & ASSOCIATES, LLC | WINDOW & DOOR CONDITION AND INTEGRITY CODES

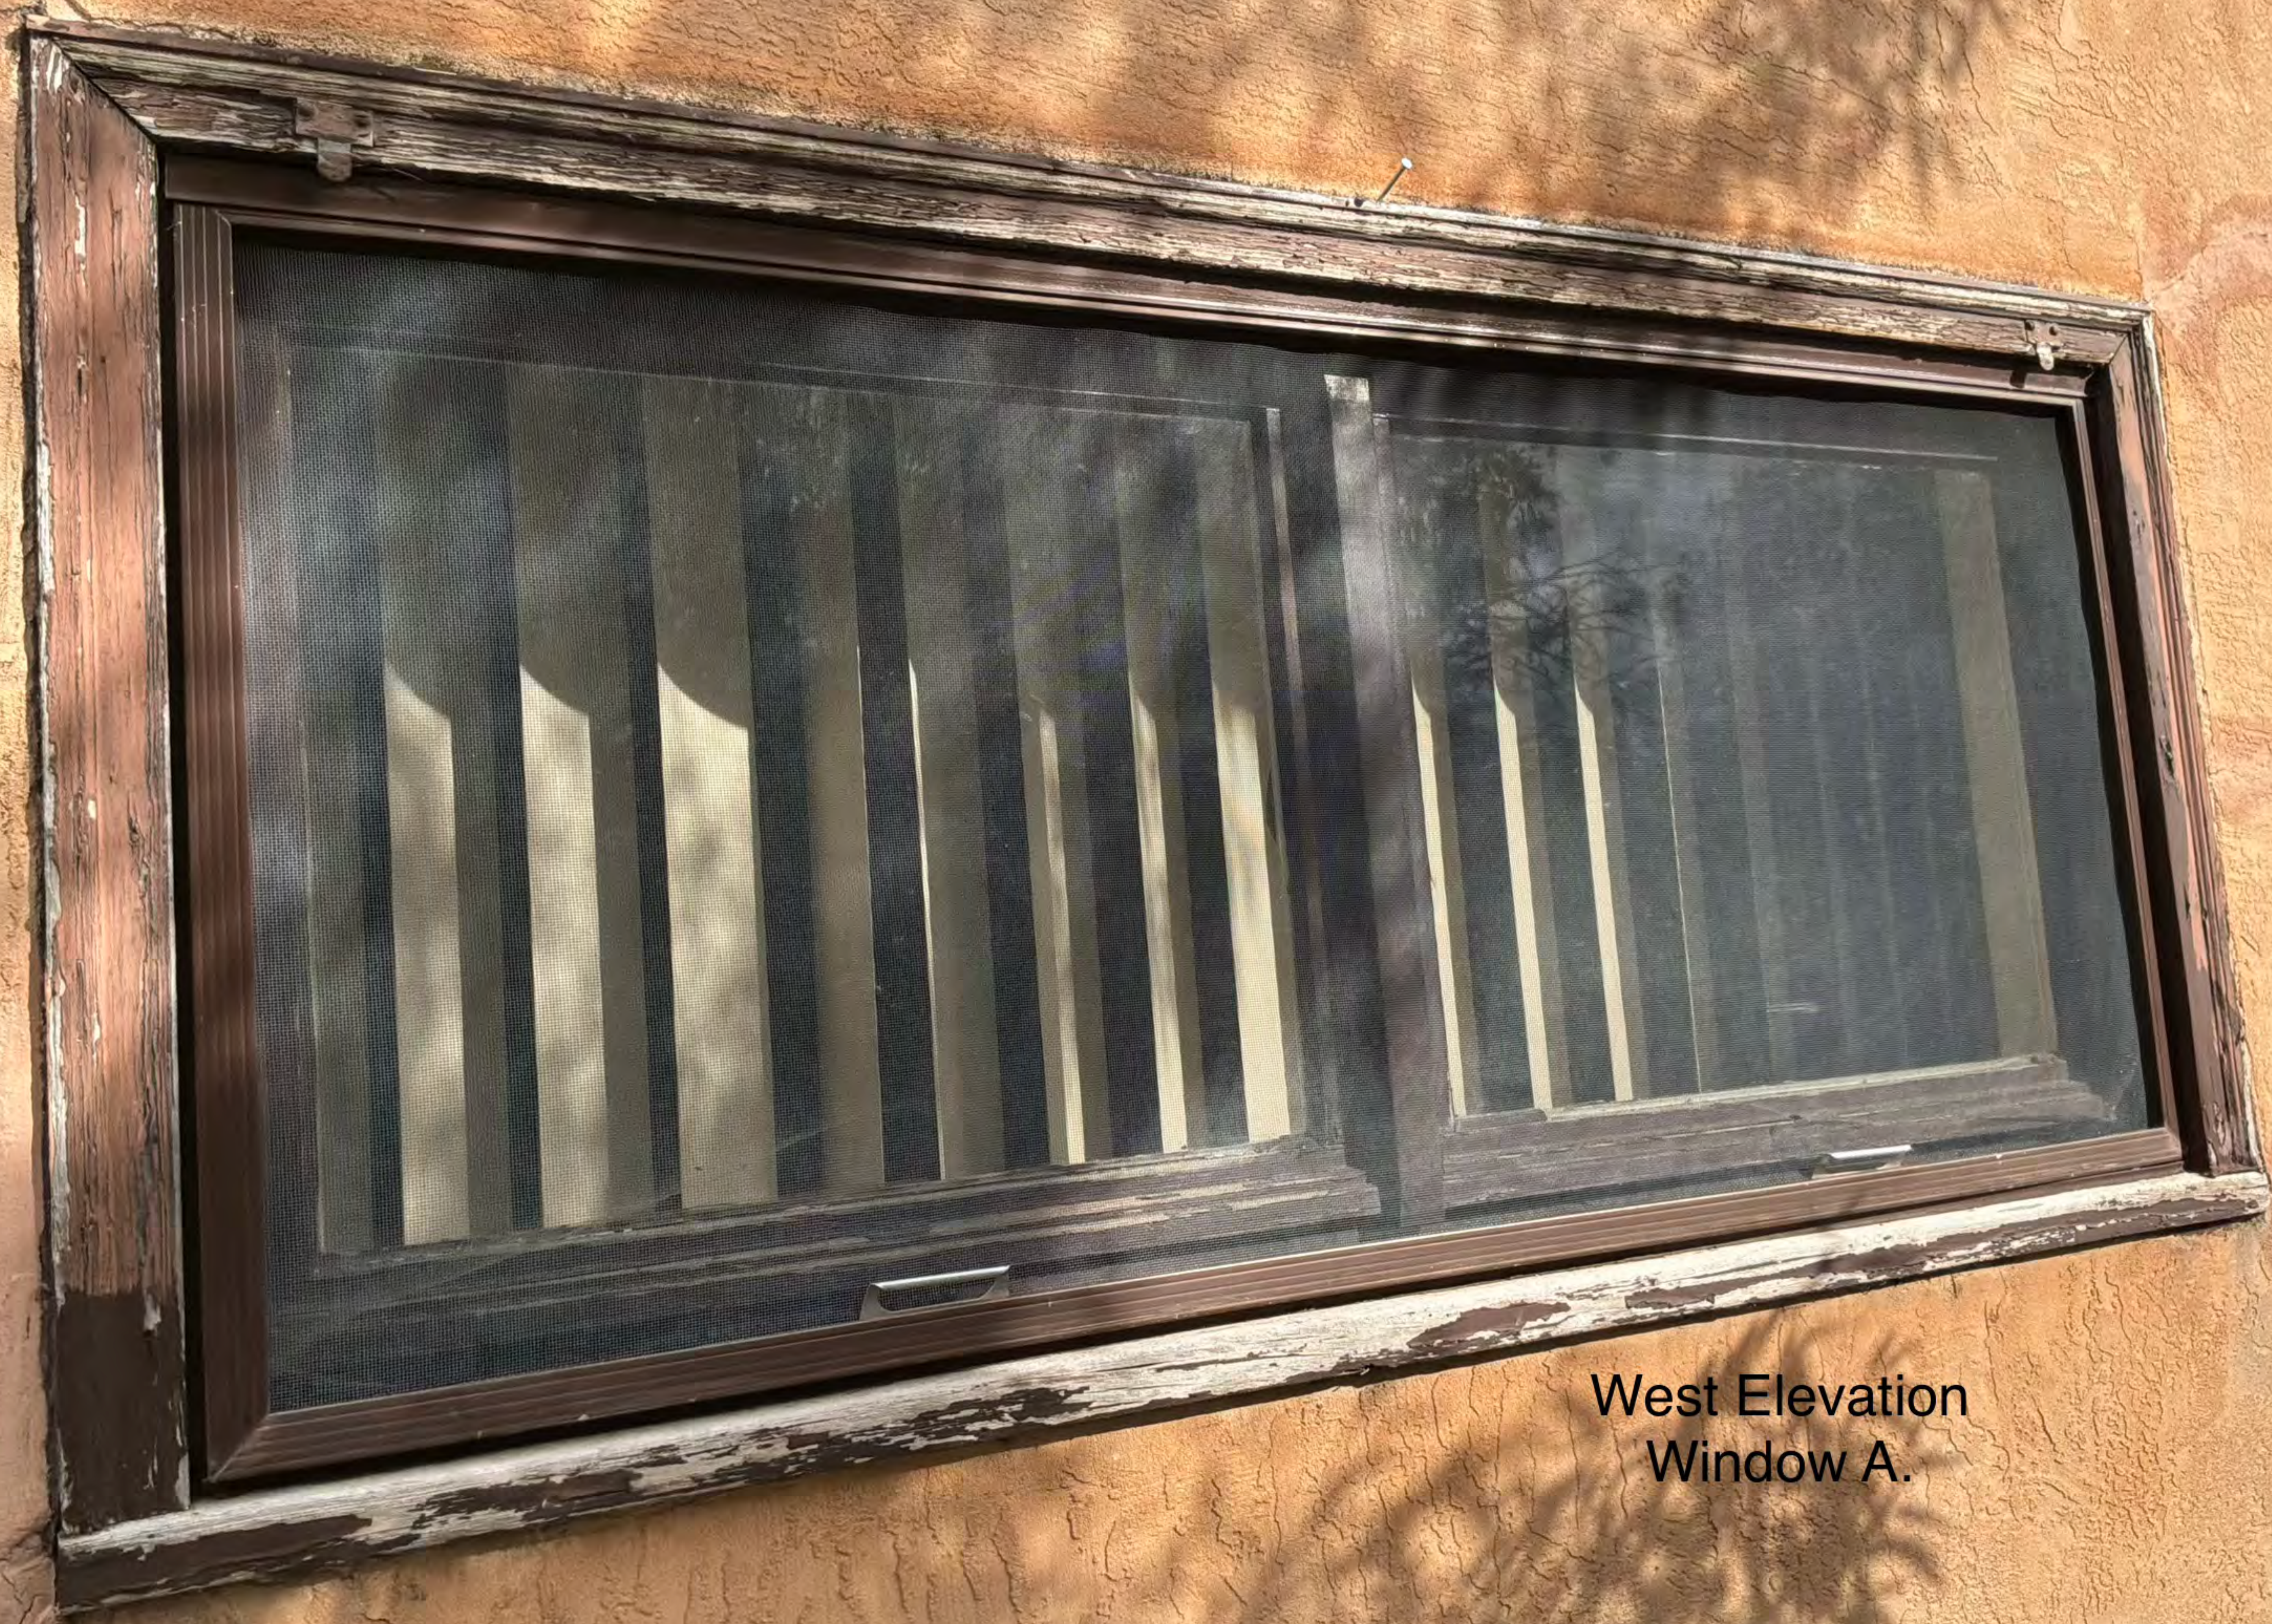
West Elevation  
Window A.

Windows A, B, C, D, F, G, H, I, and J are historic windows however the units are unrestorable. The window units are 1950 +/- Andersen horizontal gliding windows. The tracks, pins, sash rods, and locks are not available anymore therefore the windows cannot be made to operate correctly or seal.

| LABEL | WINDOW & DOOR DESCRIPTION | CONDITION & INTEGRITY CODE | HISTORIC/NON-HISTORIC - AGE |
|---|---|---|---|
| A | 54" x 25" HORIZONTAL SLIDER 1-LT ALL WOOD WITH ALUMINUM STORM | U | <b>HISTORIC</b> - THE TRACKS, PIVOT PINS & HANDLES ARE NOT AVAILABLE TO REPLACE 1950 +/- (ANDERSEN) |

My recommendation is to replace the windows with casement units with horizontal lites to replicate the steel casements of that era. The doors should be a wood paneled look of that 1950 era.

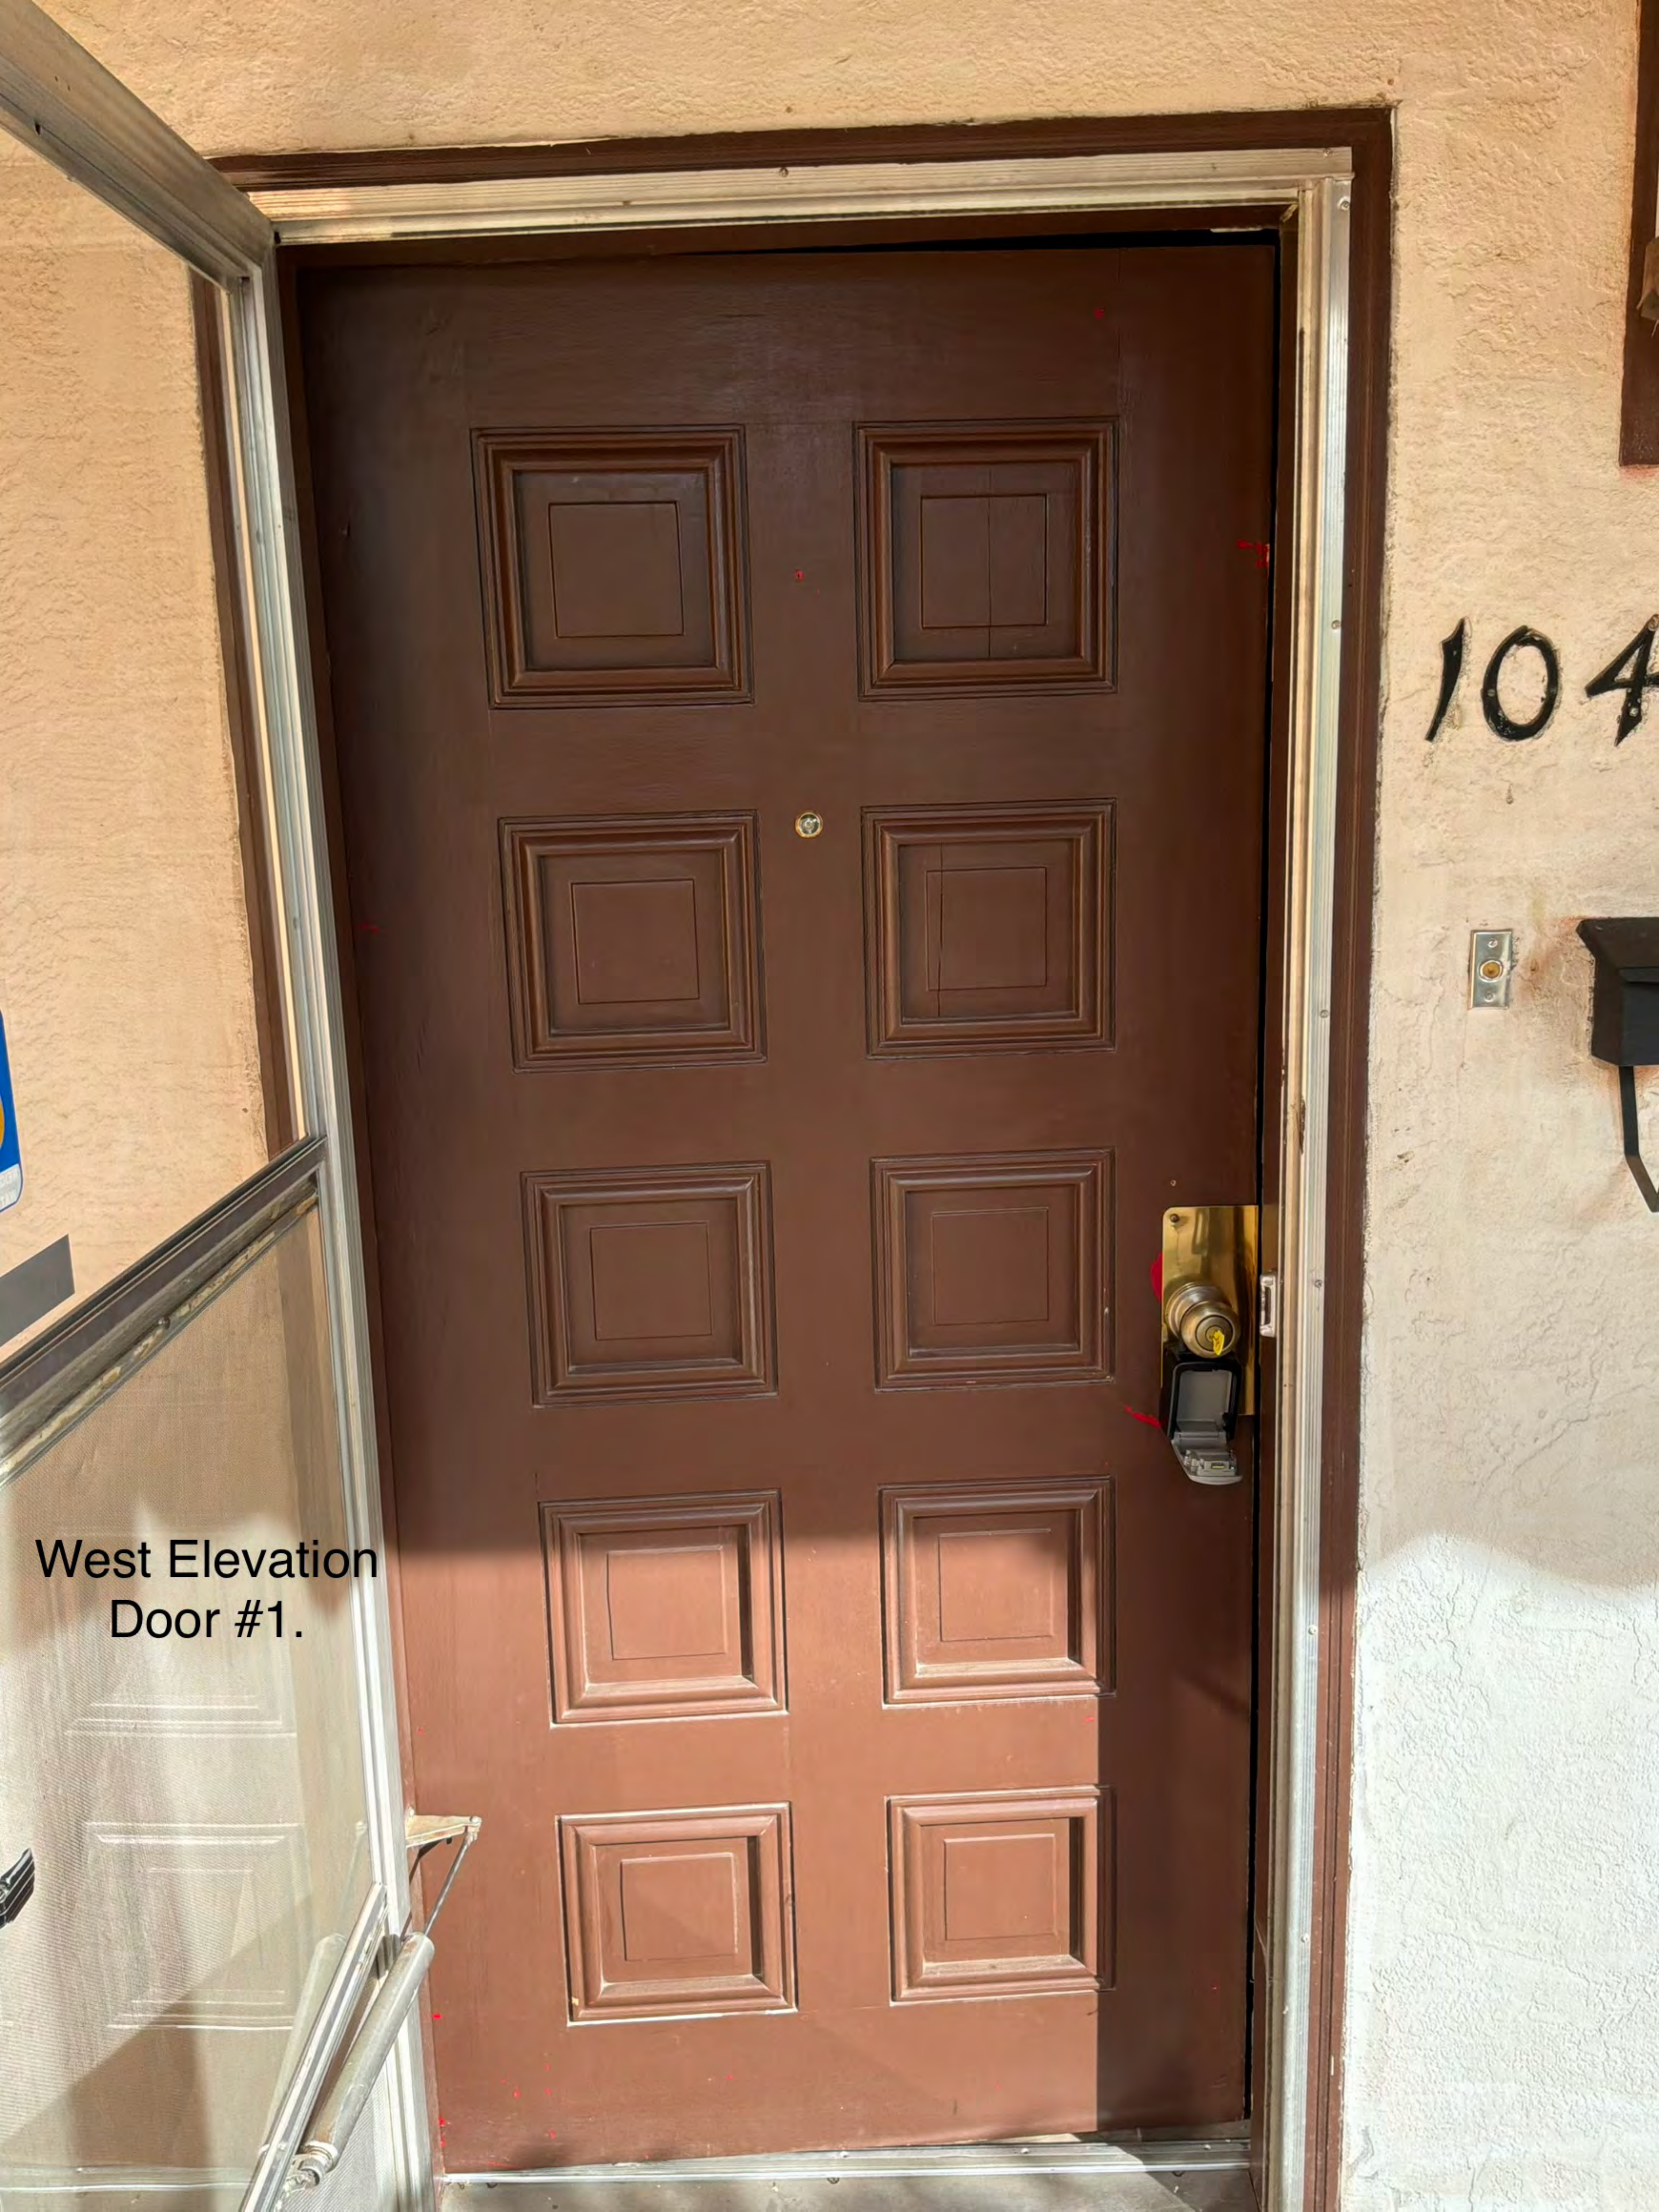
West Elevation  
Door #1.

Doors 1, 2, 3, 4, and 5 are non-historic.

| LABEL | WINDOW & DOOR DESCRIPTION | CONDITION & INTEGRITY CODE | HISTORIC/NON-HISTORIC - AGE |
|---|---|---|---|
| DR #1 | 36" x 80" LH INSWING 10-PANEL ALL WOOD DOOR | S | <b>NON-HISTORIC</b> - SIMPSON (1996) |

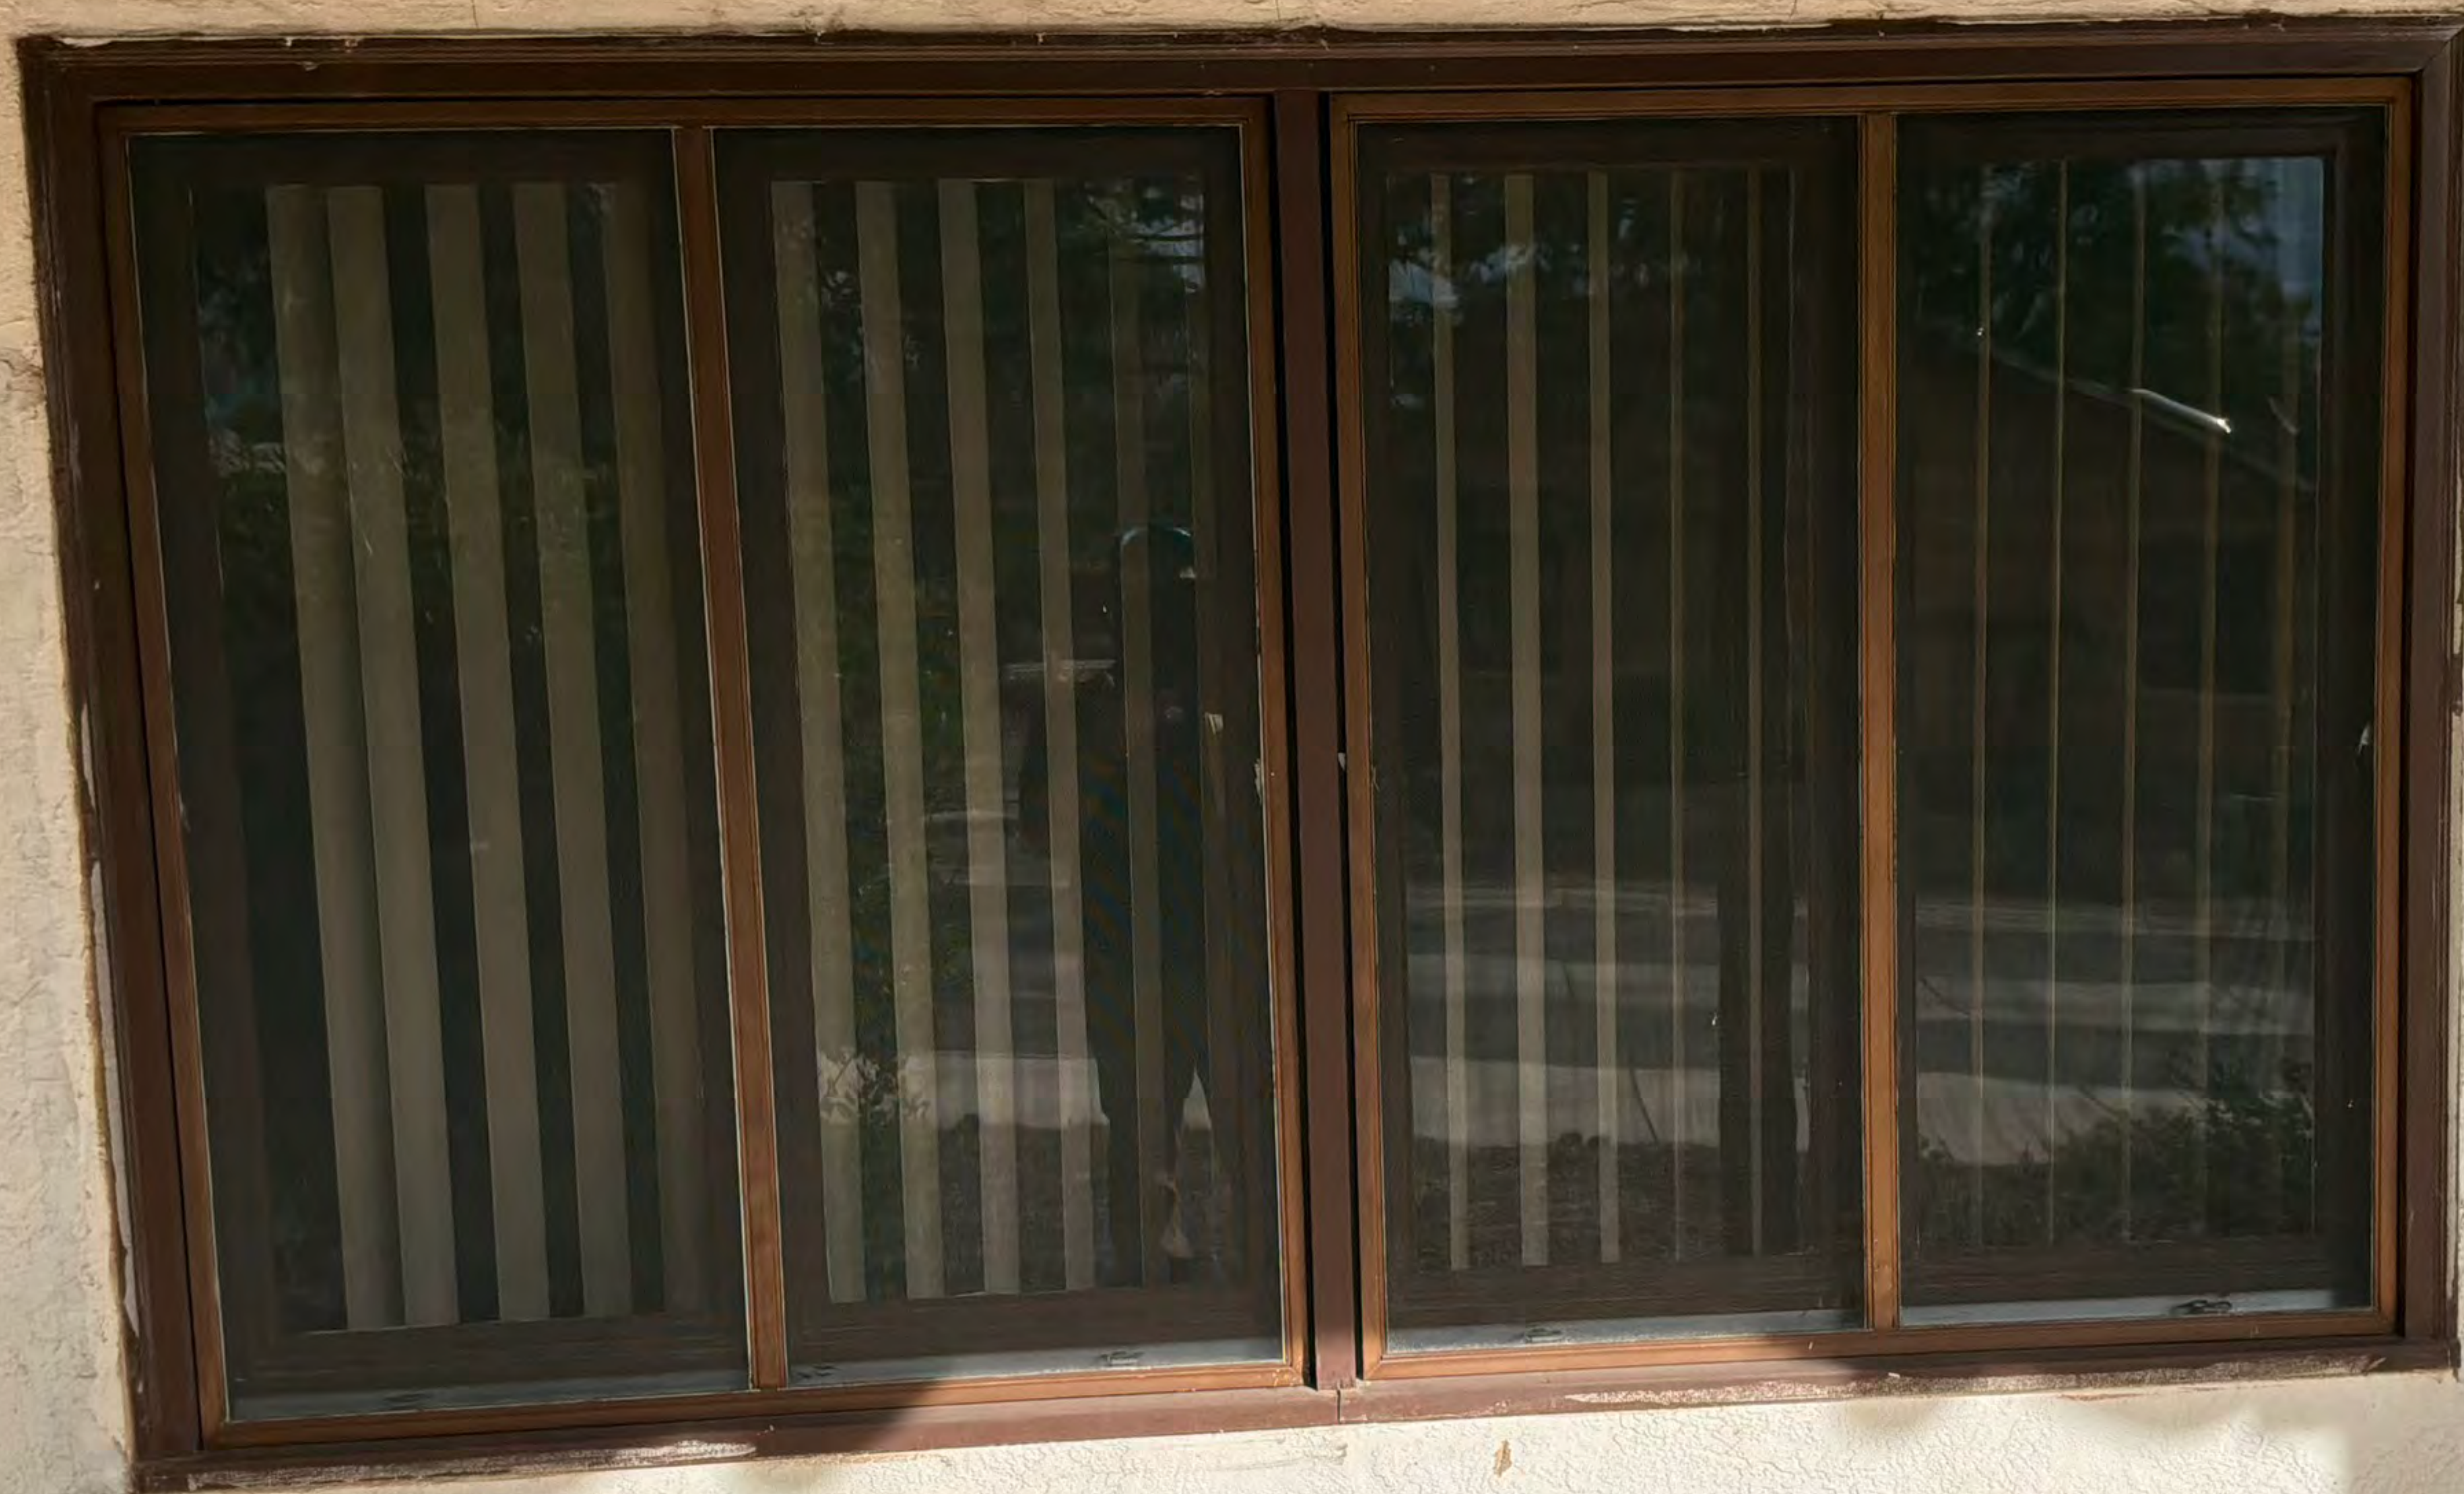
West Elevation  
Window B.

| LABEL | WINDOW & DOOR DESCRIPTION | CONDITION & INTEGRITY CODE | HISTORIC/NON-HISTORIC - AGE |
|---|---|---|---|
| B | 88" x 50" TWIN HORIZONTAL SLIDERS ALL WOOD WITH ALUMINUM STORM | U | <b>HISTORIC</b> - THE TRACKS, PIVOT PINS & HANDLES ARE NOT AVAILABLE TO REPLACE 1950 +/- (ANDERSEN) |

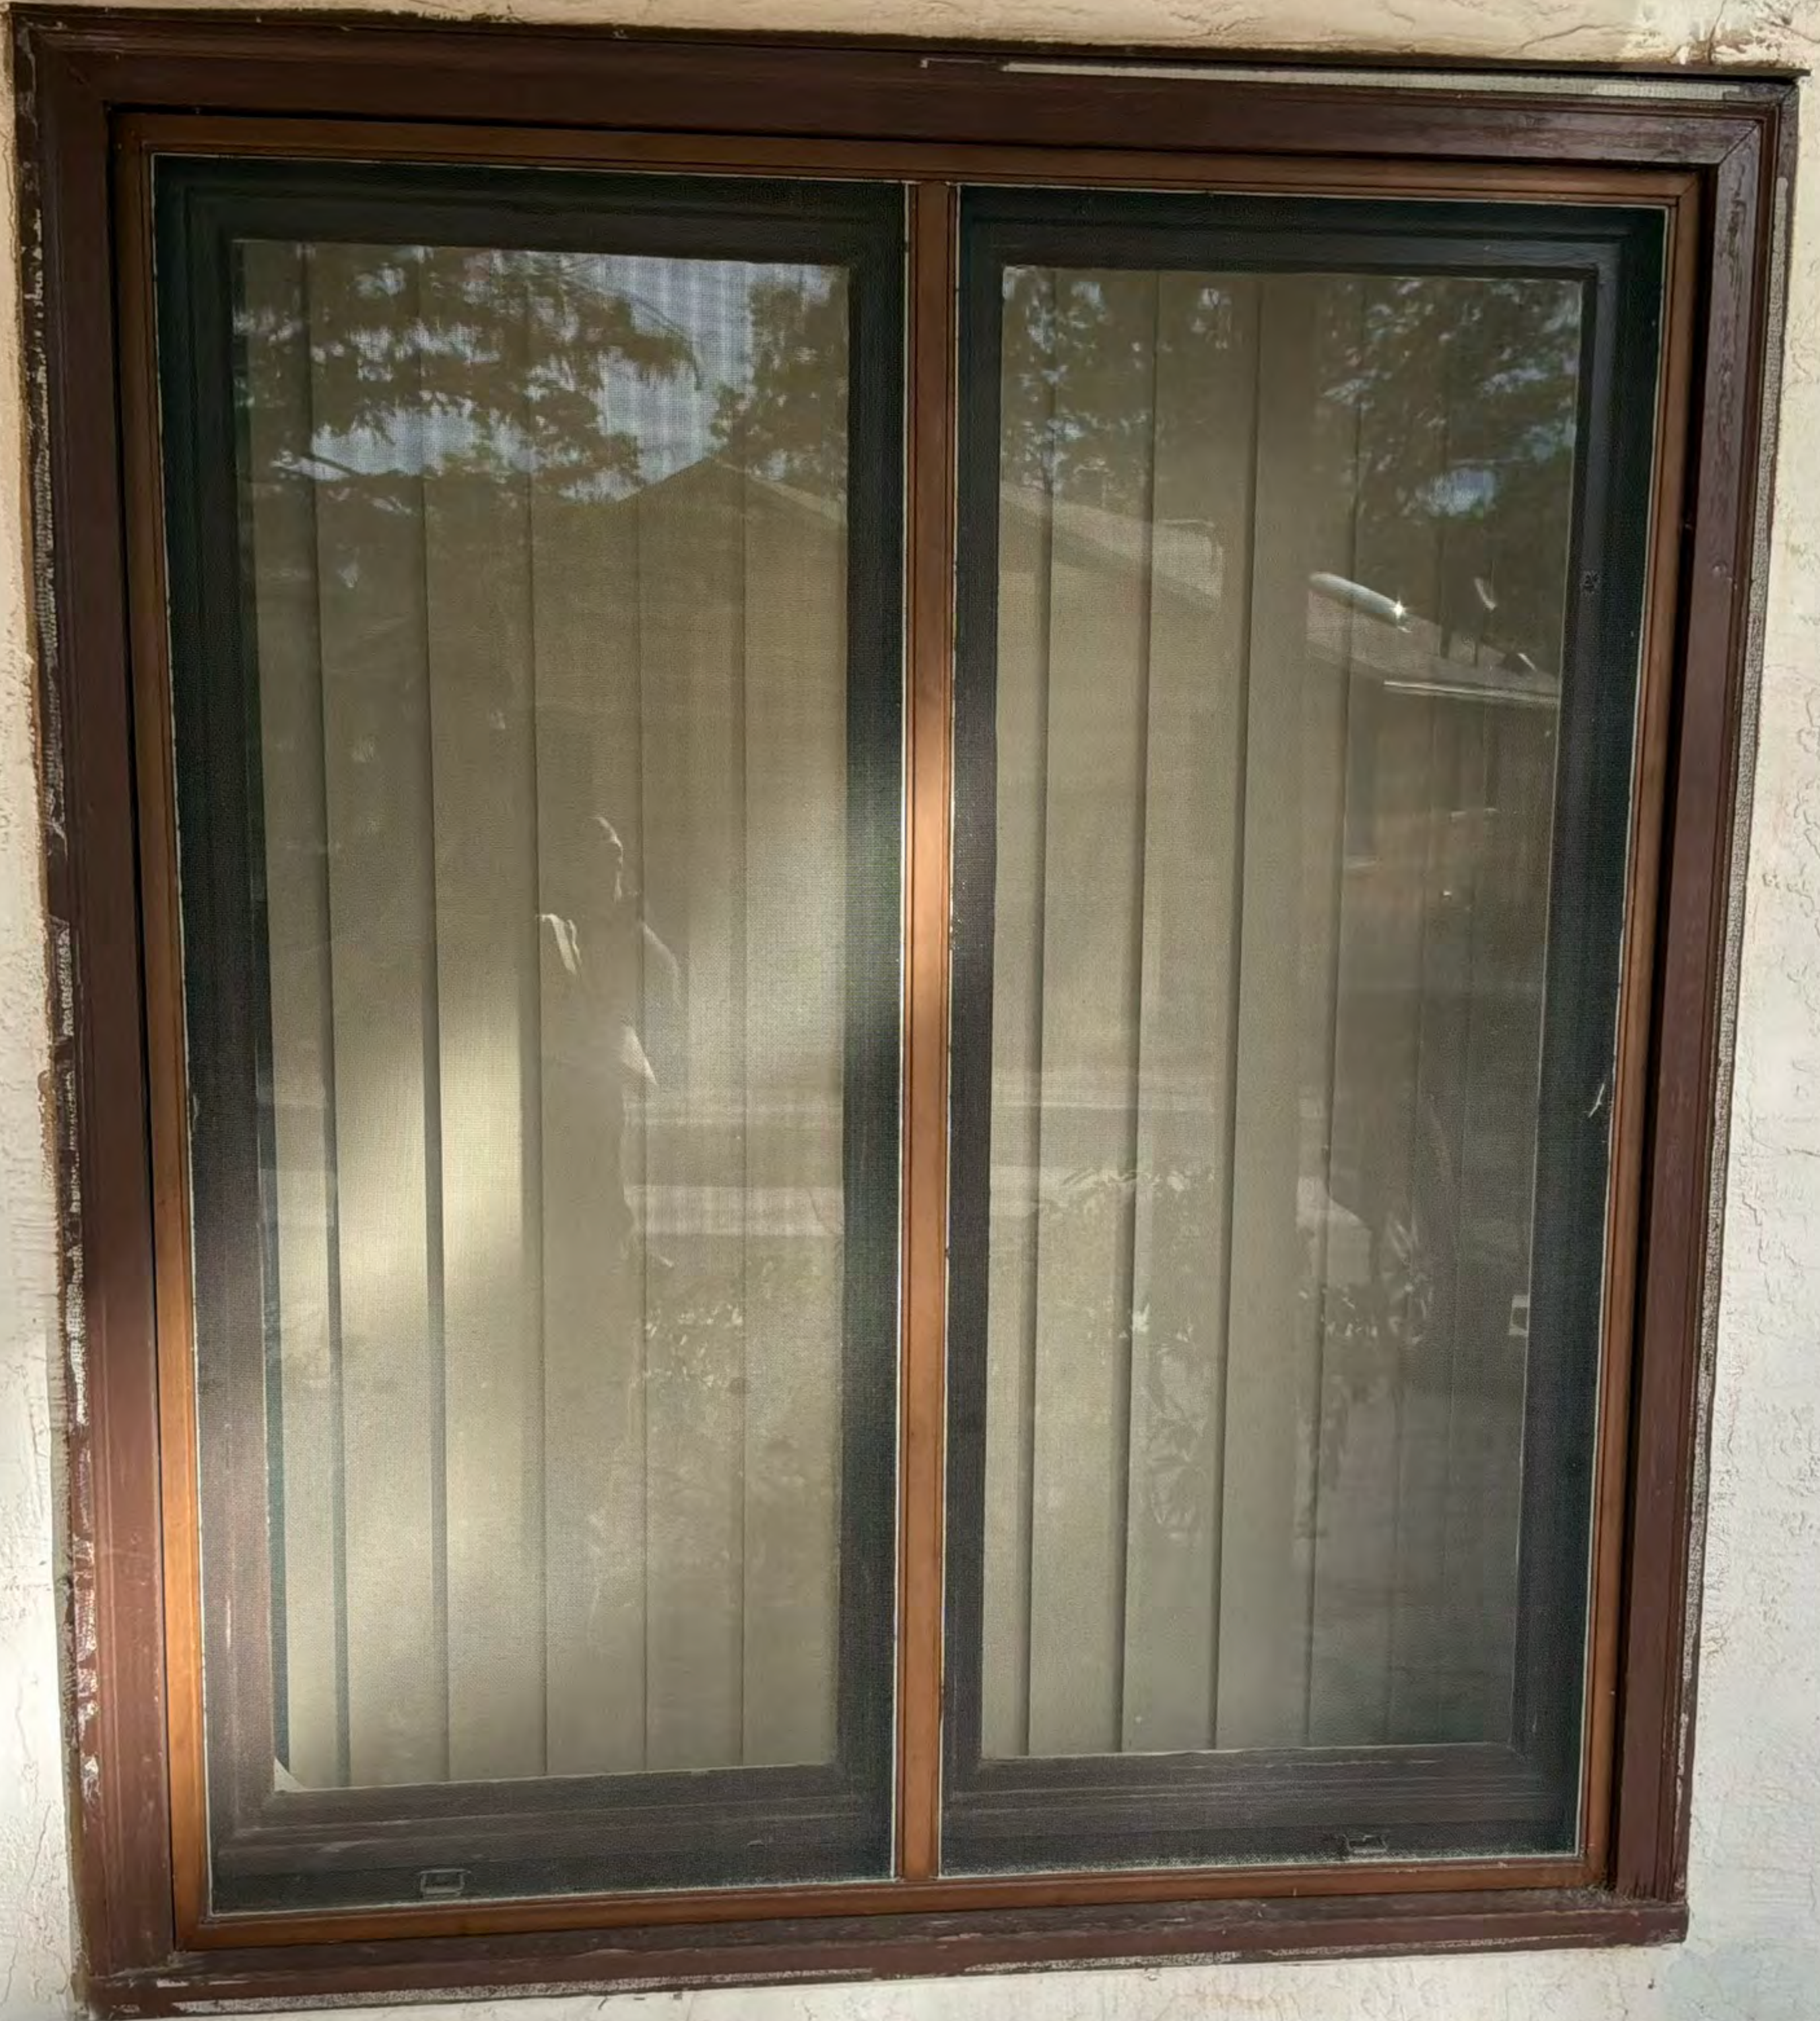
West  
Elevation  
Window C.

| LABEL | WINDOW & DOOR DESCRIPTION | CONDITION & INTEGRITY CODE | HISTORIC/NON-HISTORIC - AGE |
|---|---|---|---|
| C | 42" x 50" HORIZONTAL SLIDER 1-LT ALL WOOD WITH ALUMINUM STORM | U | <b>HISTORIC</b> - THE TRACKS, PIVOT PINS & HANDLES ARE NOT AVAILABLE TO REPLACE 1950 +/- (ANDERSEN) |

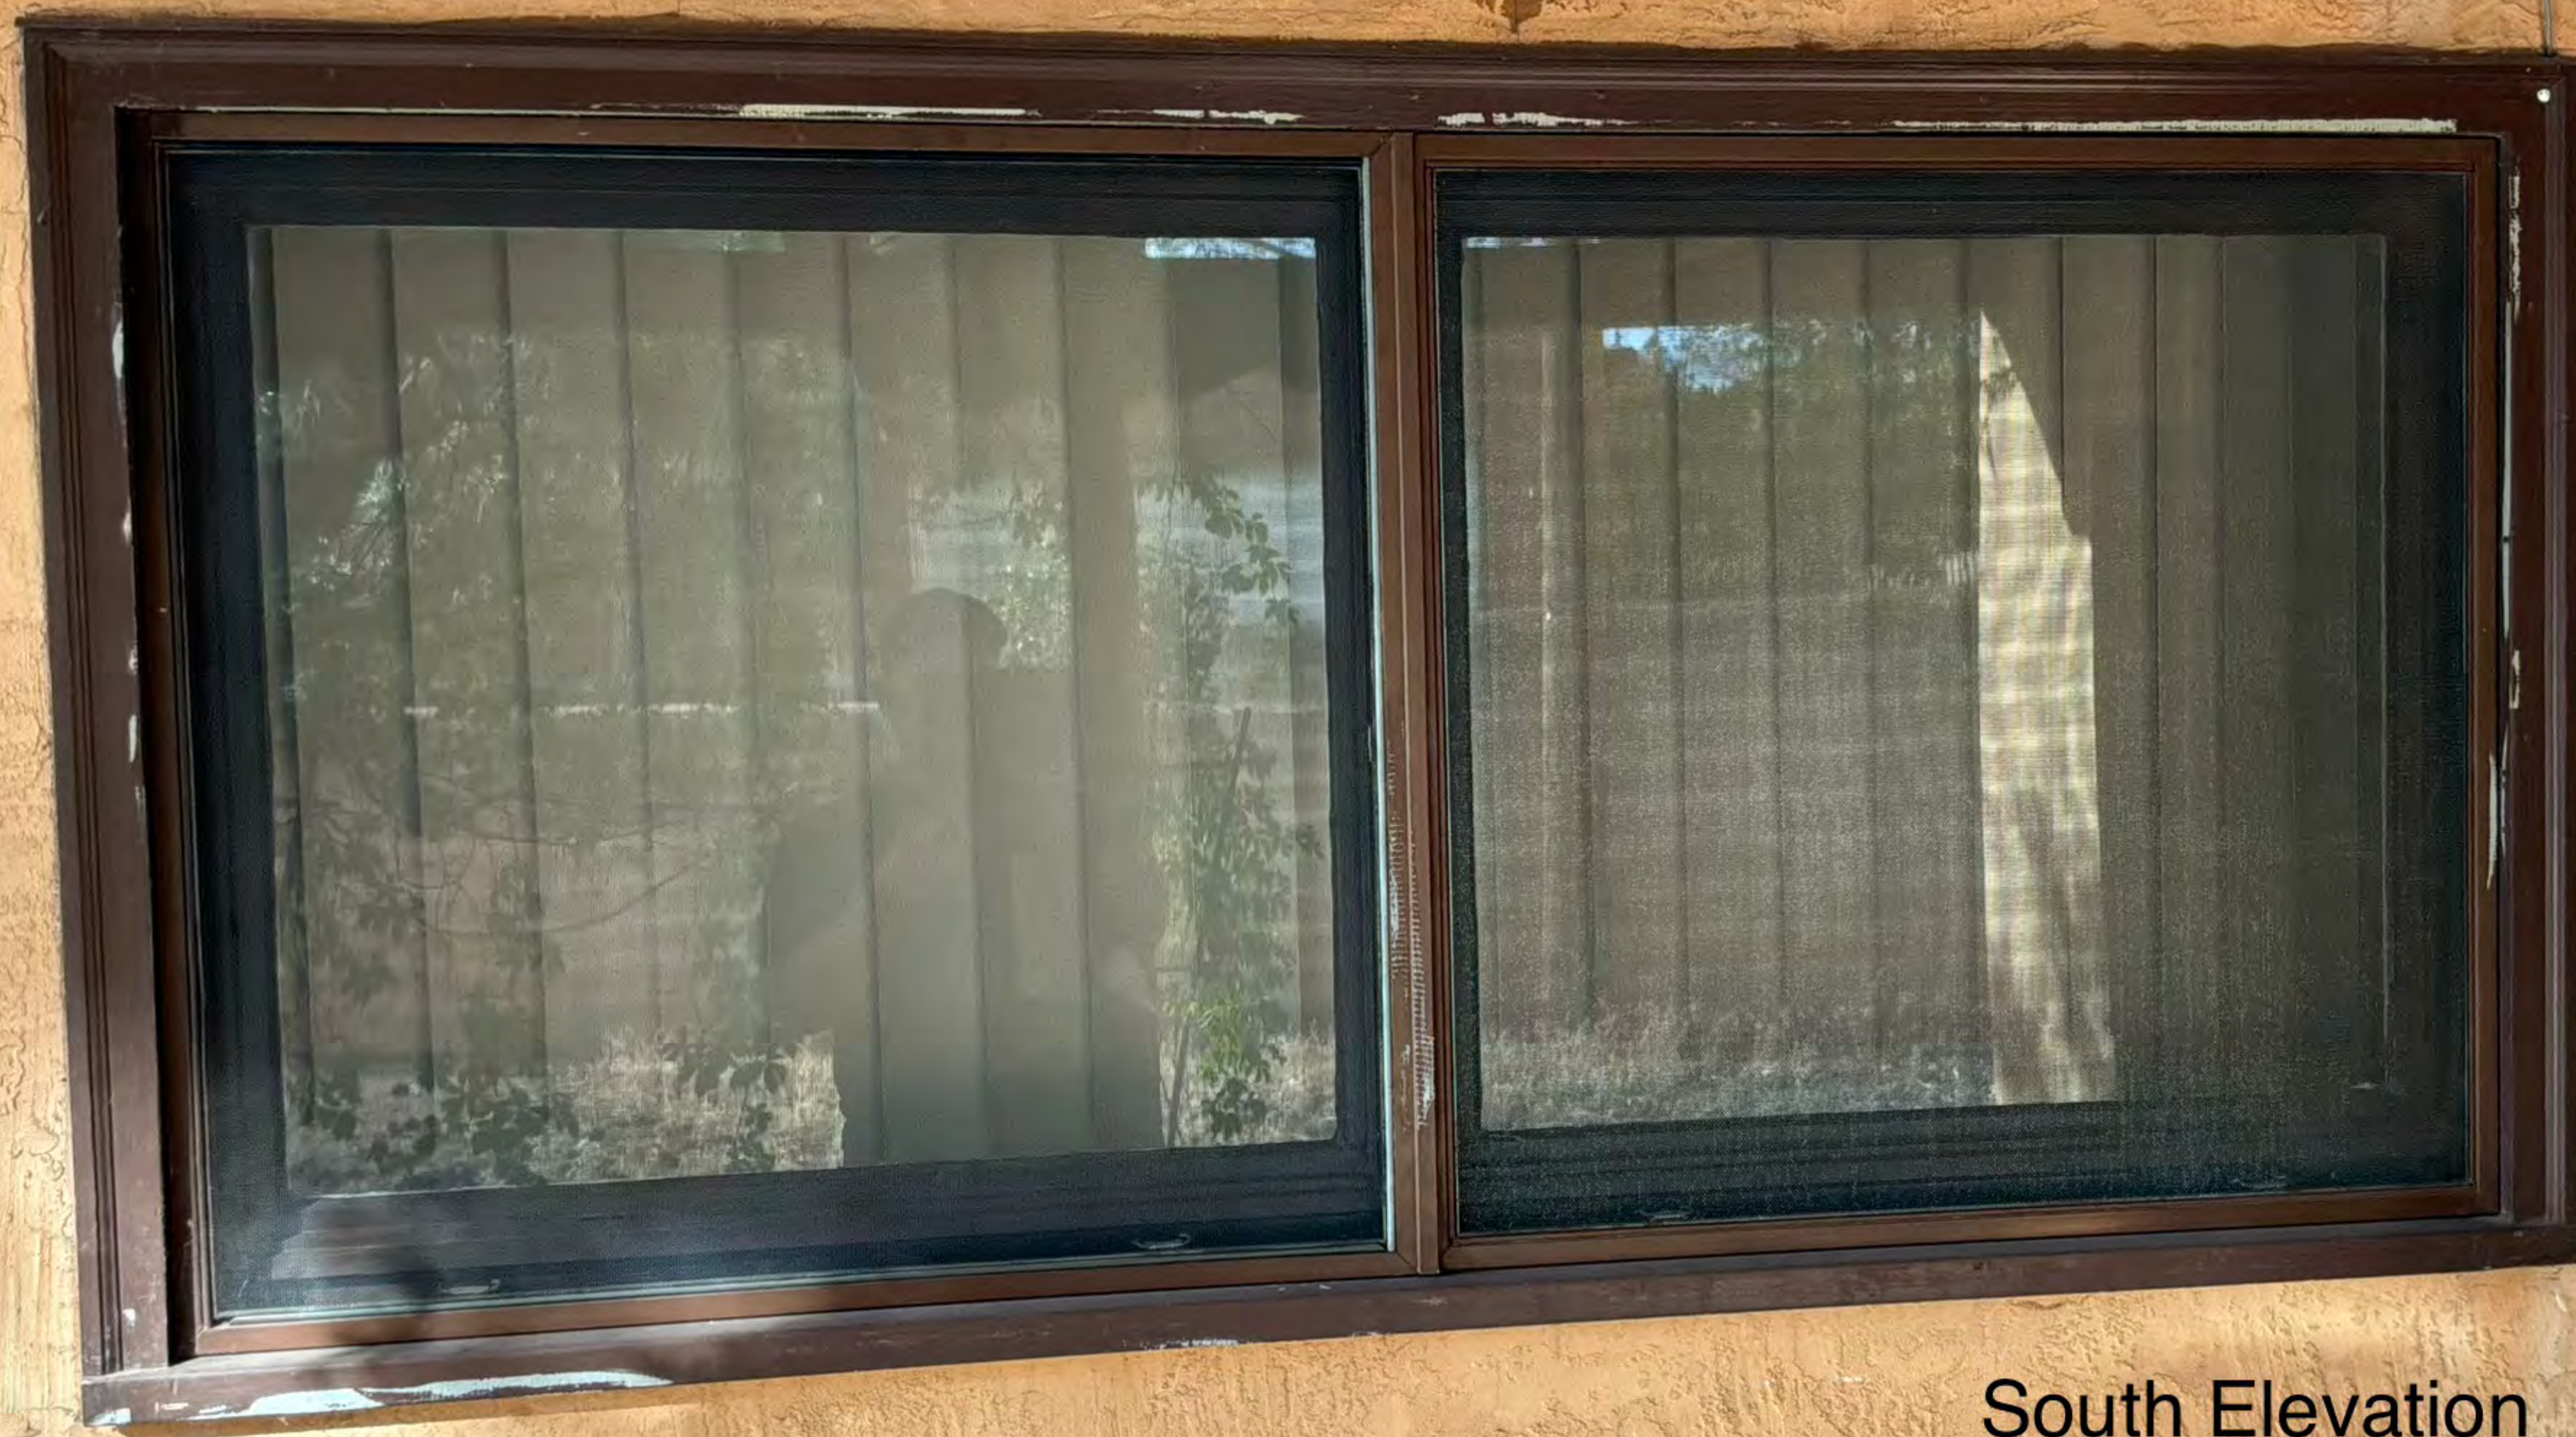
South Elevation  
Window  
D.

| LABEL | WINDOW & DOOR DESCRIPTION | CONDITION & INTEGRITY CODE | HISTORIC/NON-HISTORIC - AGE |
|---|---|---|---|
| D | 66" x 33" HORIZONTAL ALL WOOD WITH ALUMINUM STORM | U | <b>HISTORIC</b> - THE TRACKS, PIVOT PINS & HANDLES ARE NOT AVAILABLE TO REPLACE 1950 +/- (ANDERSEN) |

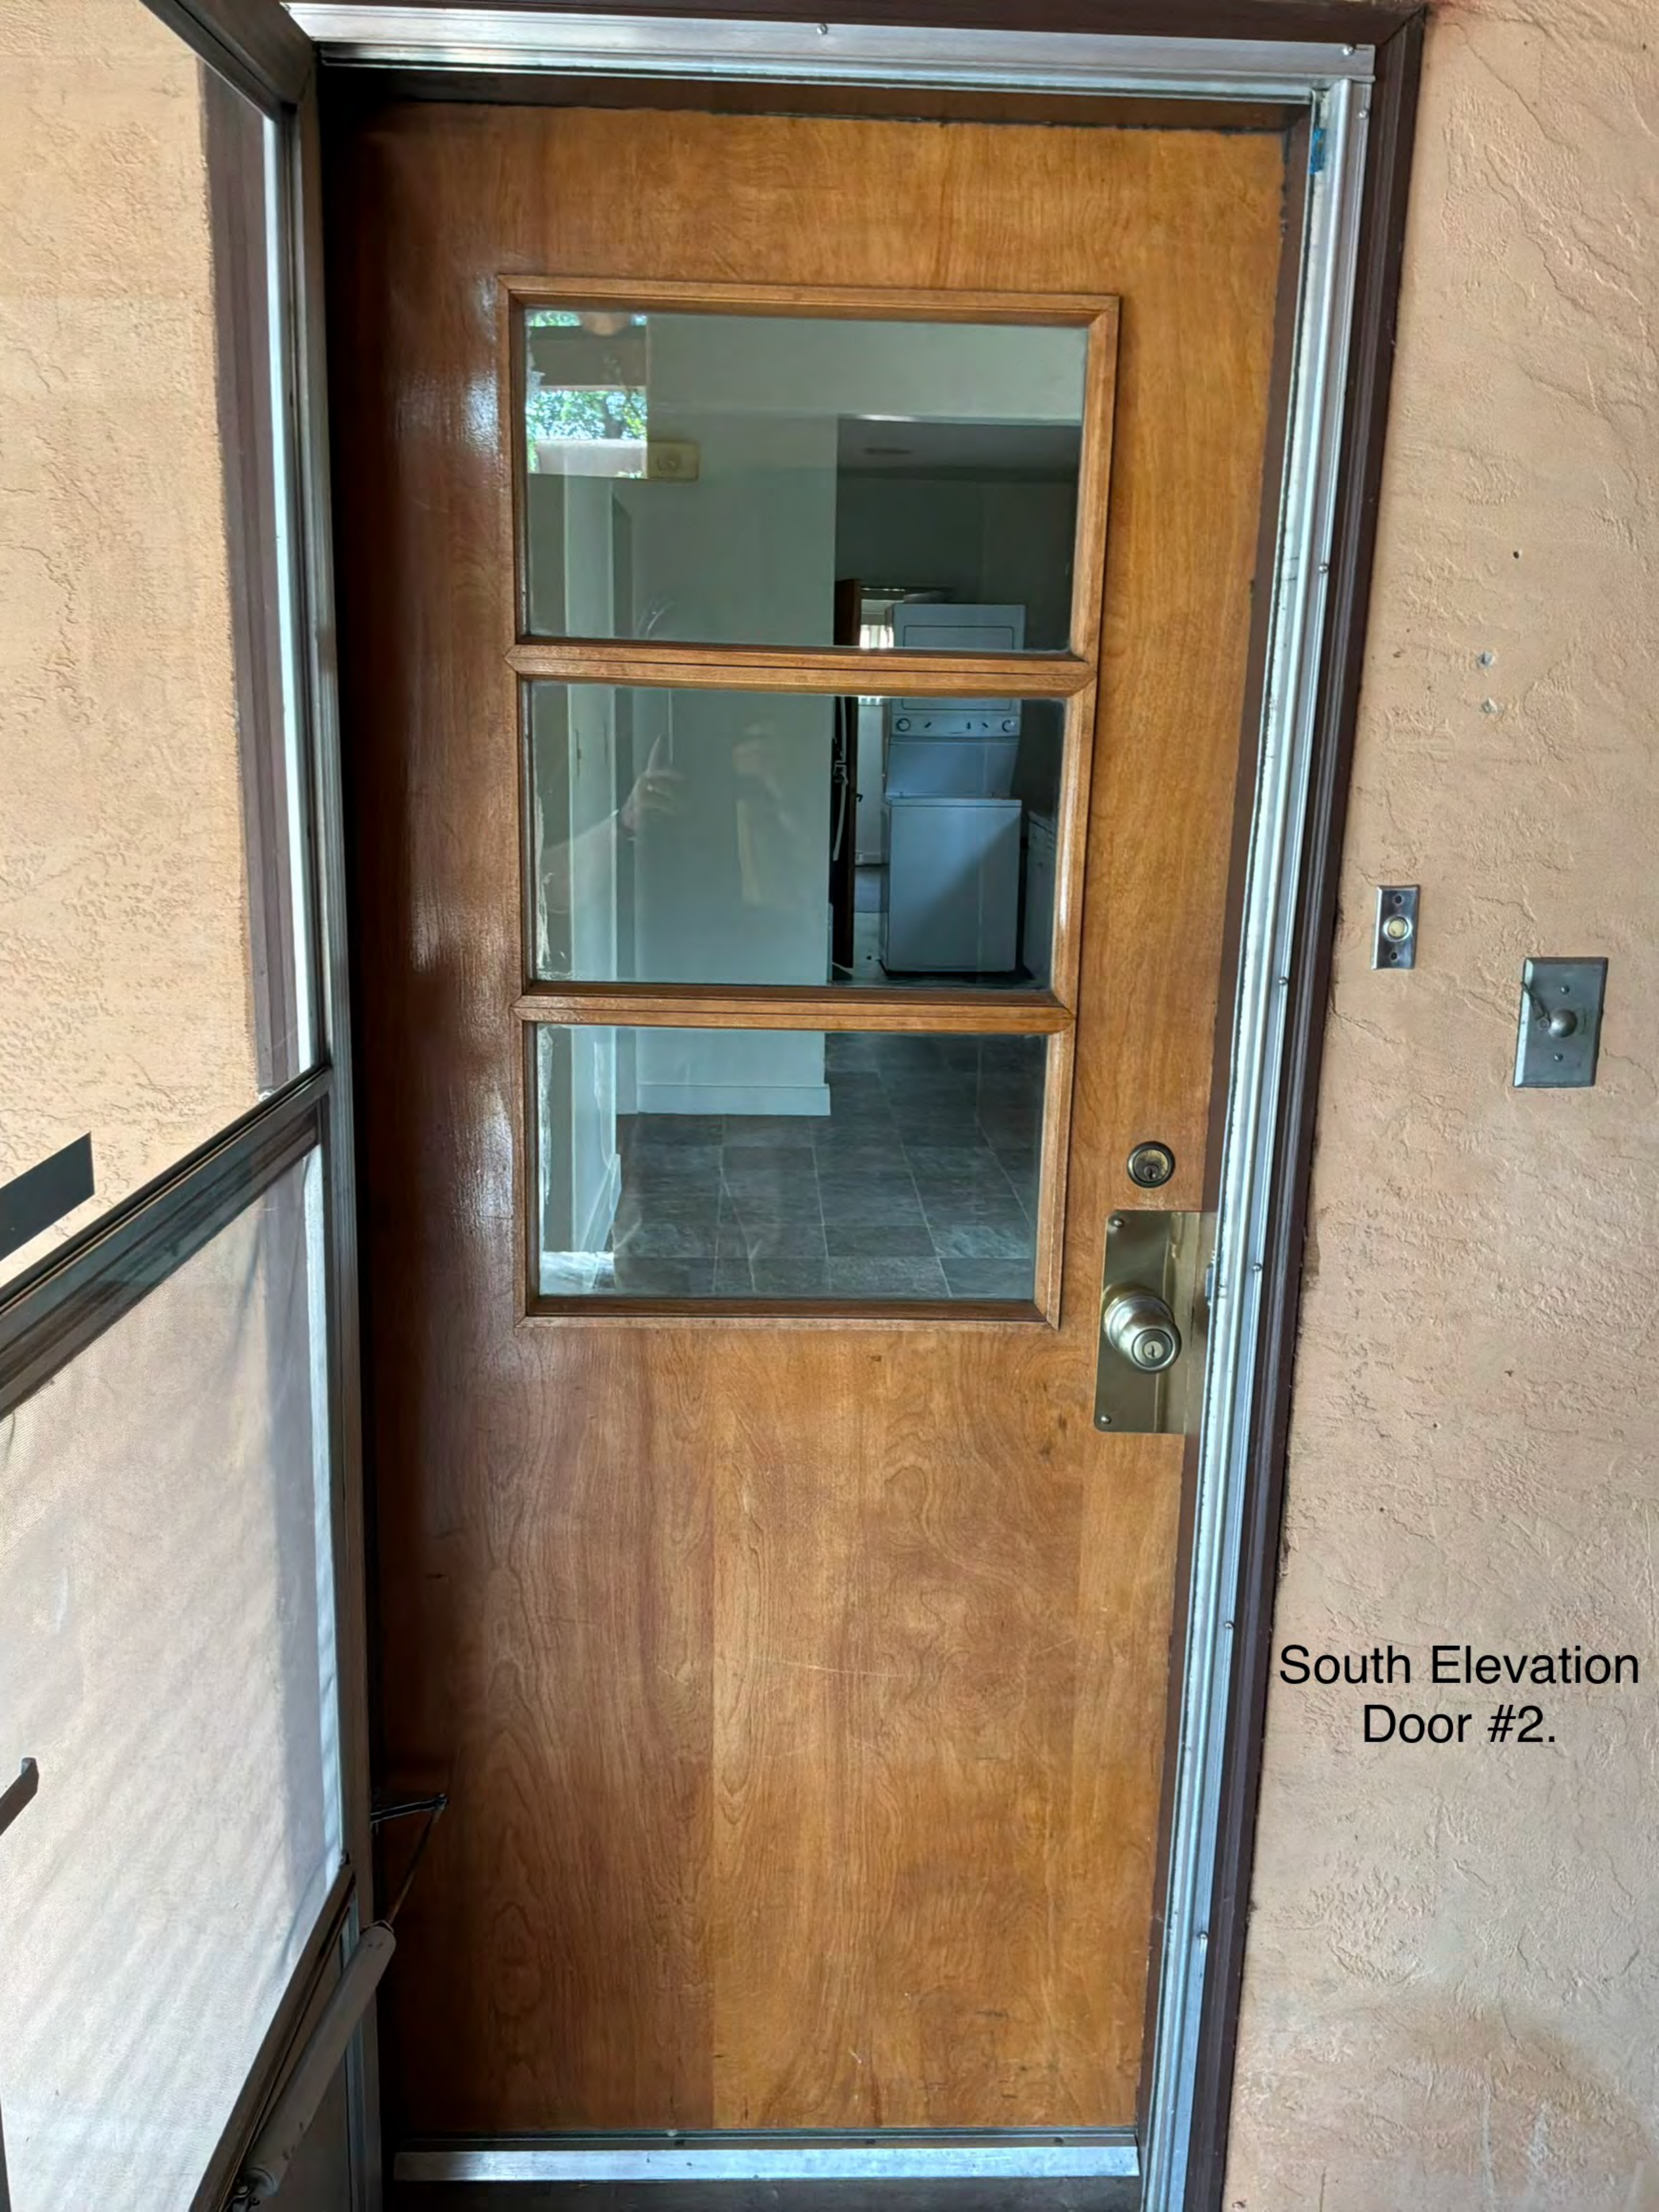
South Elevation  
Door #2.

| LABEL | WINDOW & DOOR DESCRIPTION | CONDITION & INTEGRITY CODE | HISTORIC/NON-HISTORIC - AGE |
|---|---|---|---|
| DR #2 | 32" x 80" LH INSWING DOOR BIRCH WITH HALF LITE 3 LITE KIT ALL WOOD | S | <b>NON-HISTORIC</b> - BIRCH DOOR WITH LITE KITE VENEERED (1996) |
