# RPA & Associates, LLC.

| JOB | DATE |
|---|---|
| 104 Camino Mathias | 07/28/2026 |

## RPA & ASSOCIATES, LLC | WINDOW & DOOR CONDITION AND INTEGRITY CODES

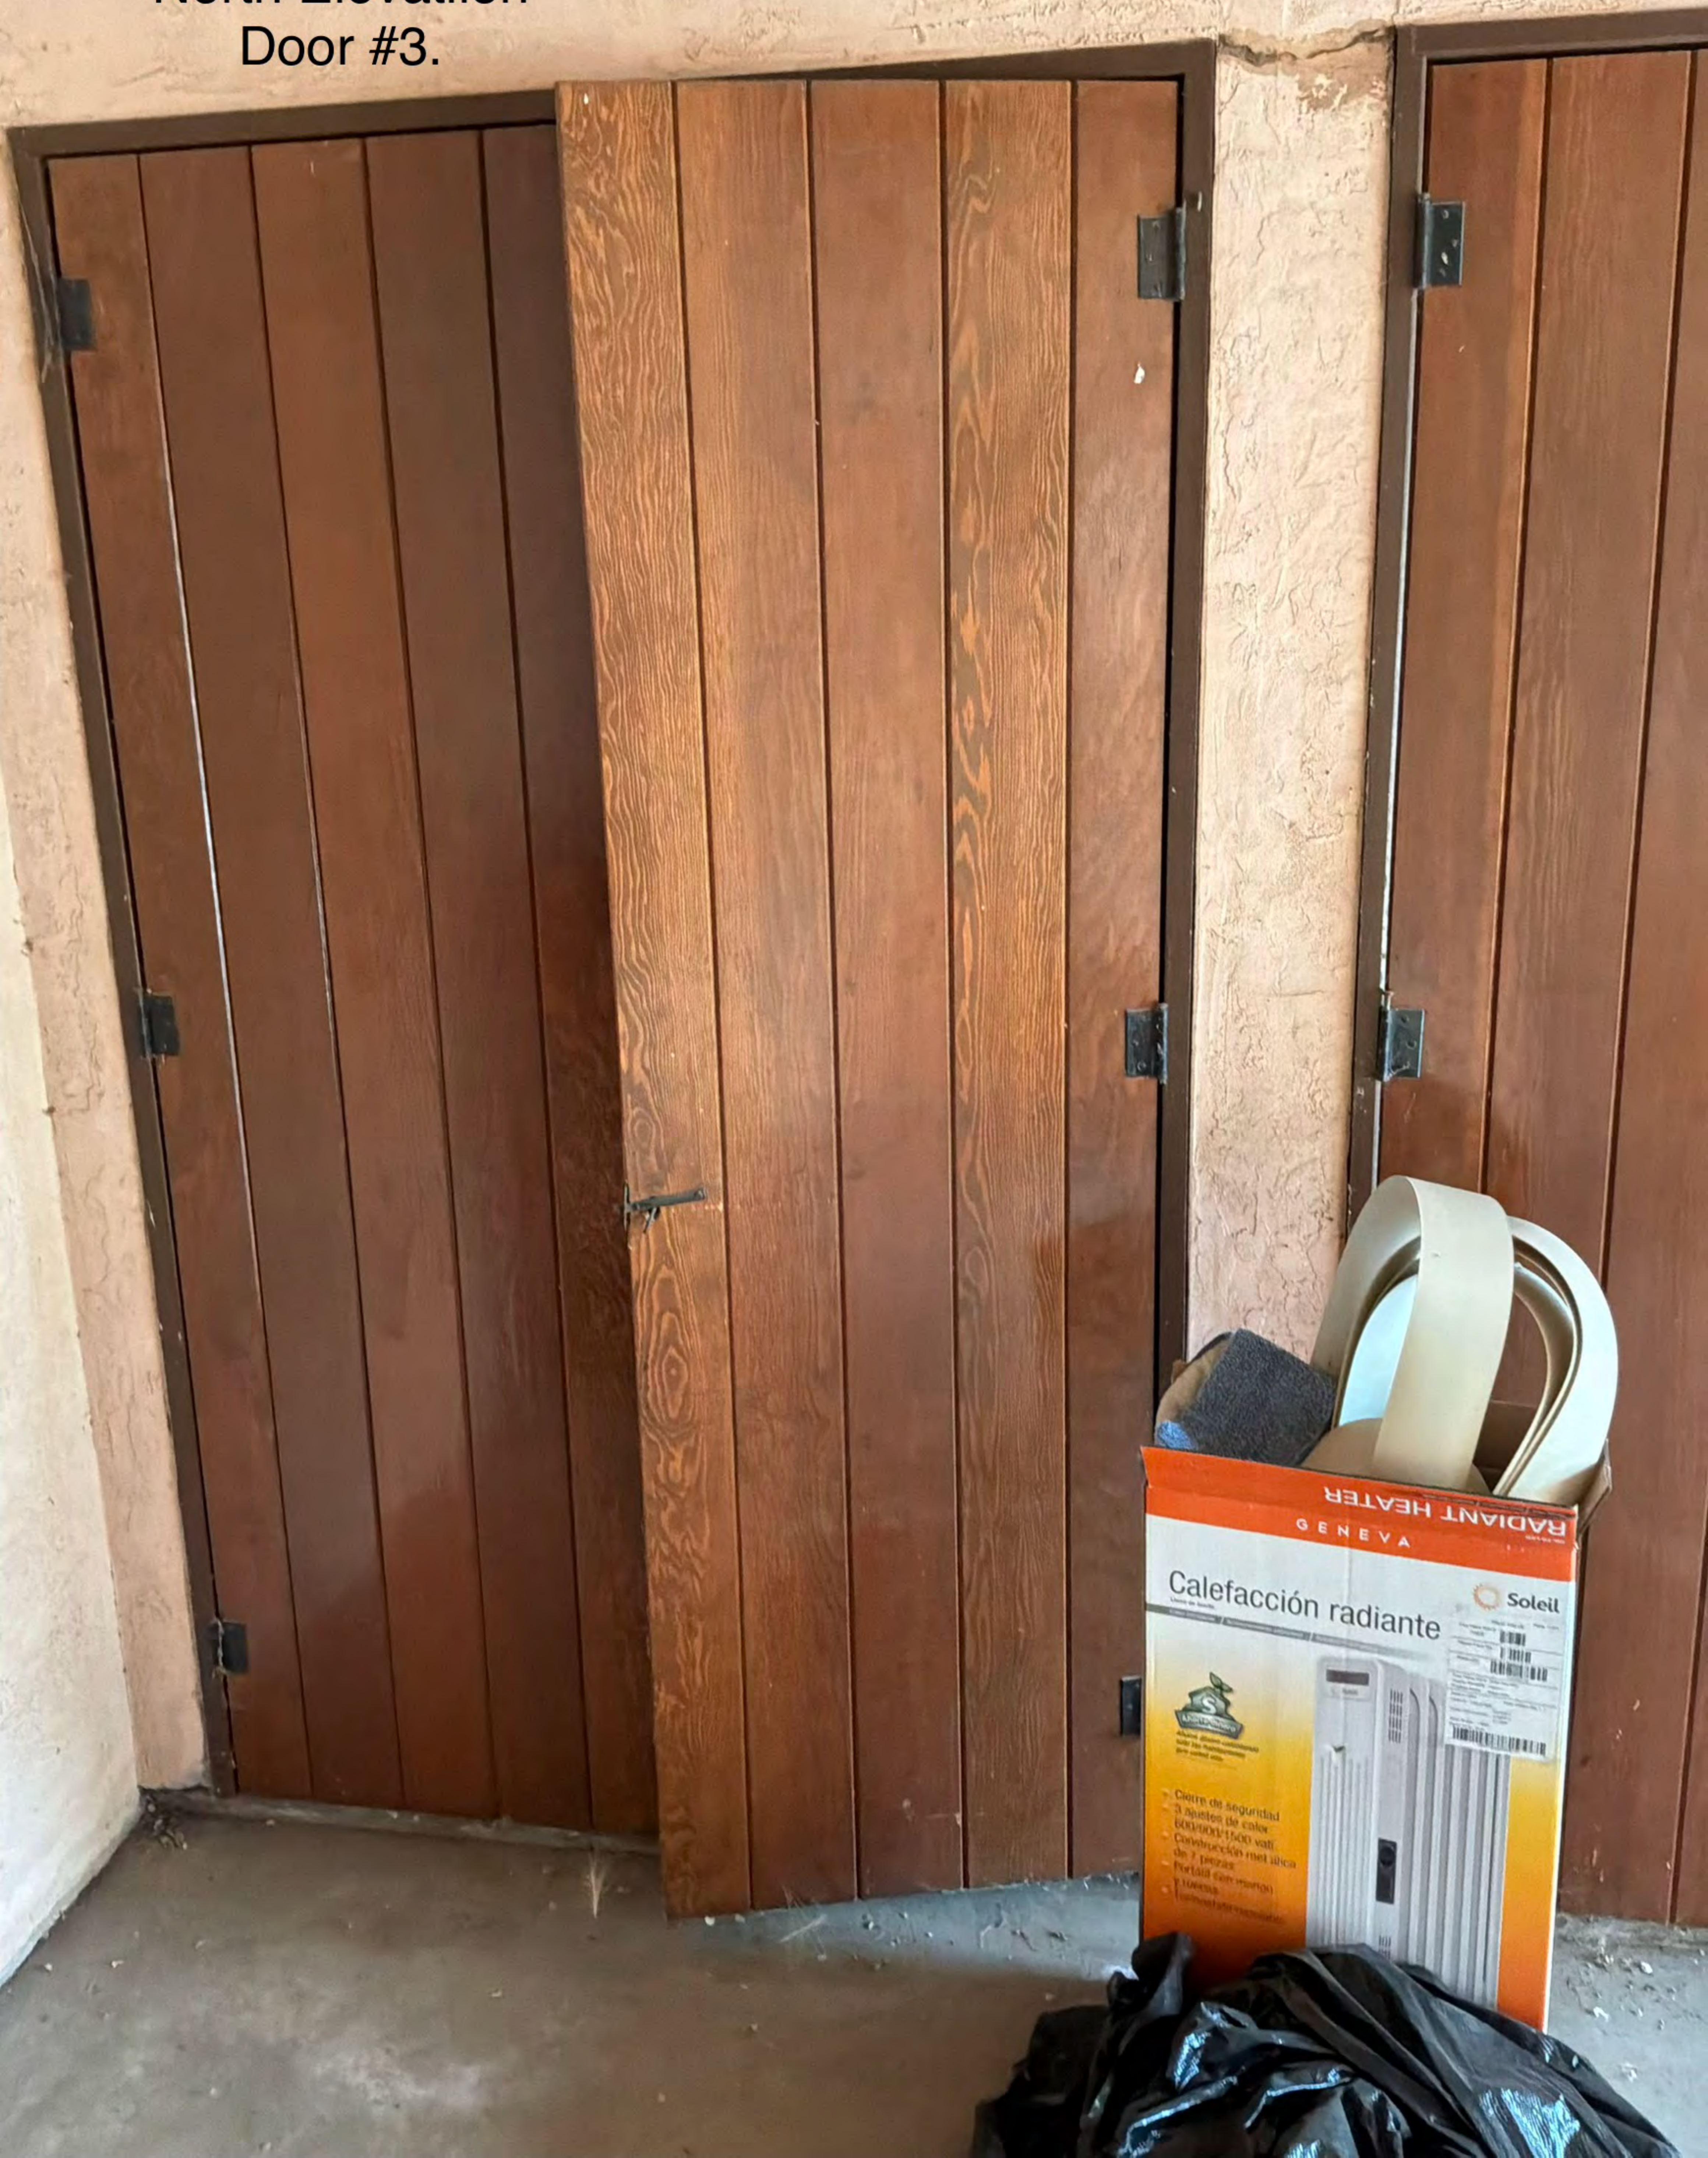
North Elevatiion  
Door #3.

Doors 1, 2, 3, 4, and 5 are non-historic.

| LABEL | WINDOW & DOOR DESCRIPTION | CONDITION & INTEGRITY CODE | HISTORIC/NON-HISTORIC - AGE |
|---|---|---|---|
| DR #3 | 48" x 82" TWIN LH OUTSWING T&G ALL WOOD DOOR | F | <b>NON-HISTORIC</b> - SHOP MADE DOORS, MECHANICAL AIR NAILS (1996) |

My recommendation is to replace the windows with casement units with horizontal lites to replicate the steel casements of that era. The doors should be a wood paneled look of that 1950 era.

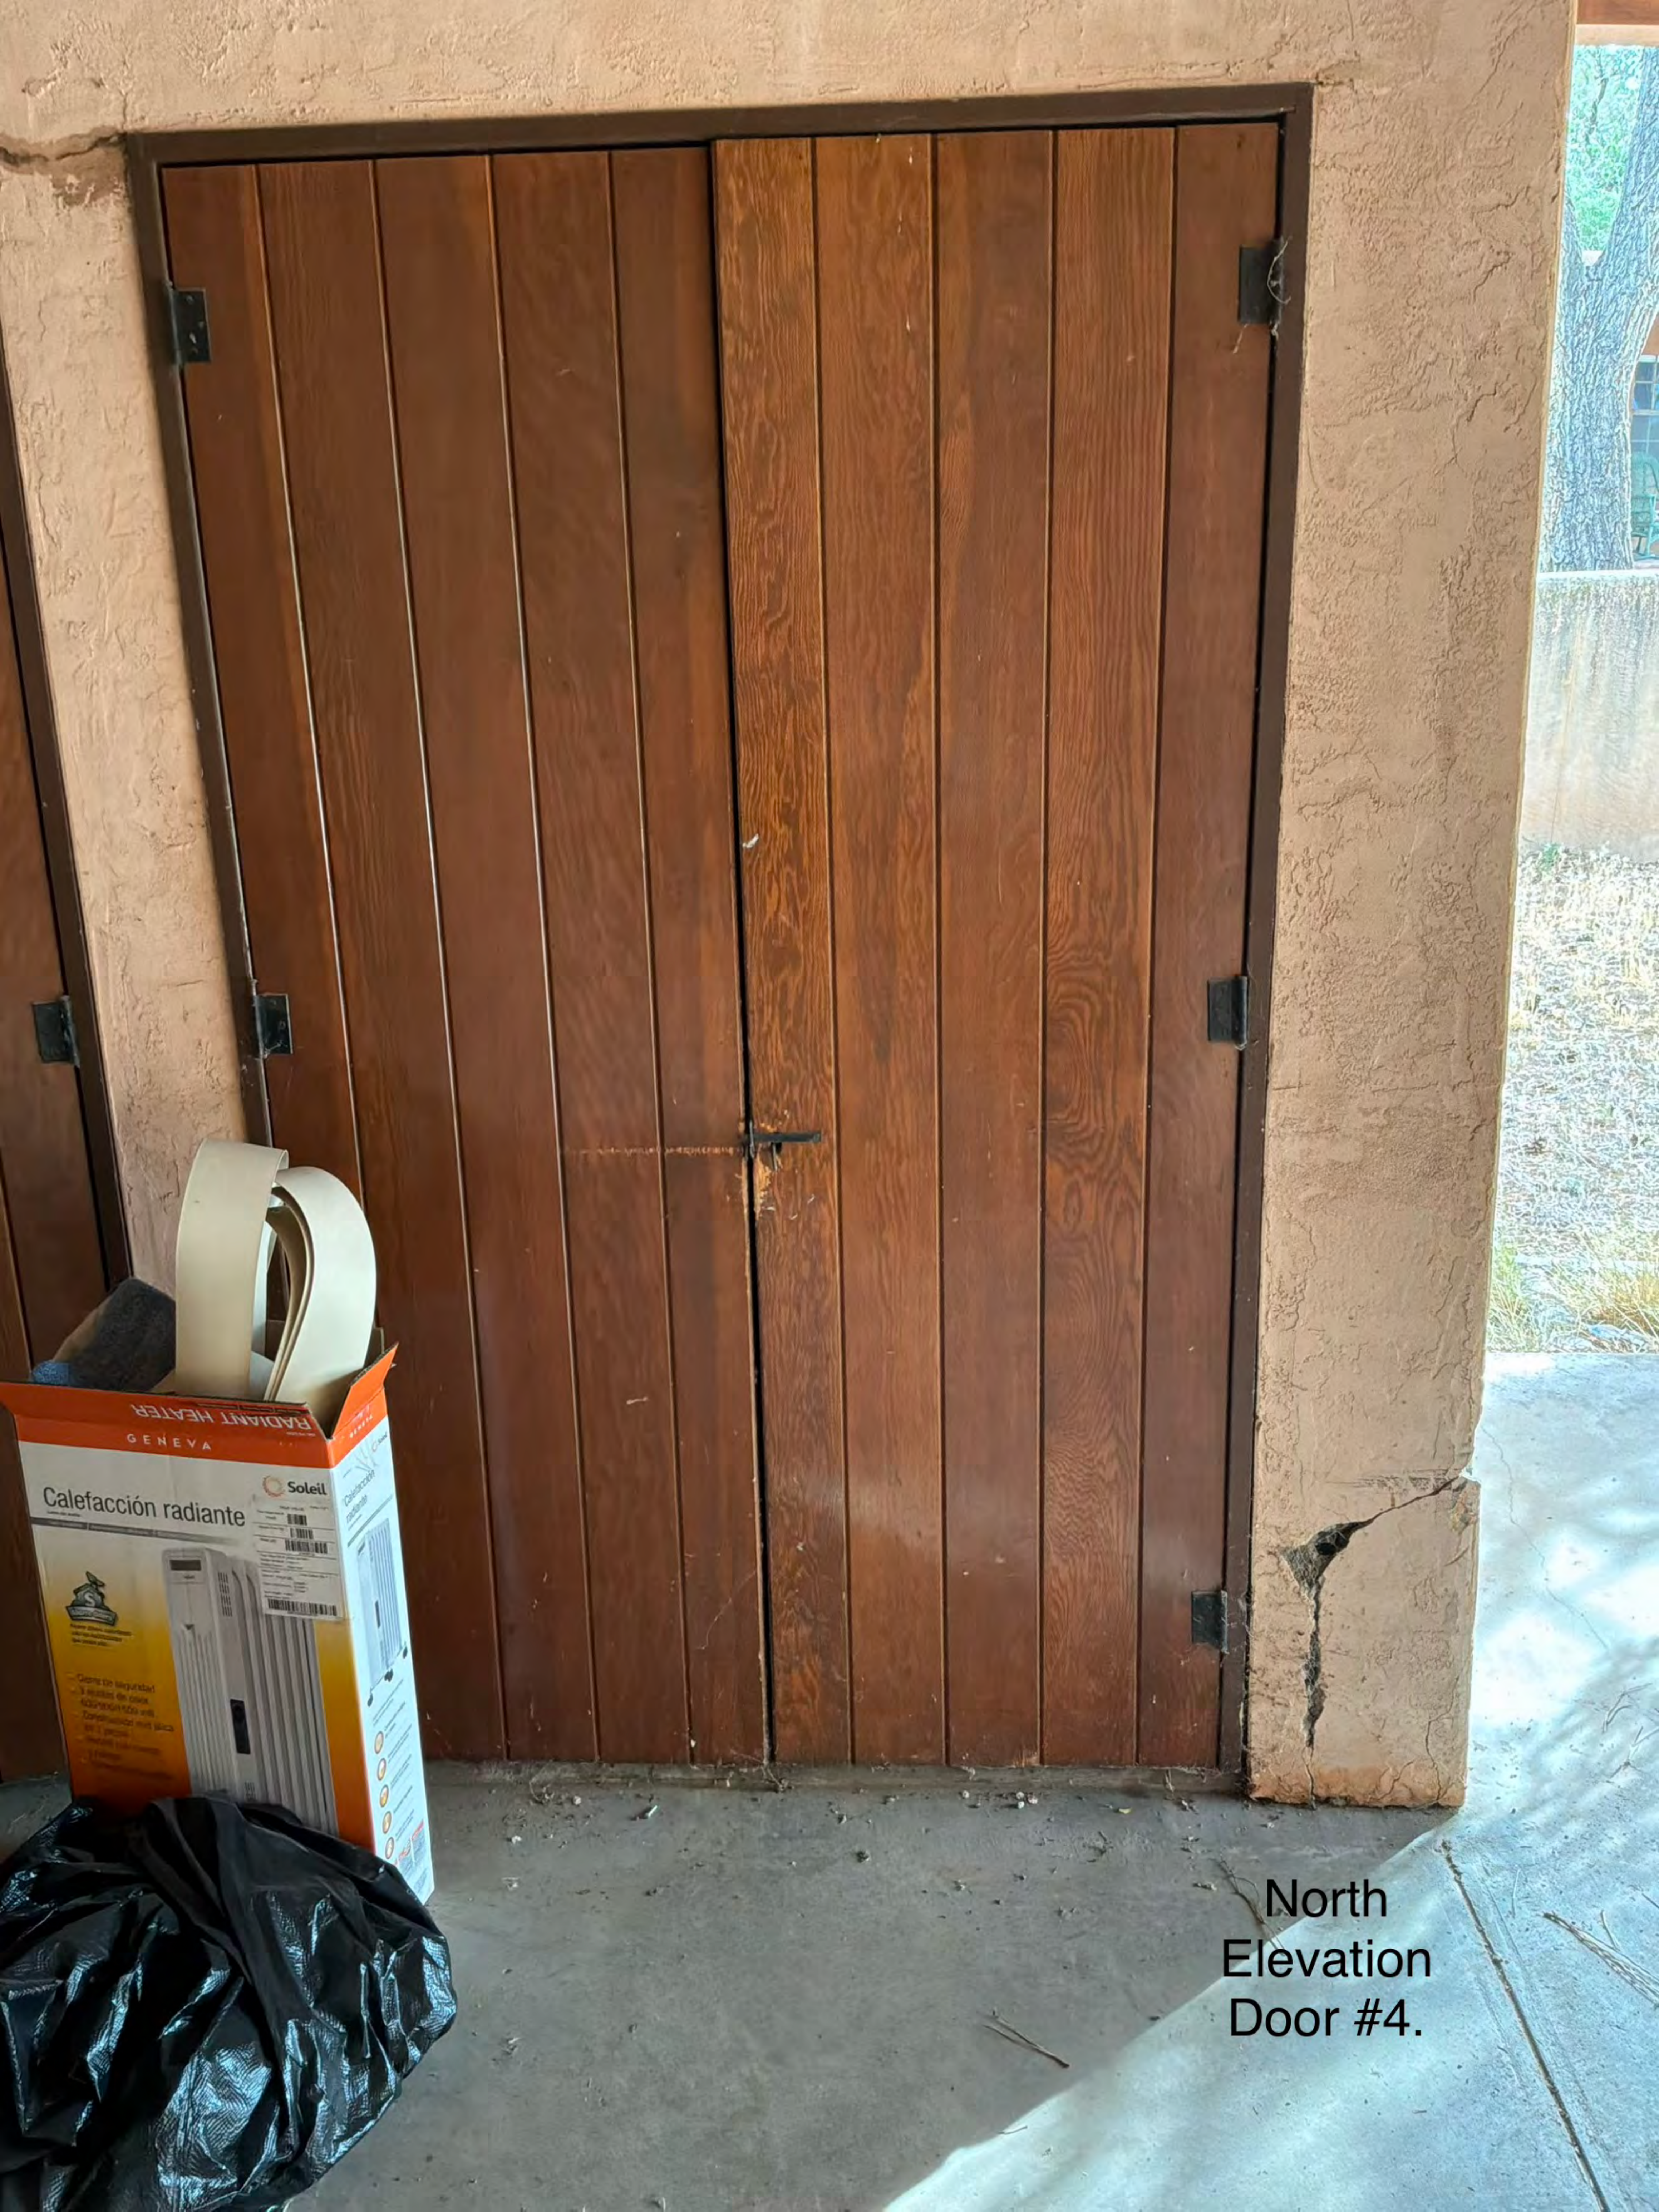
North  
Elevation  
Door #4.

| LABEL | WINDOW & DOOR DESCRIPTION | CONDITION & INTEGRITY CODE | HISTORIC/NON-HISTORIC - AGE |
|---|---|---|---|
| DR #4 | 48" x 82" TWIN RH OUTSWING T&G ALL WOOD DOOR | F | <b>NON-HISTORIC</b> - SHOP MADE DOORS, MECHANICAL AIR NAILS (1996) |

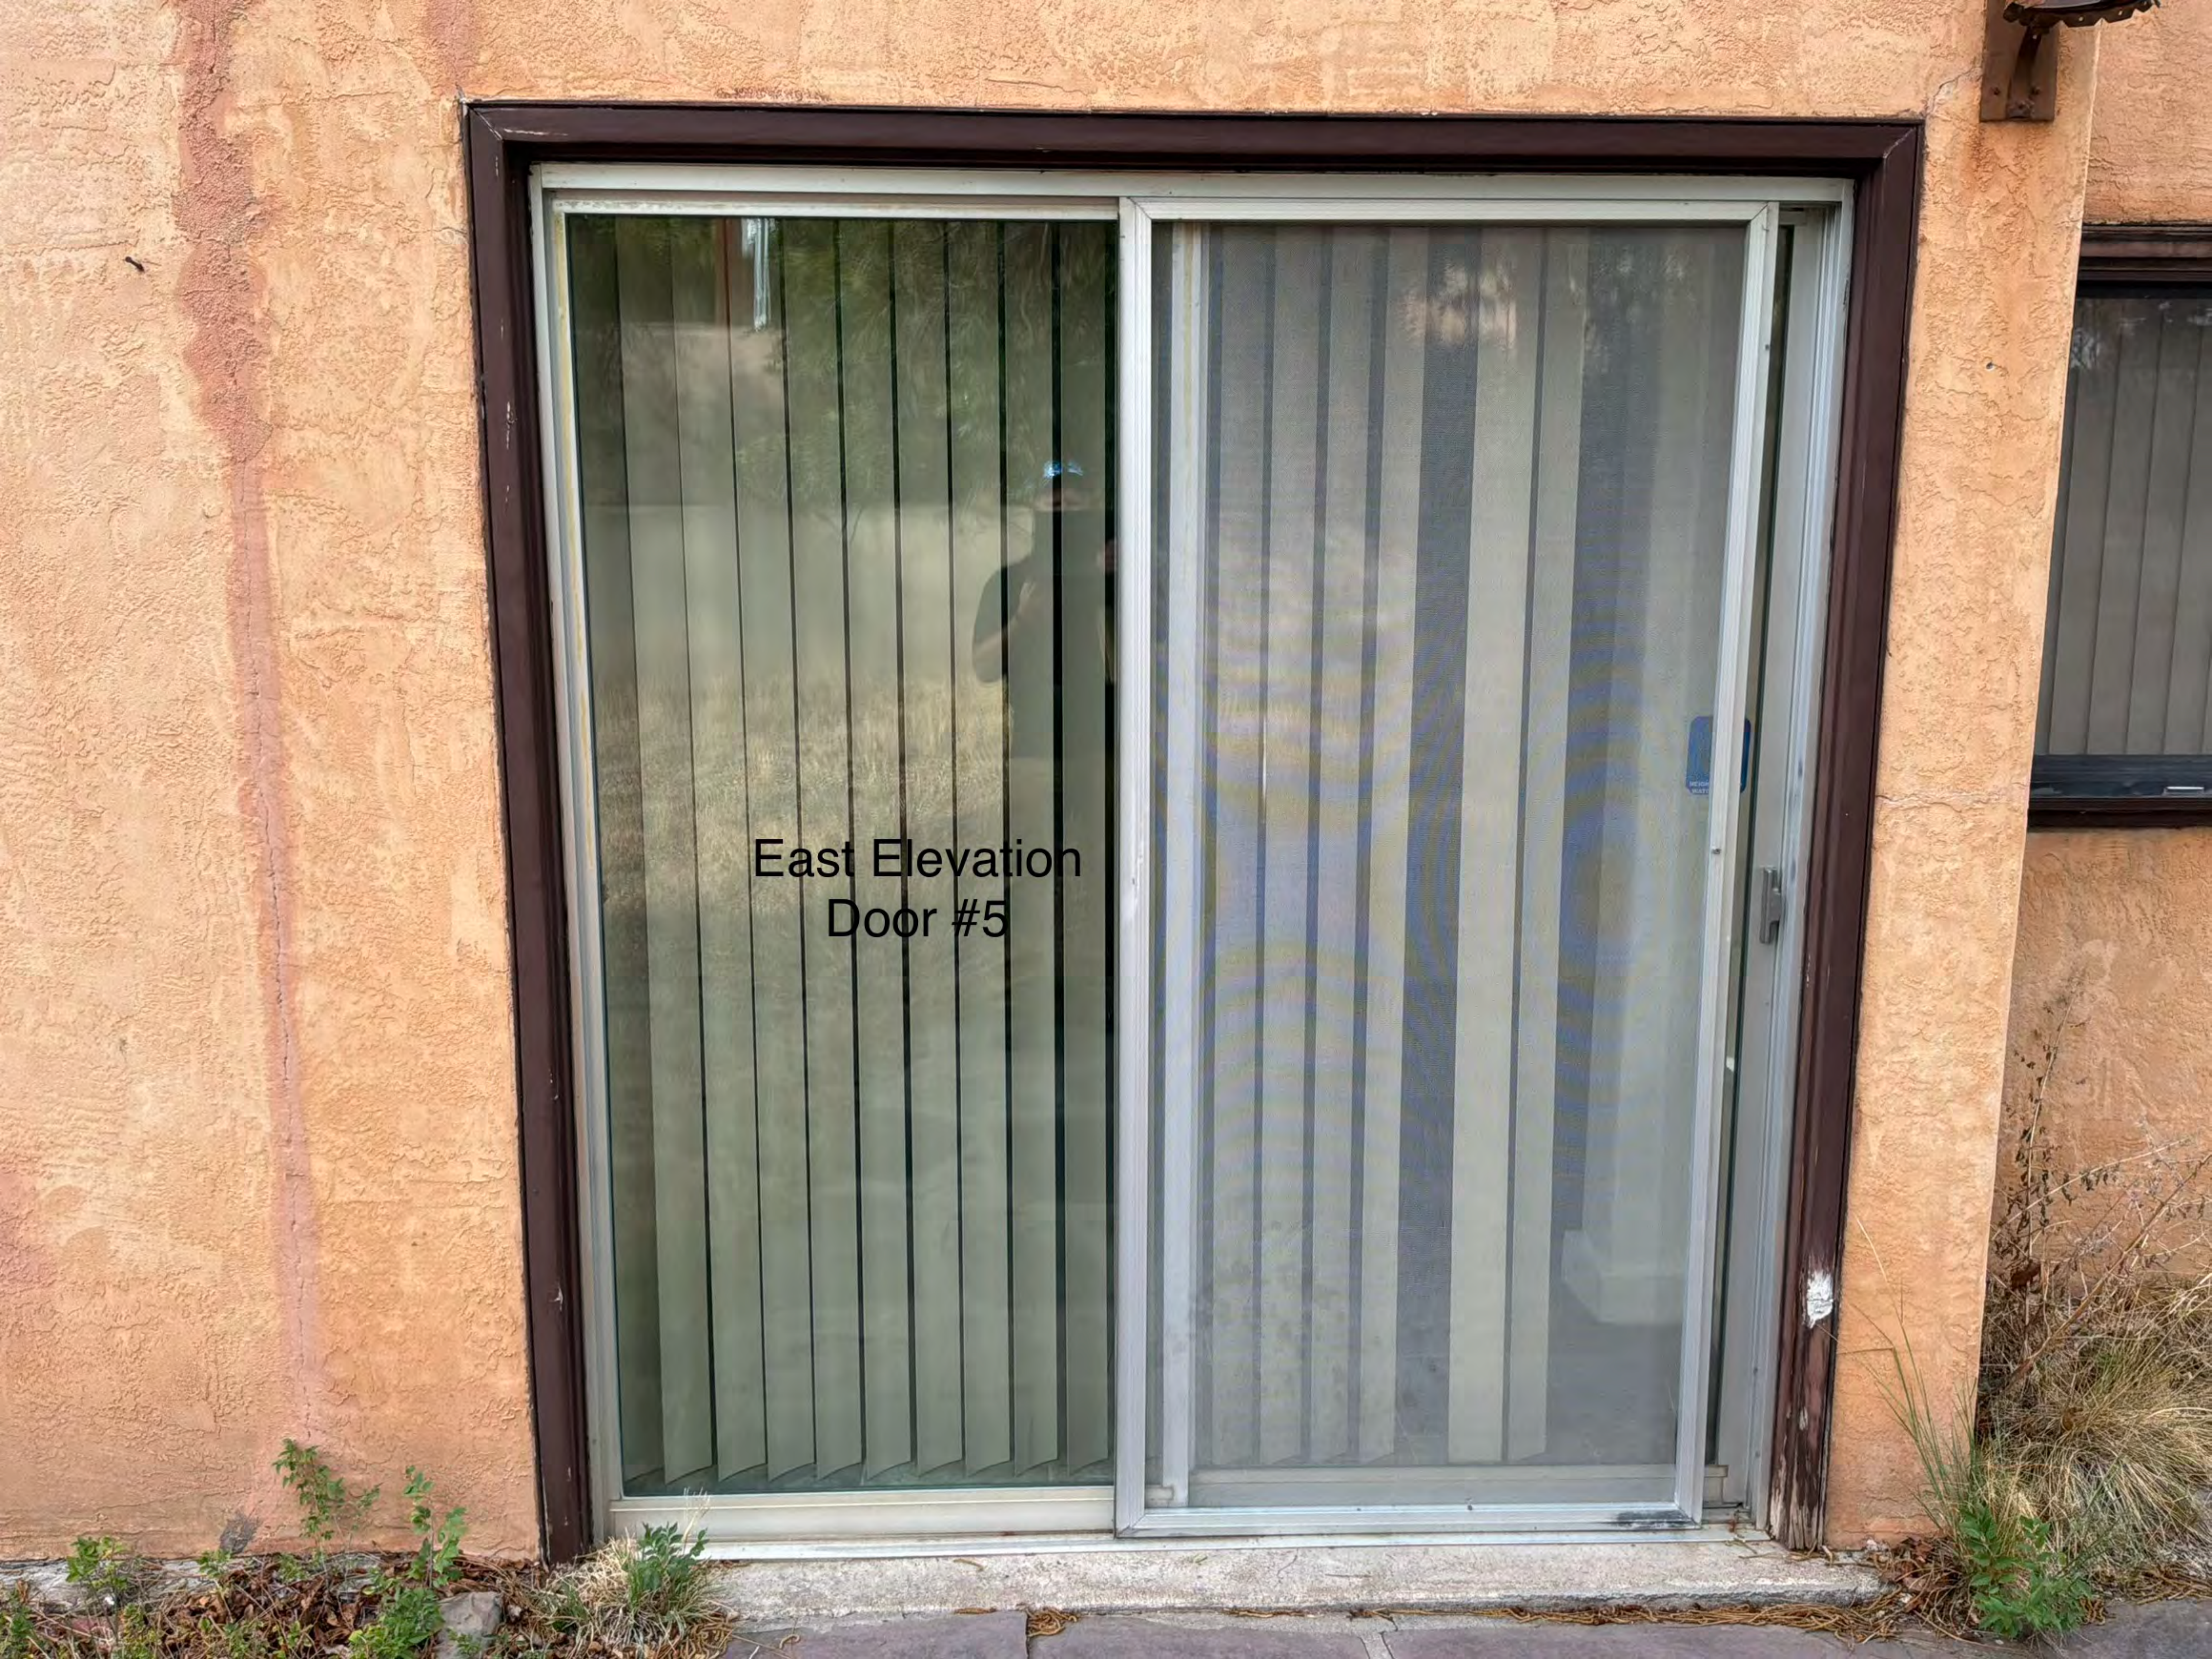
East Elevation  
Door #5

| LABEL | WINDOW & DOOR DESCRIPTION | CONDITION & INTEGRITY CODE | HISTORIC/NON-HISTORIC - AGE |
|---|---|---|---|
| DR #5 | 72" x 82" SLIDING GLASS DOORS, MILL FINISH, 1-LT ALL ALUMINUM | S | <b>NON-HISTORIC</b> - ALENCO MANUFACTURED GLASS DATE 1987 |

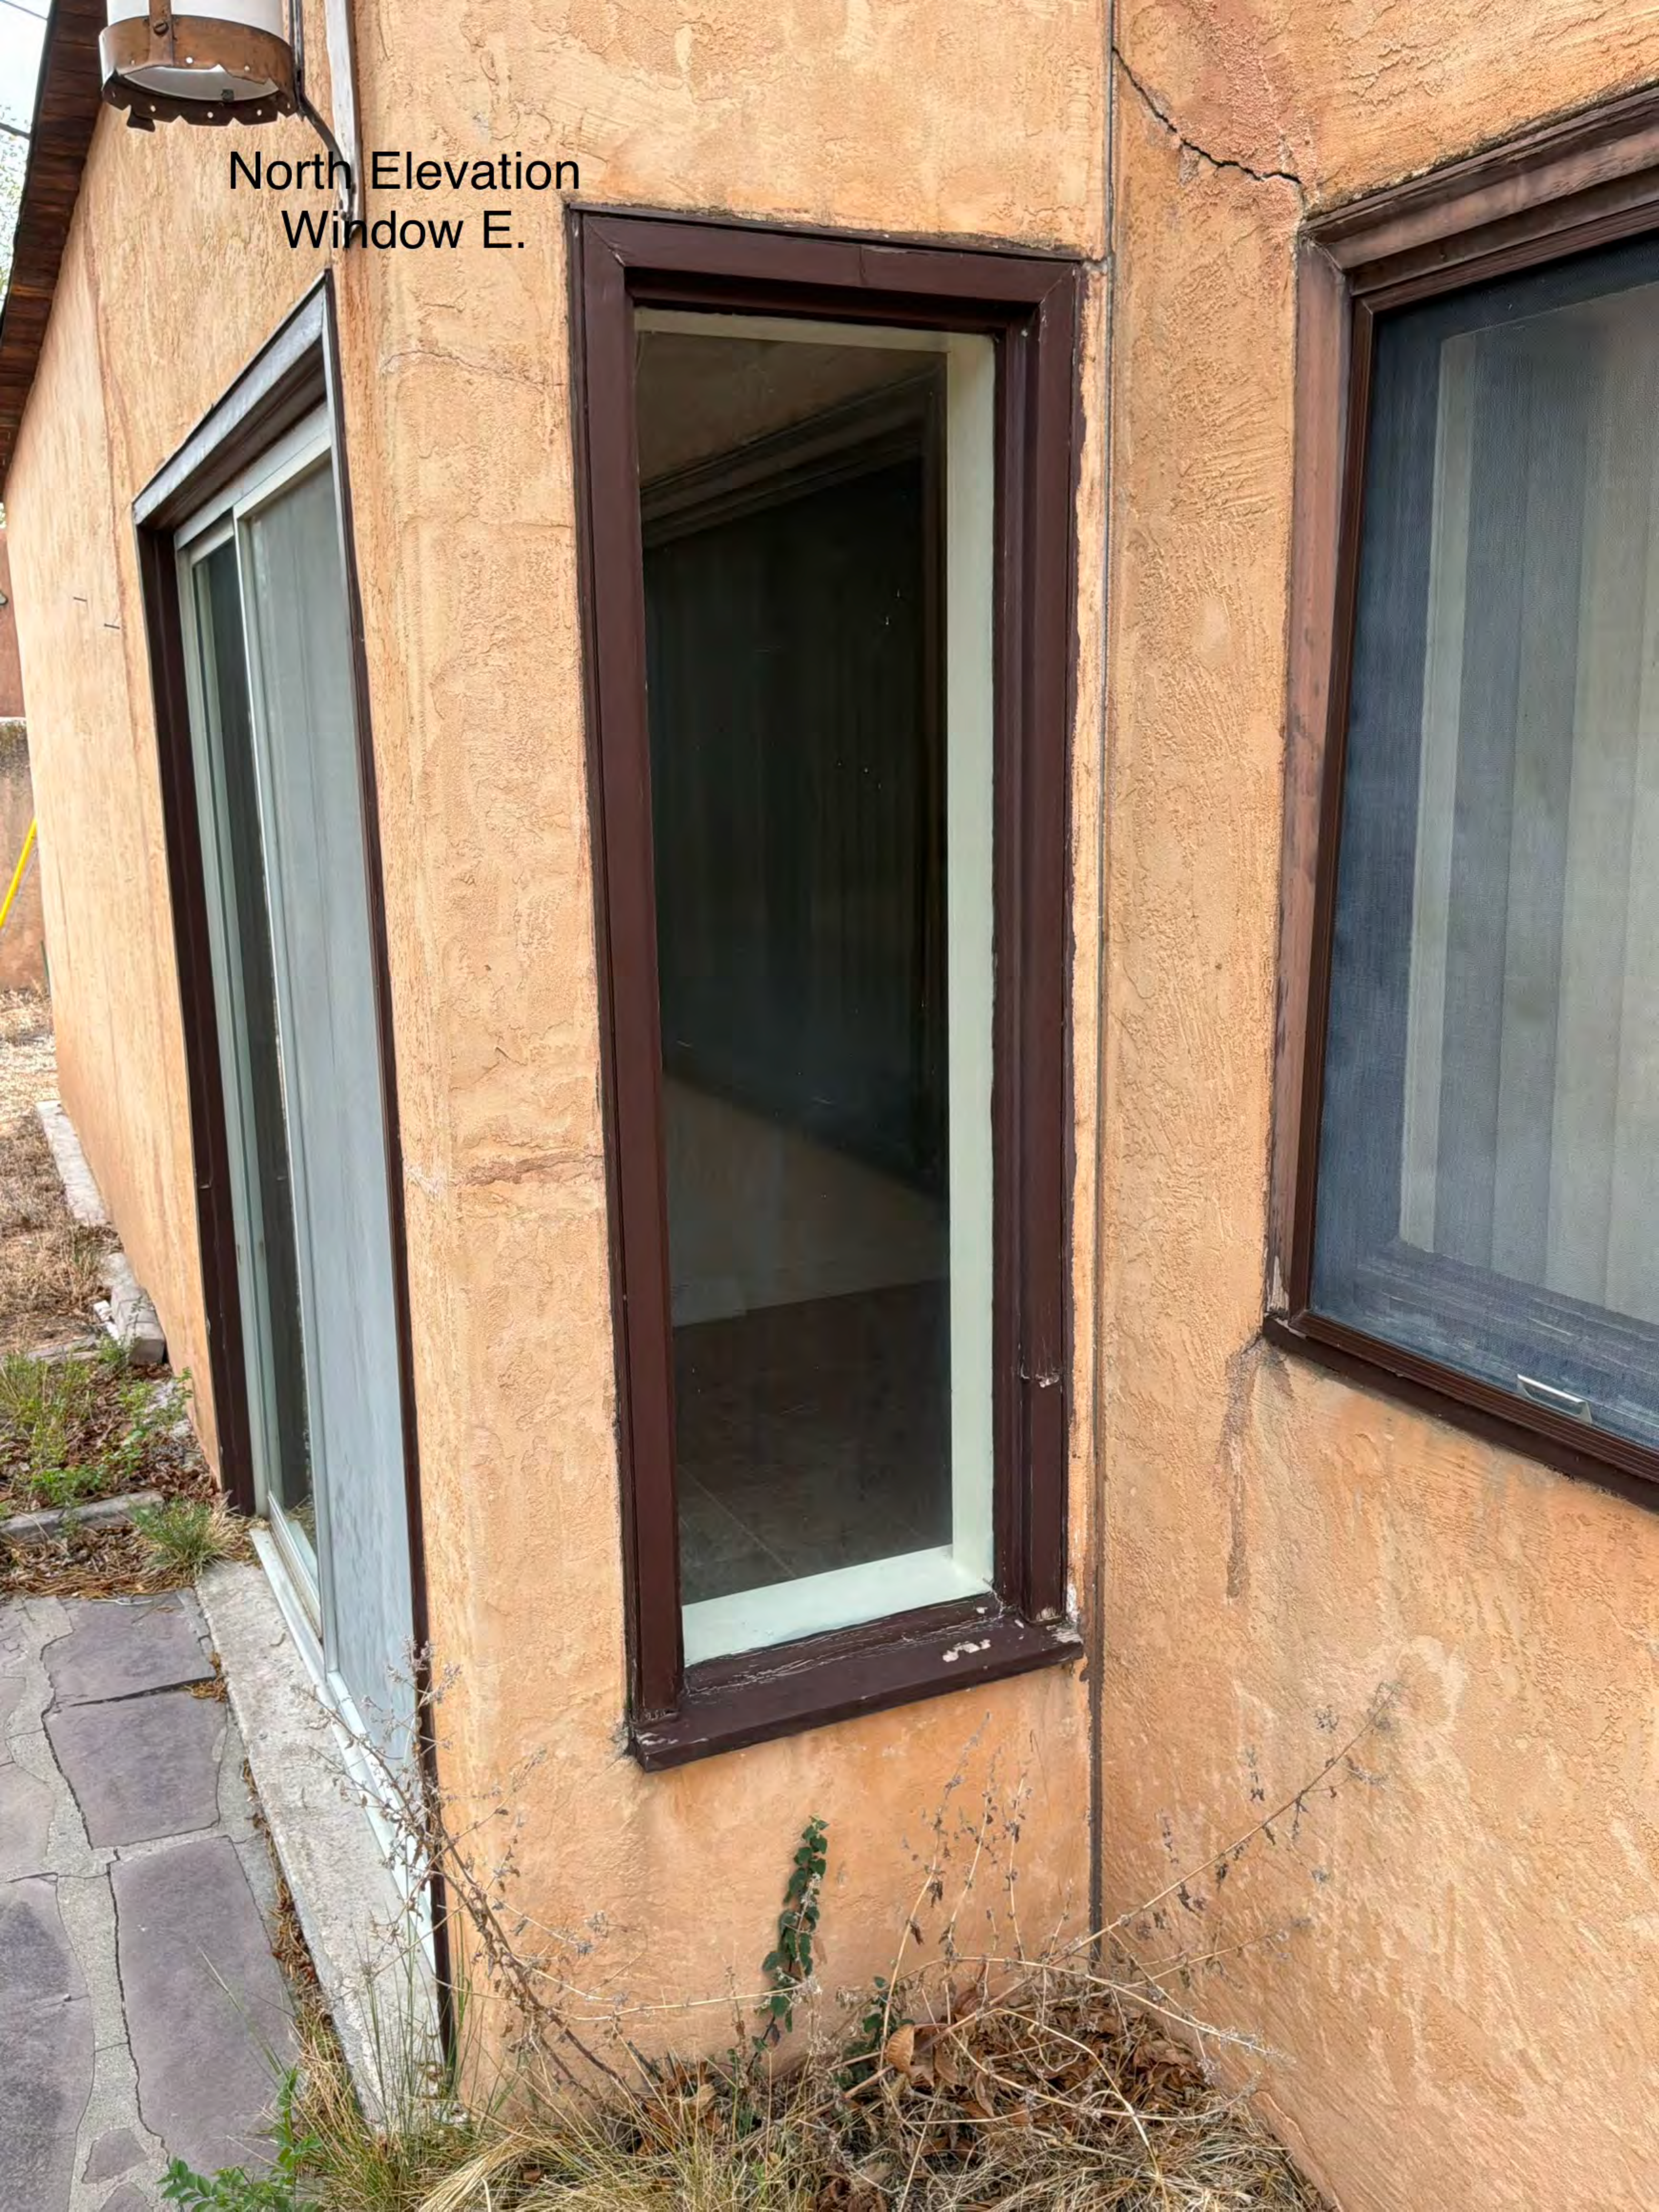
North Elevation  
Window E.

Window E is non-historic.

| LABEL | WINDOW & DOOR DESCRIPTION | CONDITION & INTEGRITY CODE | HISTORIC/NON-HISTORIC - AGE |
|---|---|---|---|
| E | 20" x 60" FIXED 1-LT ALL WOOD WINDOW STOPPED IN GLASS | F | <b>NON-HISTORIC</b> - GLASS DATE 1987, GLAZED |

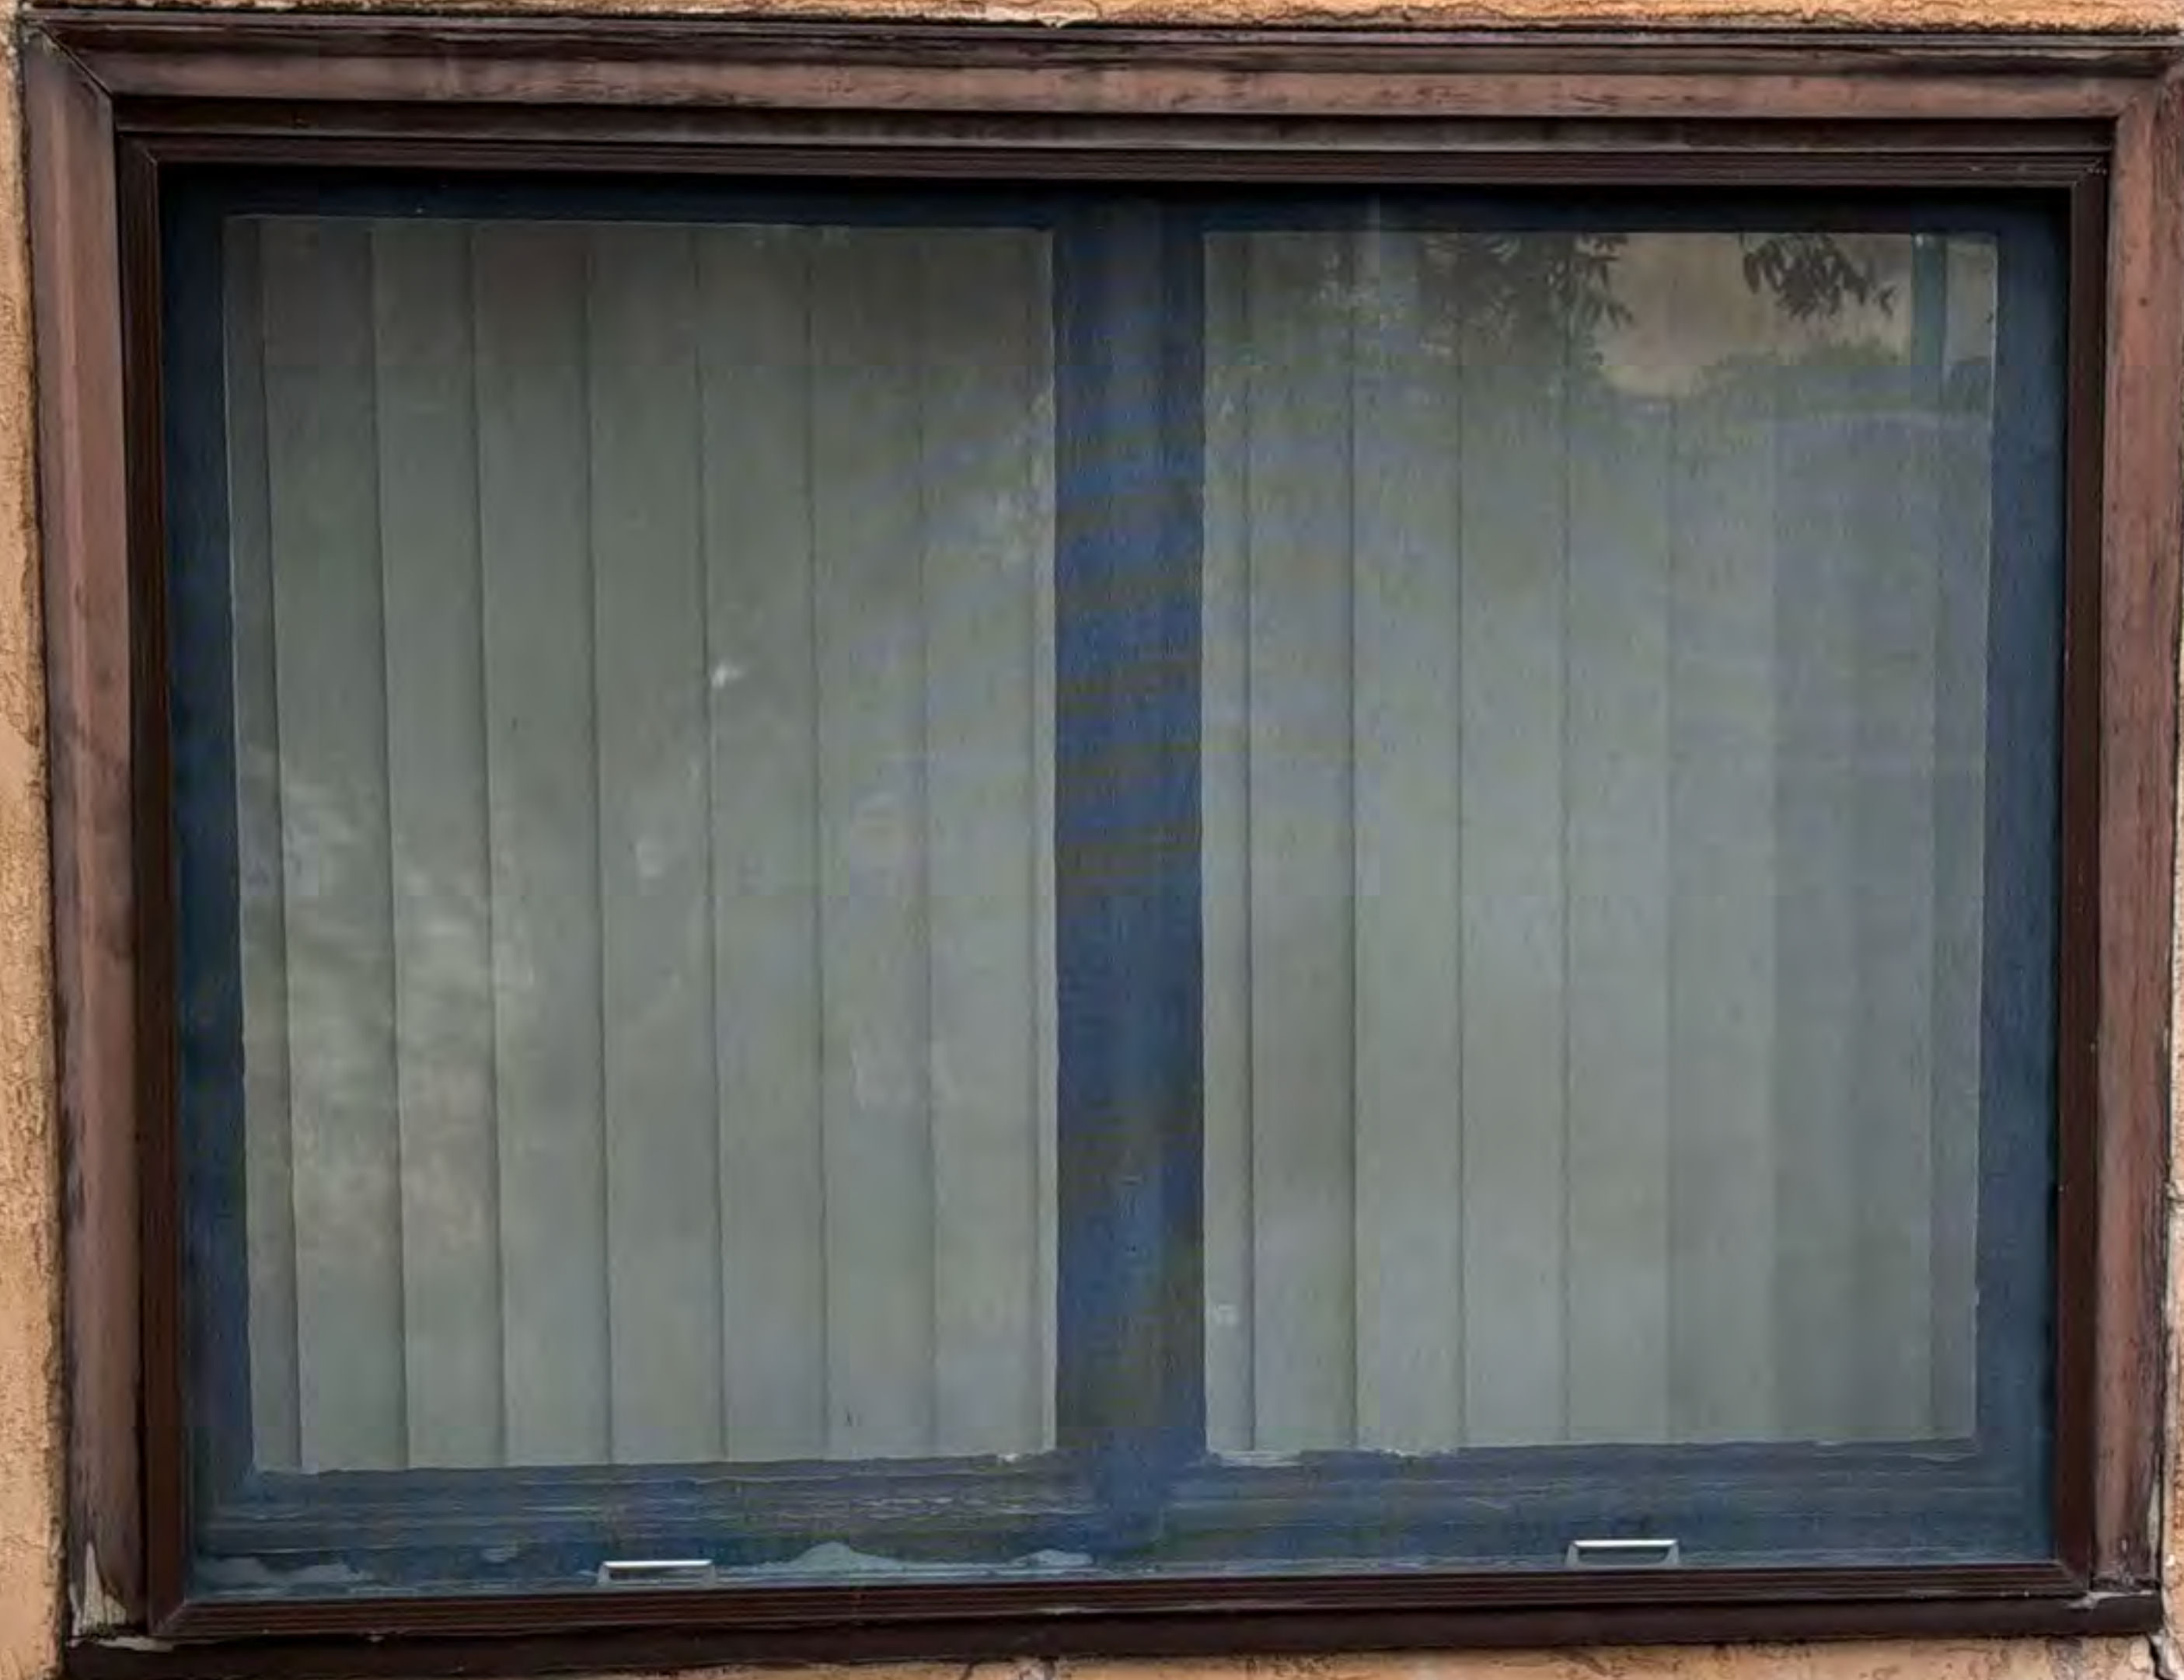
East Elevation  
Window F.

Windows A, B, C, D, F, G, H, I, and J are historic windows however the units are unrestorable. The window units are 1950 +/- Andersen horizontal gliding windows. The tracks, pins, sash rods, and locks are not available anymore therefore the windows cannot be made to operate correctly or seal.

| LABEL | WINDOW & DOOR DESCRIPTION | CONDITION & INTEGRITY CODE | HISTORIC/NON-HISTORIC - AGE |
|---|---|---|---|
| F | 53" x 42" HORIZONTAL SLIDER 1-LT ALL WOOD WITH ALUMINUM | U | <b>HISTORIC</b> - THE TRACKS, PIVOT PINS & HANDLES ARE NOT AVAILABLE TO REPLACE 1950 +/- (ANDERSEN) |

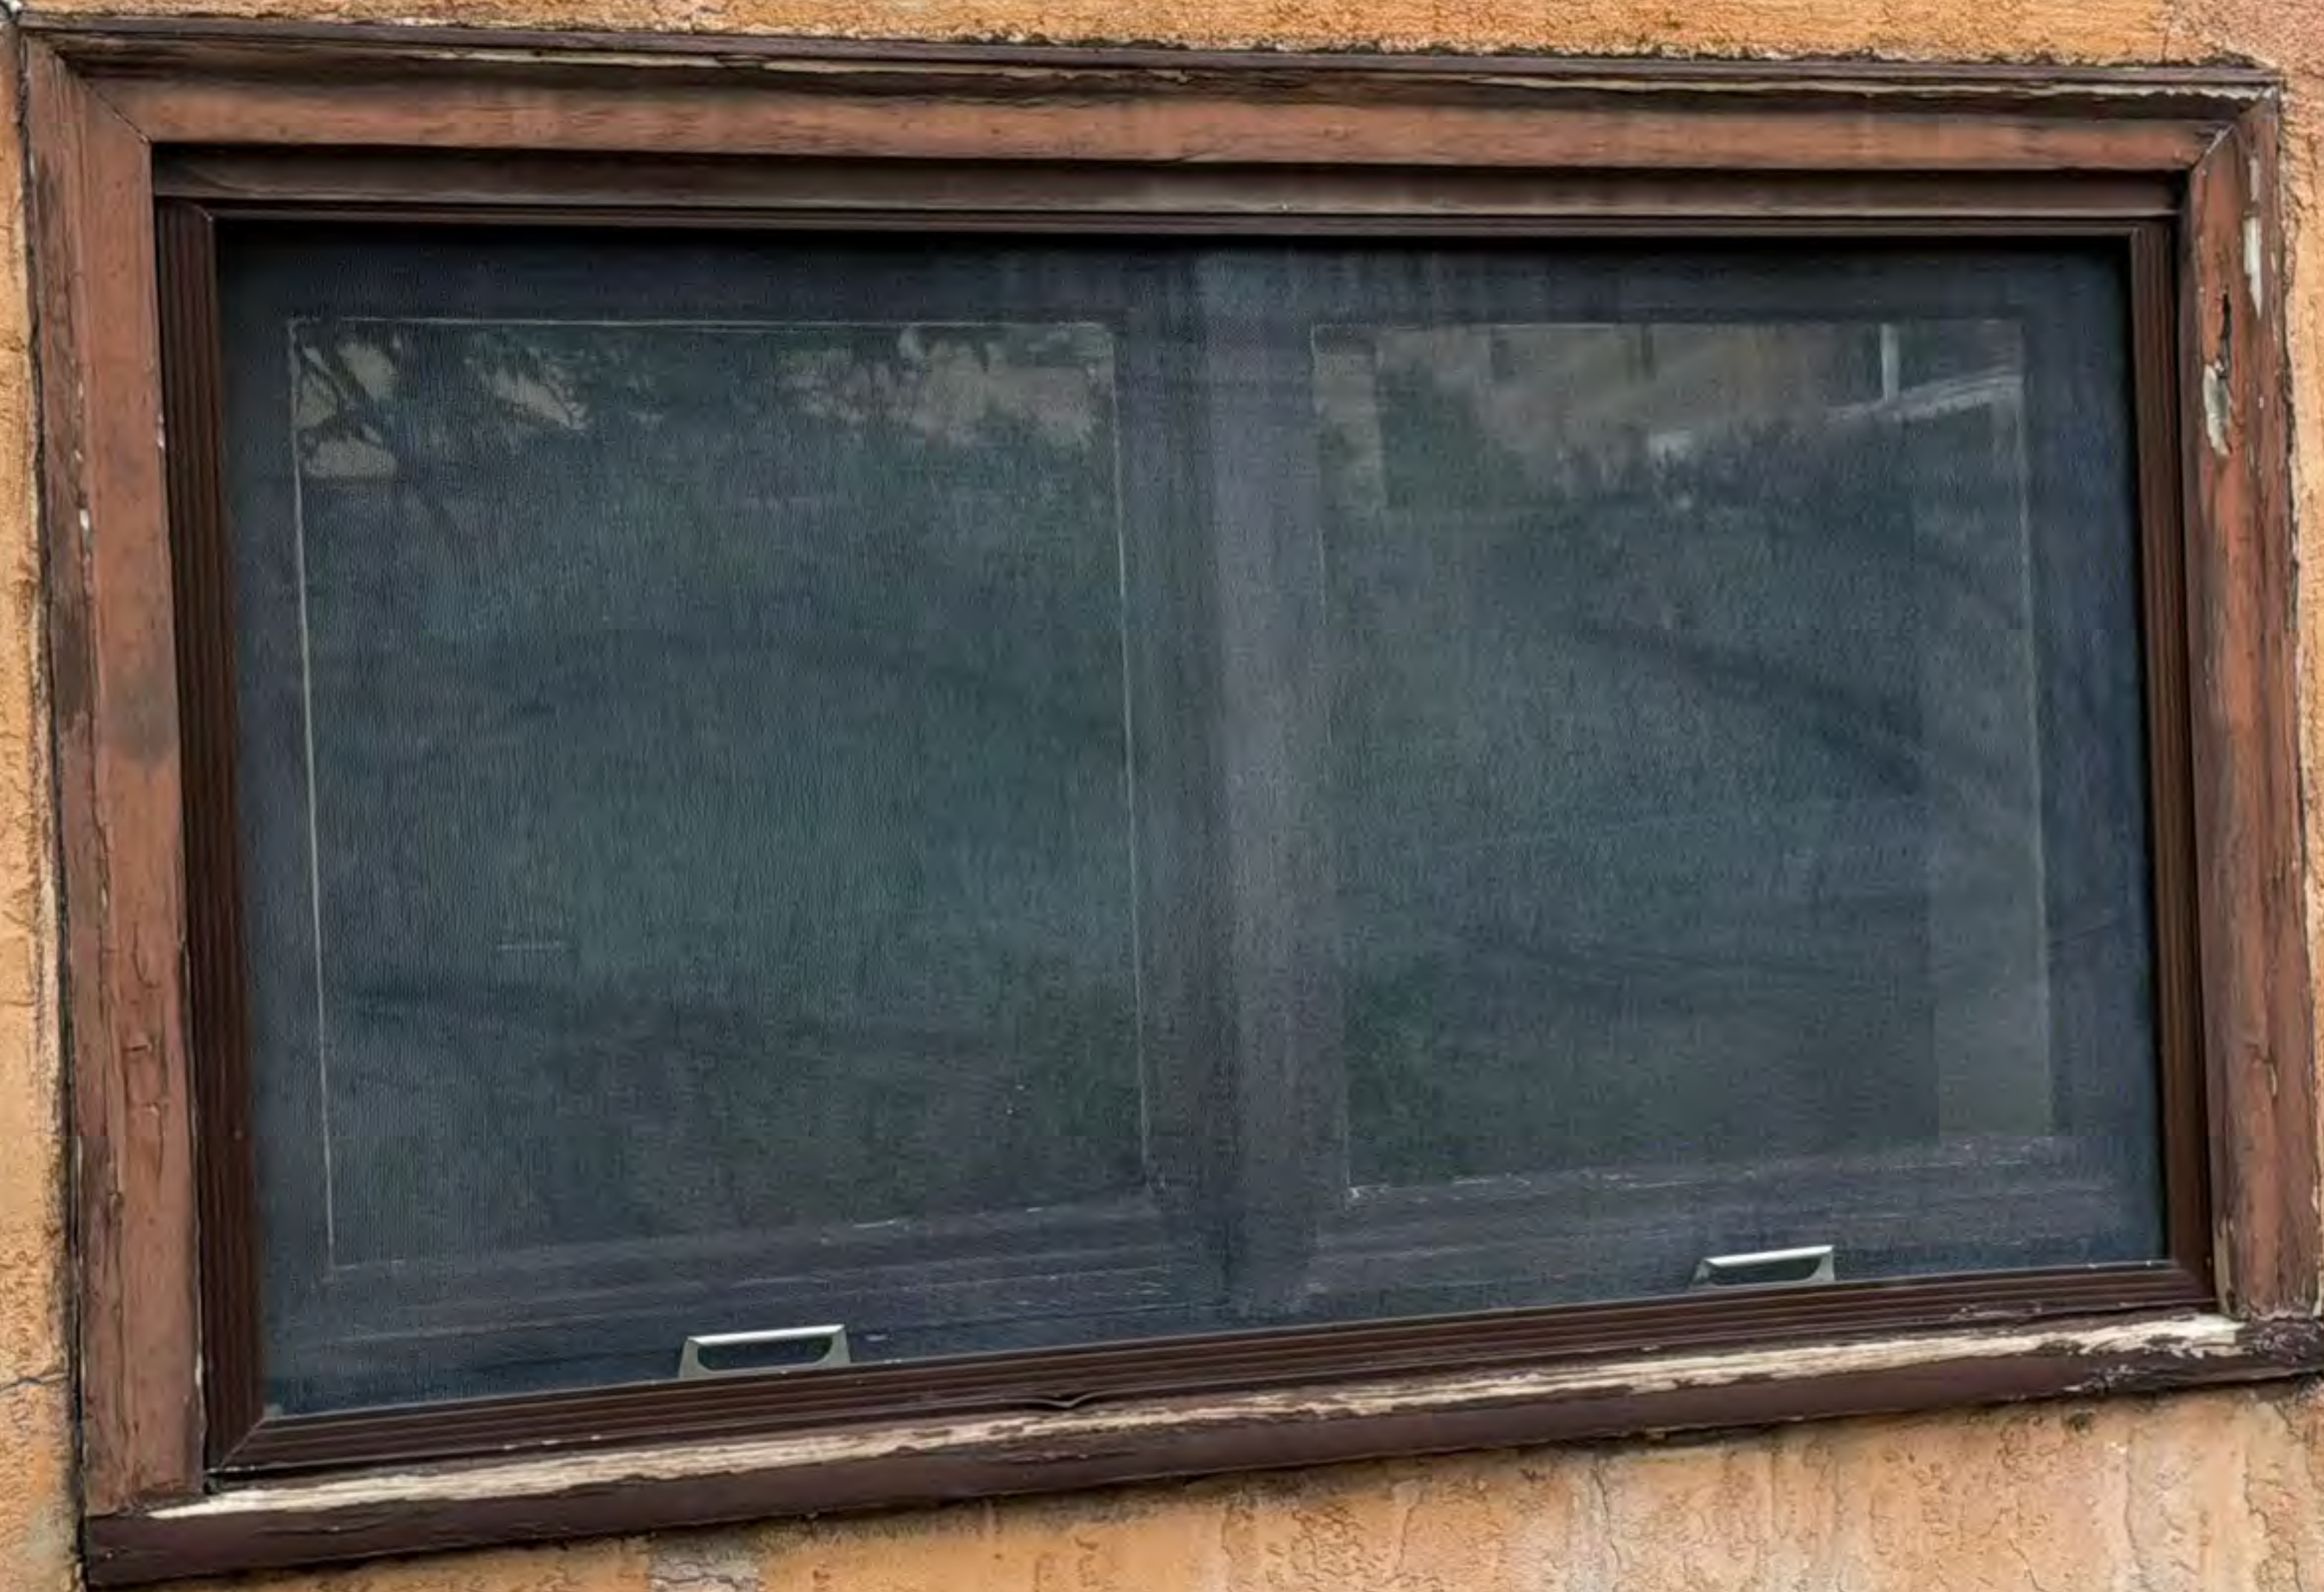
East  
Elevation  
Window G.

| LABEL | WINDOW & DOOR DESCRIPTION | CONDITION & INTEGRITY CODE | HISTORIC/NON-HISTORIC - AGE |
|---|---|---|---|
| G | 42" x 24" HORIZONTAL SLIDER 1-LT ALL WOOD WITH ALUMINUM | U | <b>HISTORIC</b> - THE TRACKS, PIVOT PINS & HANDLES ARE NOT AVAILABLE TO REPLACE 1950 +/- (ANDERSEN) |
