# RPA & Associates, LLC.

| JOB | DATE |
|---|---|
| 104 Camino Mathias | 07/28/2026 |

## RPA & ASSOCIATES, LLC | WINDOW & DOOR CONDITION AND INTEGRITY CODES

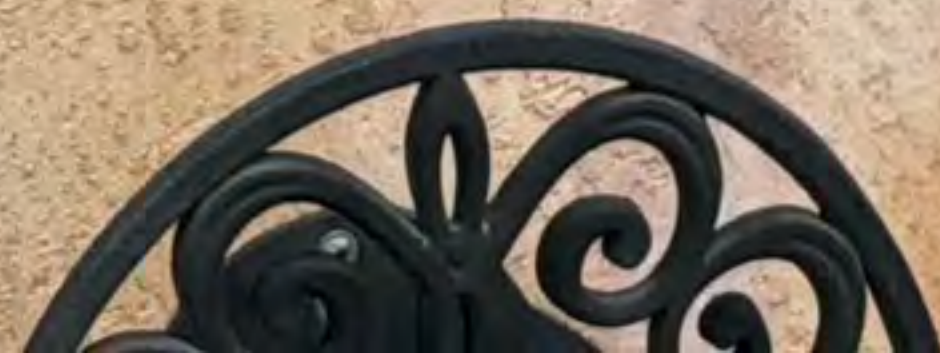
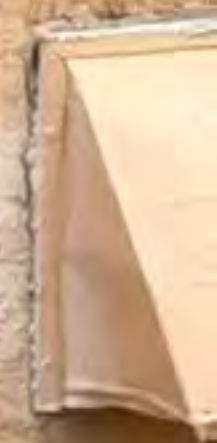
East Elevation  
Window H.

| LABEL | WINDOW & DOOR DESCRIPTION | CONDITION & INTEGRITY CODE | HISTORIC/NON-HISTORIC - AGE |
|---|---|---|---|
| H | 54" x 25" HORIZONTAL SLIDER 1-LT ALL WOOD WITH ALUMINUM | U | <b>HISTORIC</b> - THE TRACKS, PIVOT PINS & HANDLES ARE NOT AVAILABLE TO REPLACE 1950 +/- (ANDERSEN) |

My recommendation is to replace the windows with casement units with horizontal lites to replicate the steel casements of that era. The doors should be a wood paneled look of that 1950 era.

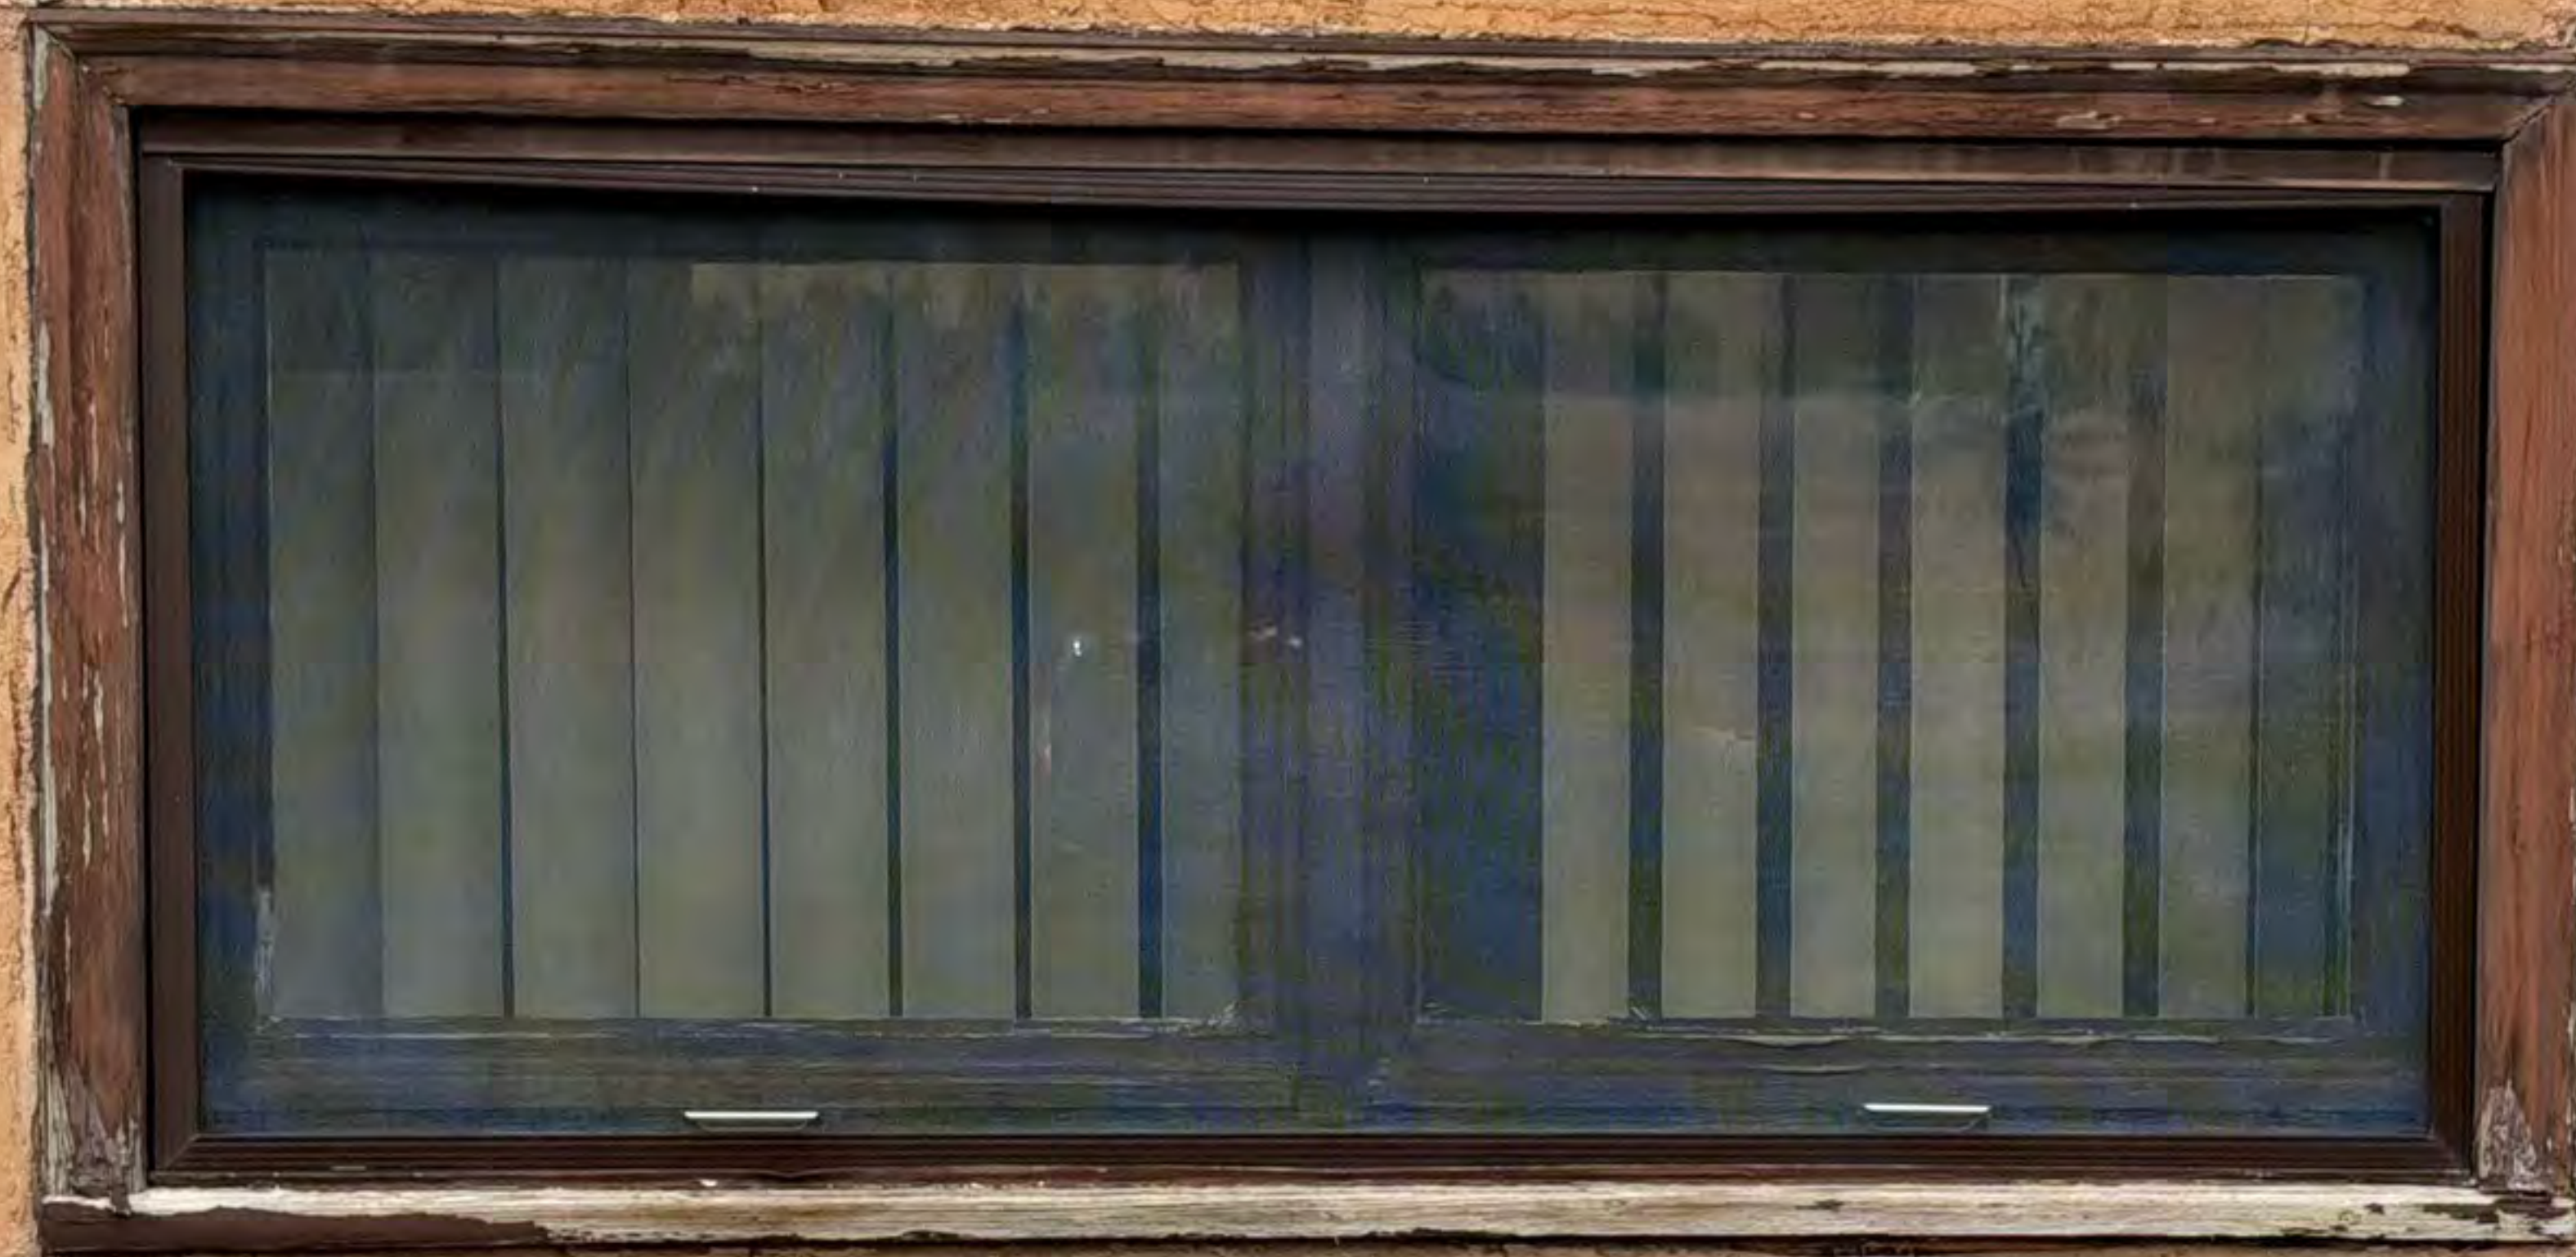
Windows A, B, C, D, F, G, H, I, and J are historic windows however the units are unrestorable. The window units are 1950 +/- Andersen horizontal gliding windows. The tracks, pins, sash rods, and locks are not available anymore therefore the windows cannot be made to operate correctly or seal.

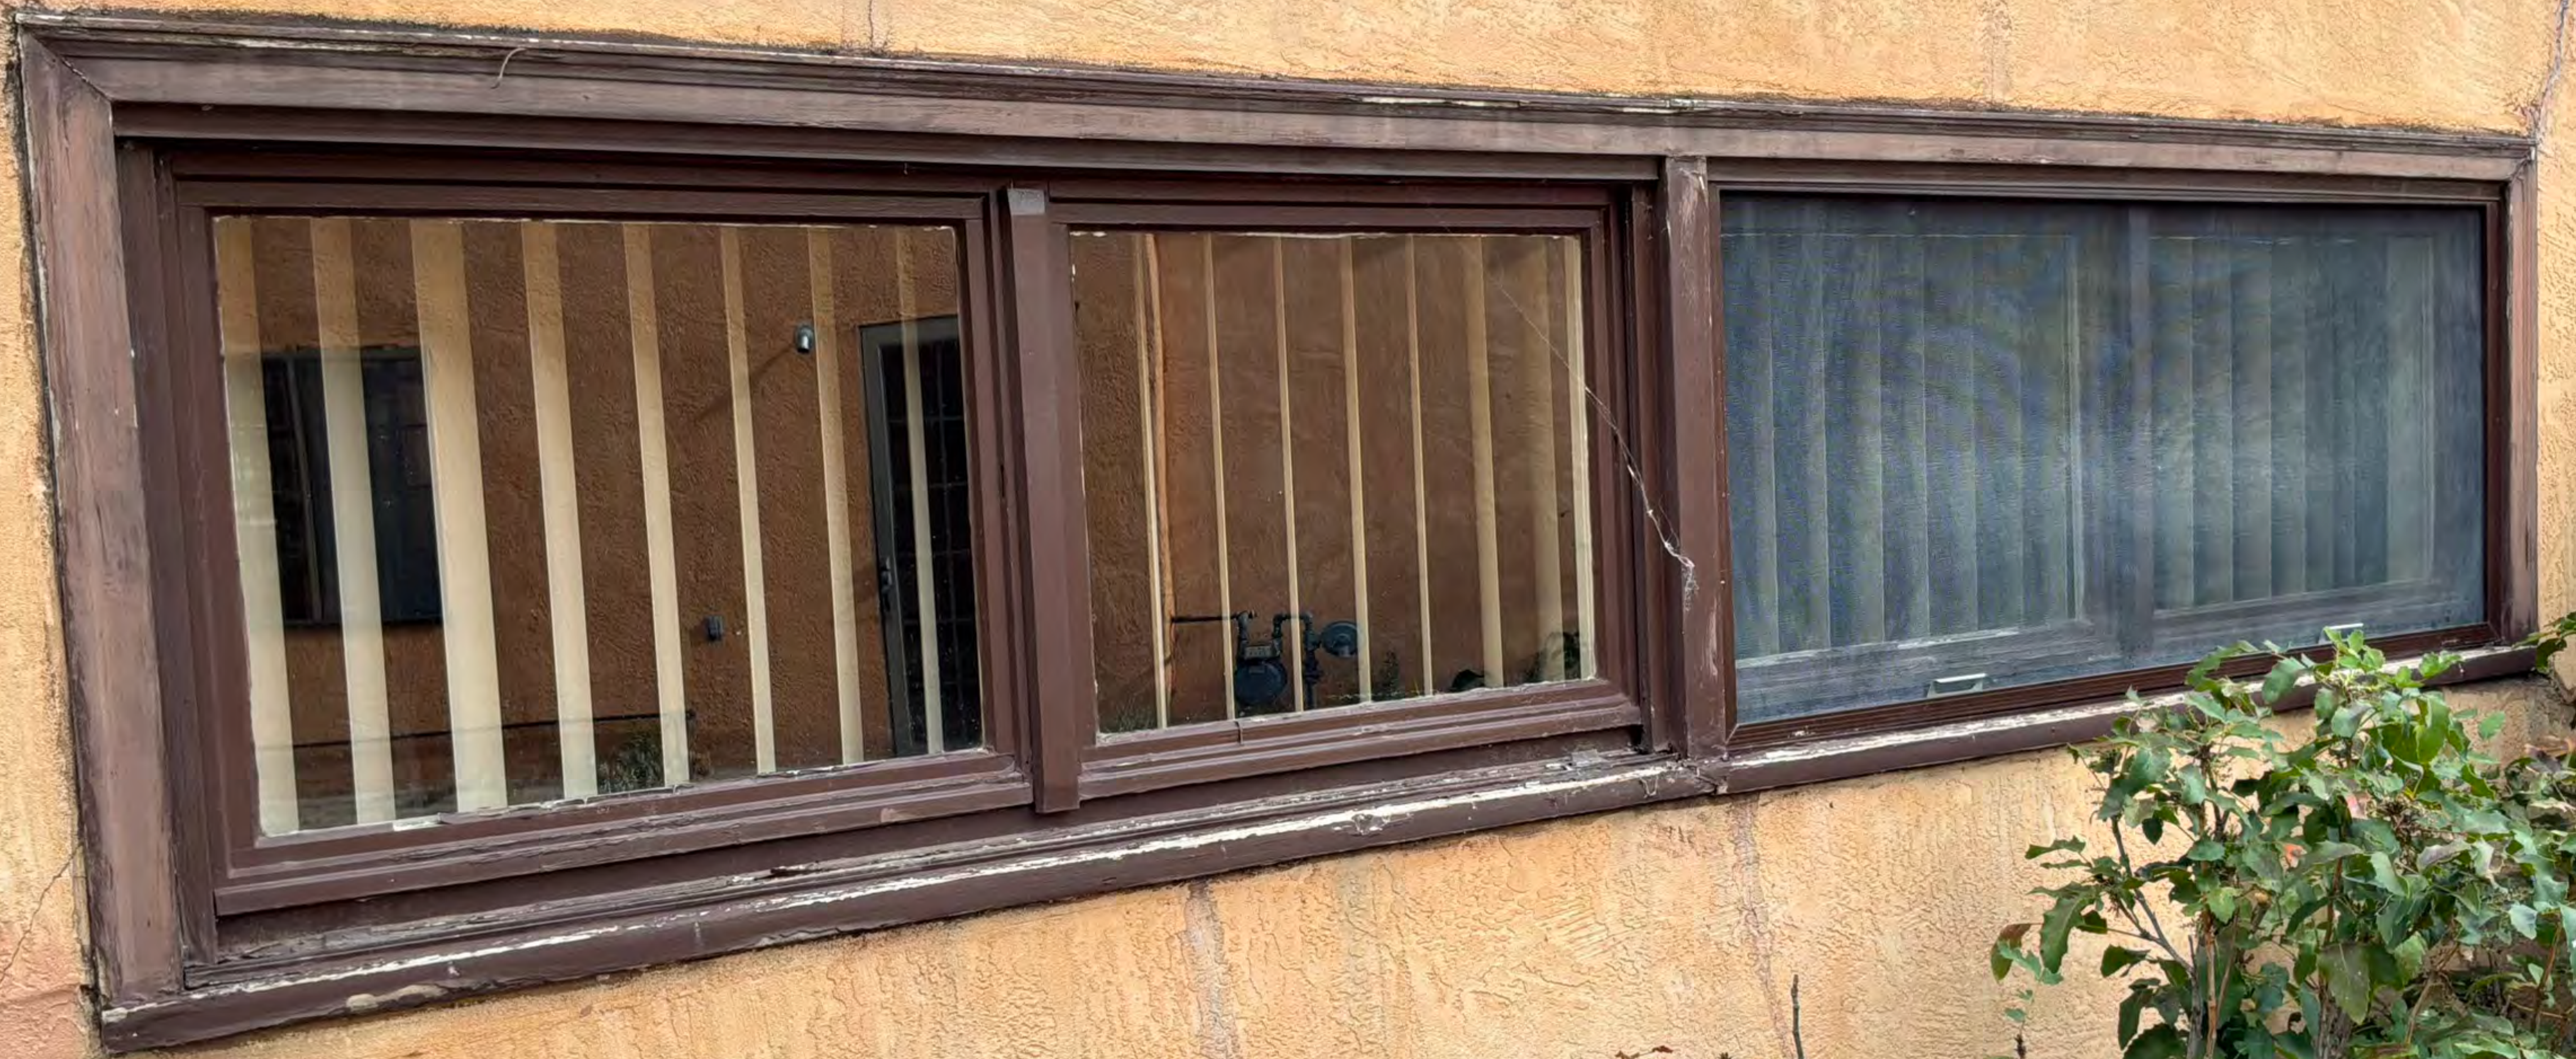
North Elevation  
Window I.

| LABEL | WINDOW & DOOR DESCRIPTION | CONDITION & INTEGRITY CODE | HISTORIC/NON-HISTORIC - AGE |
|---|---|---|---|
| I | 108" x 25" TWIN HORIZONTAL SLIDER 1-LT ALL WOOD WITH ALUMINUM | U | <b>HISTORIC</b> - THE TRACKS, PIVOT PINS & HANDLES ARE NOT AVAILABLE TO REPLACE 1950 +/- (ANDERSEN) |

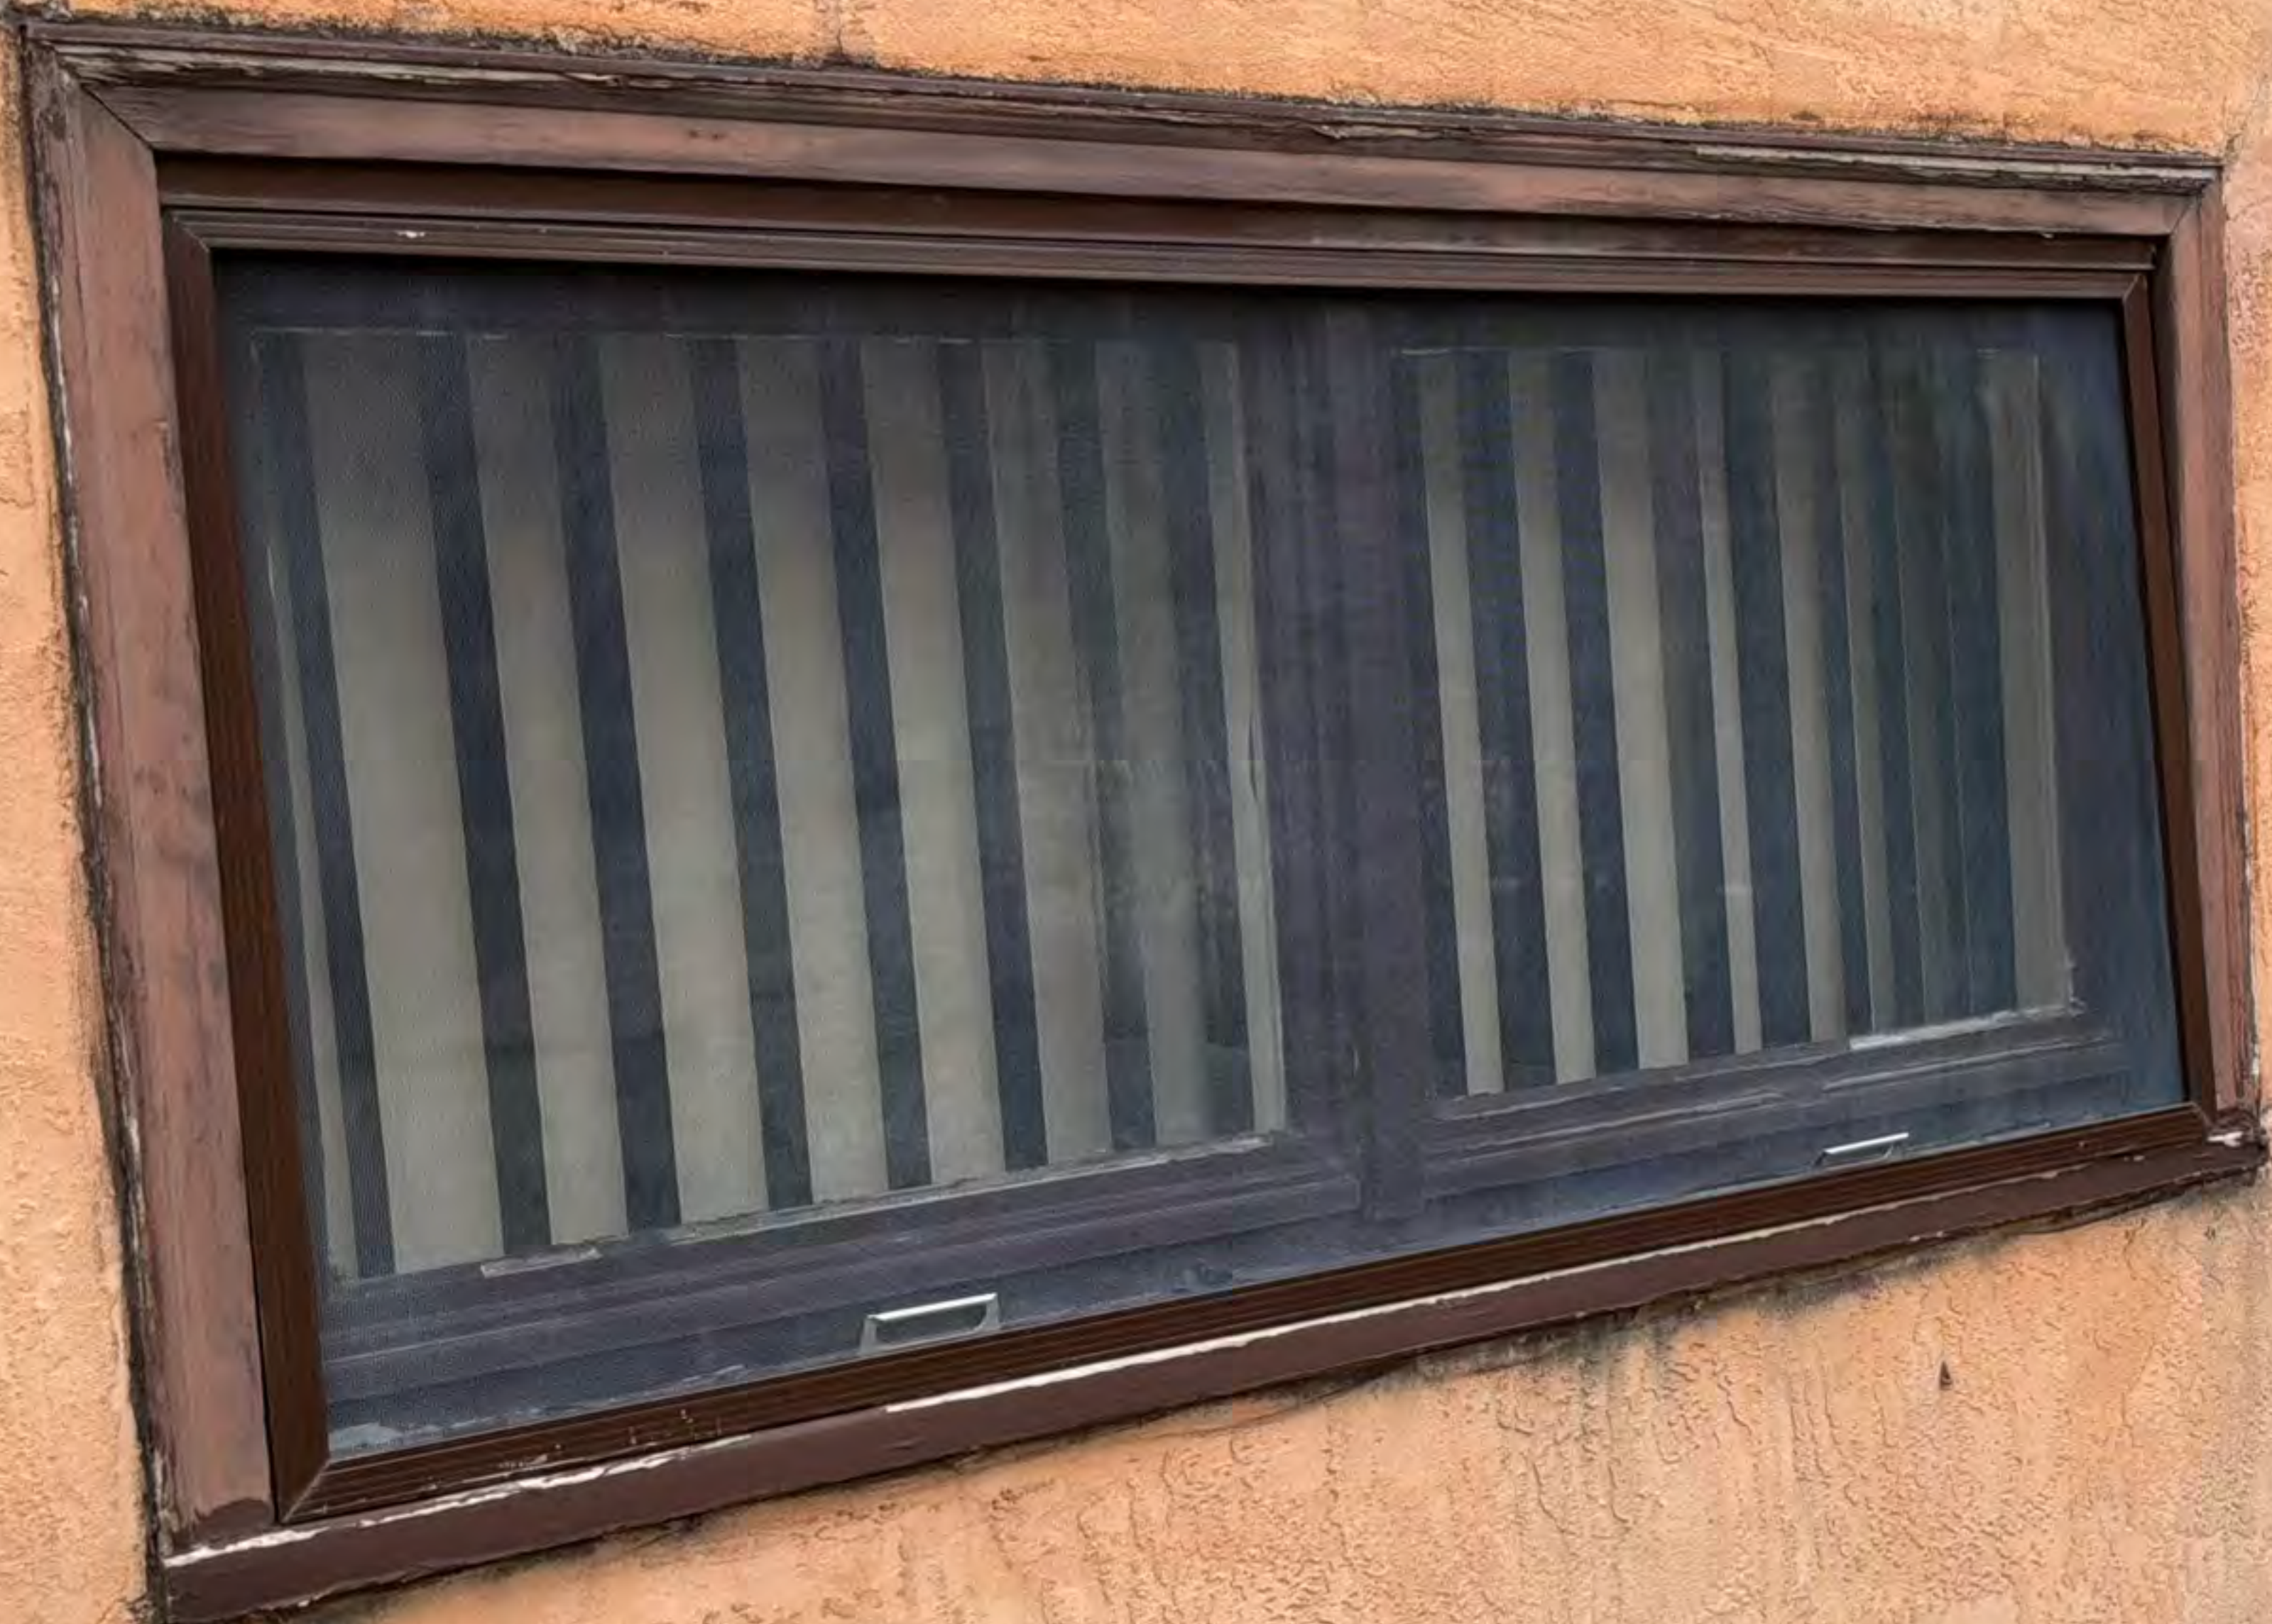
North Elevation  
Window J.

| LABEL | WINDOW & DOOR DESCRIPTION | CONDITION & INTEGRITY CODE | HISTORIC/NON-HISTORIC - AGE |
|---|---|---|---|
| J | 54" x 25" HORIZONTAL SLIDER 1-LT ALL WOOD WITH ALUMINUM | U | <b>HISTORIC</b> - THE TRACKS, PIVOT PINS & HANDLES ARE NOT AVAILABLE TO REPLACE 1950 +/- (ANDERSEN) |

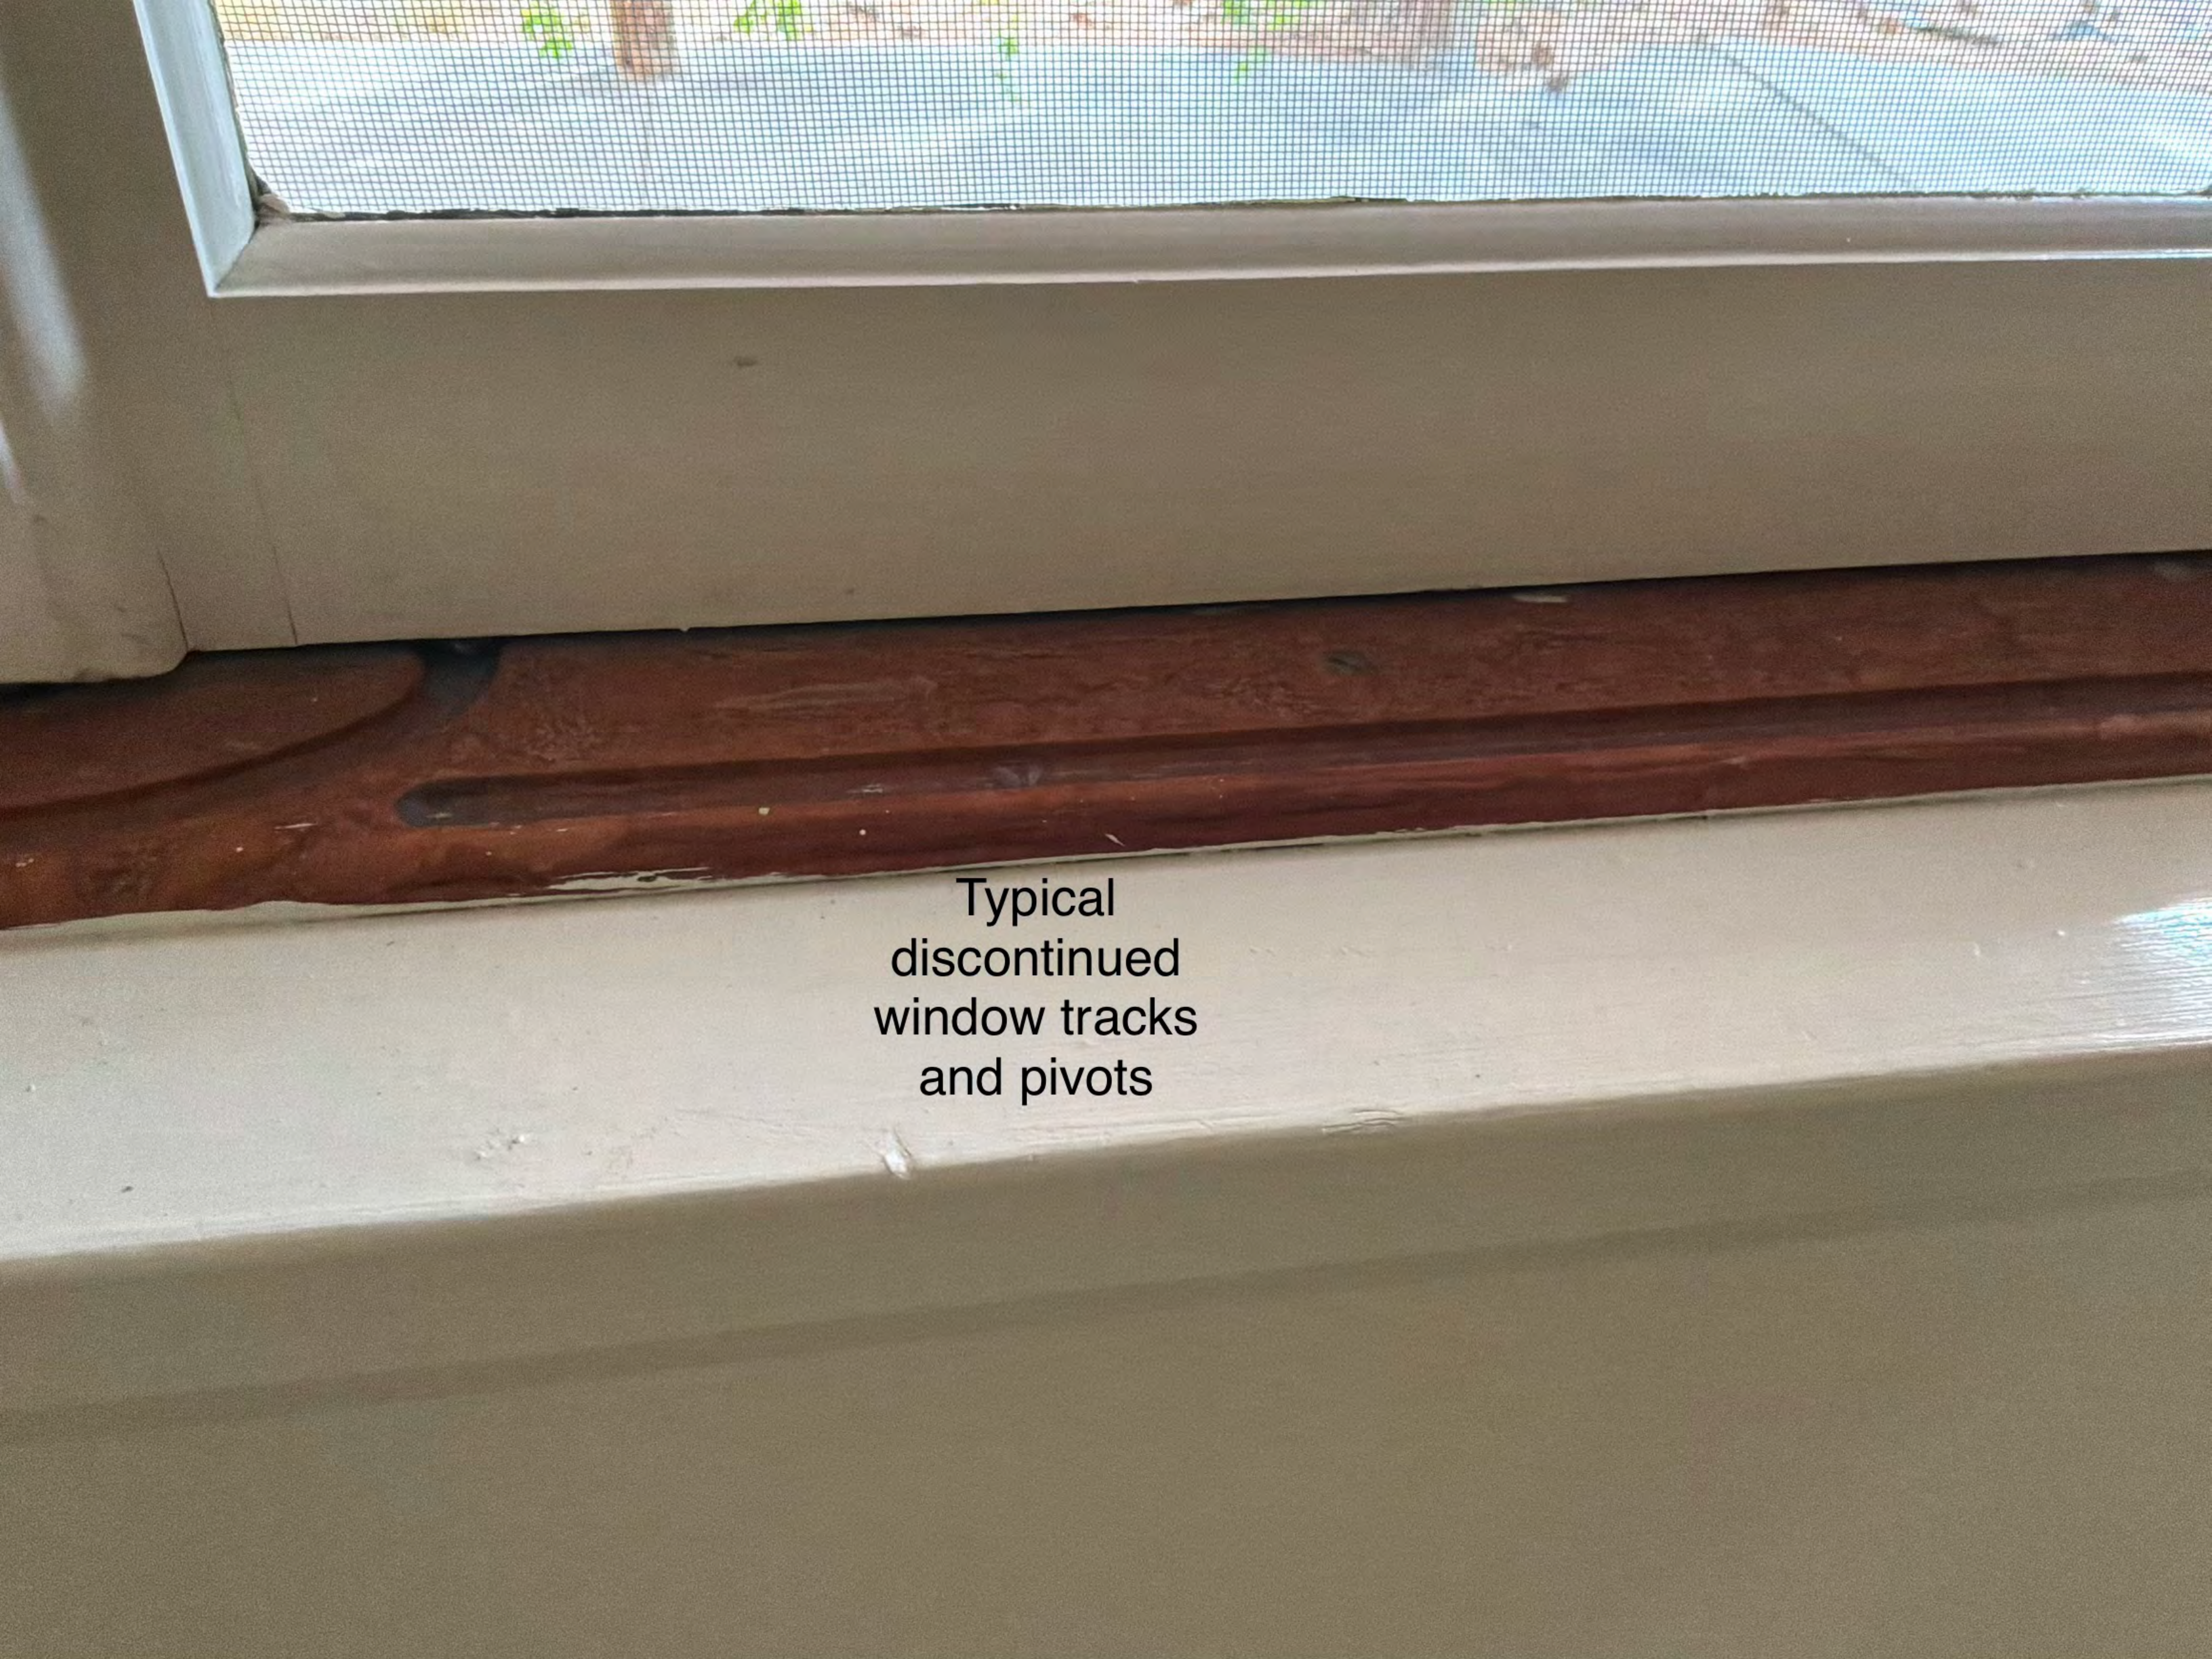
Typical  
discontinued  
window tracks  
and pivots

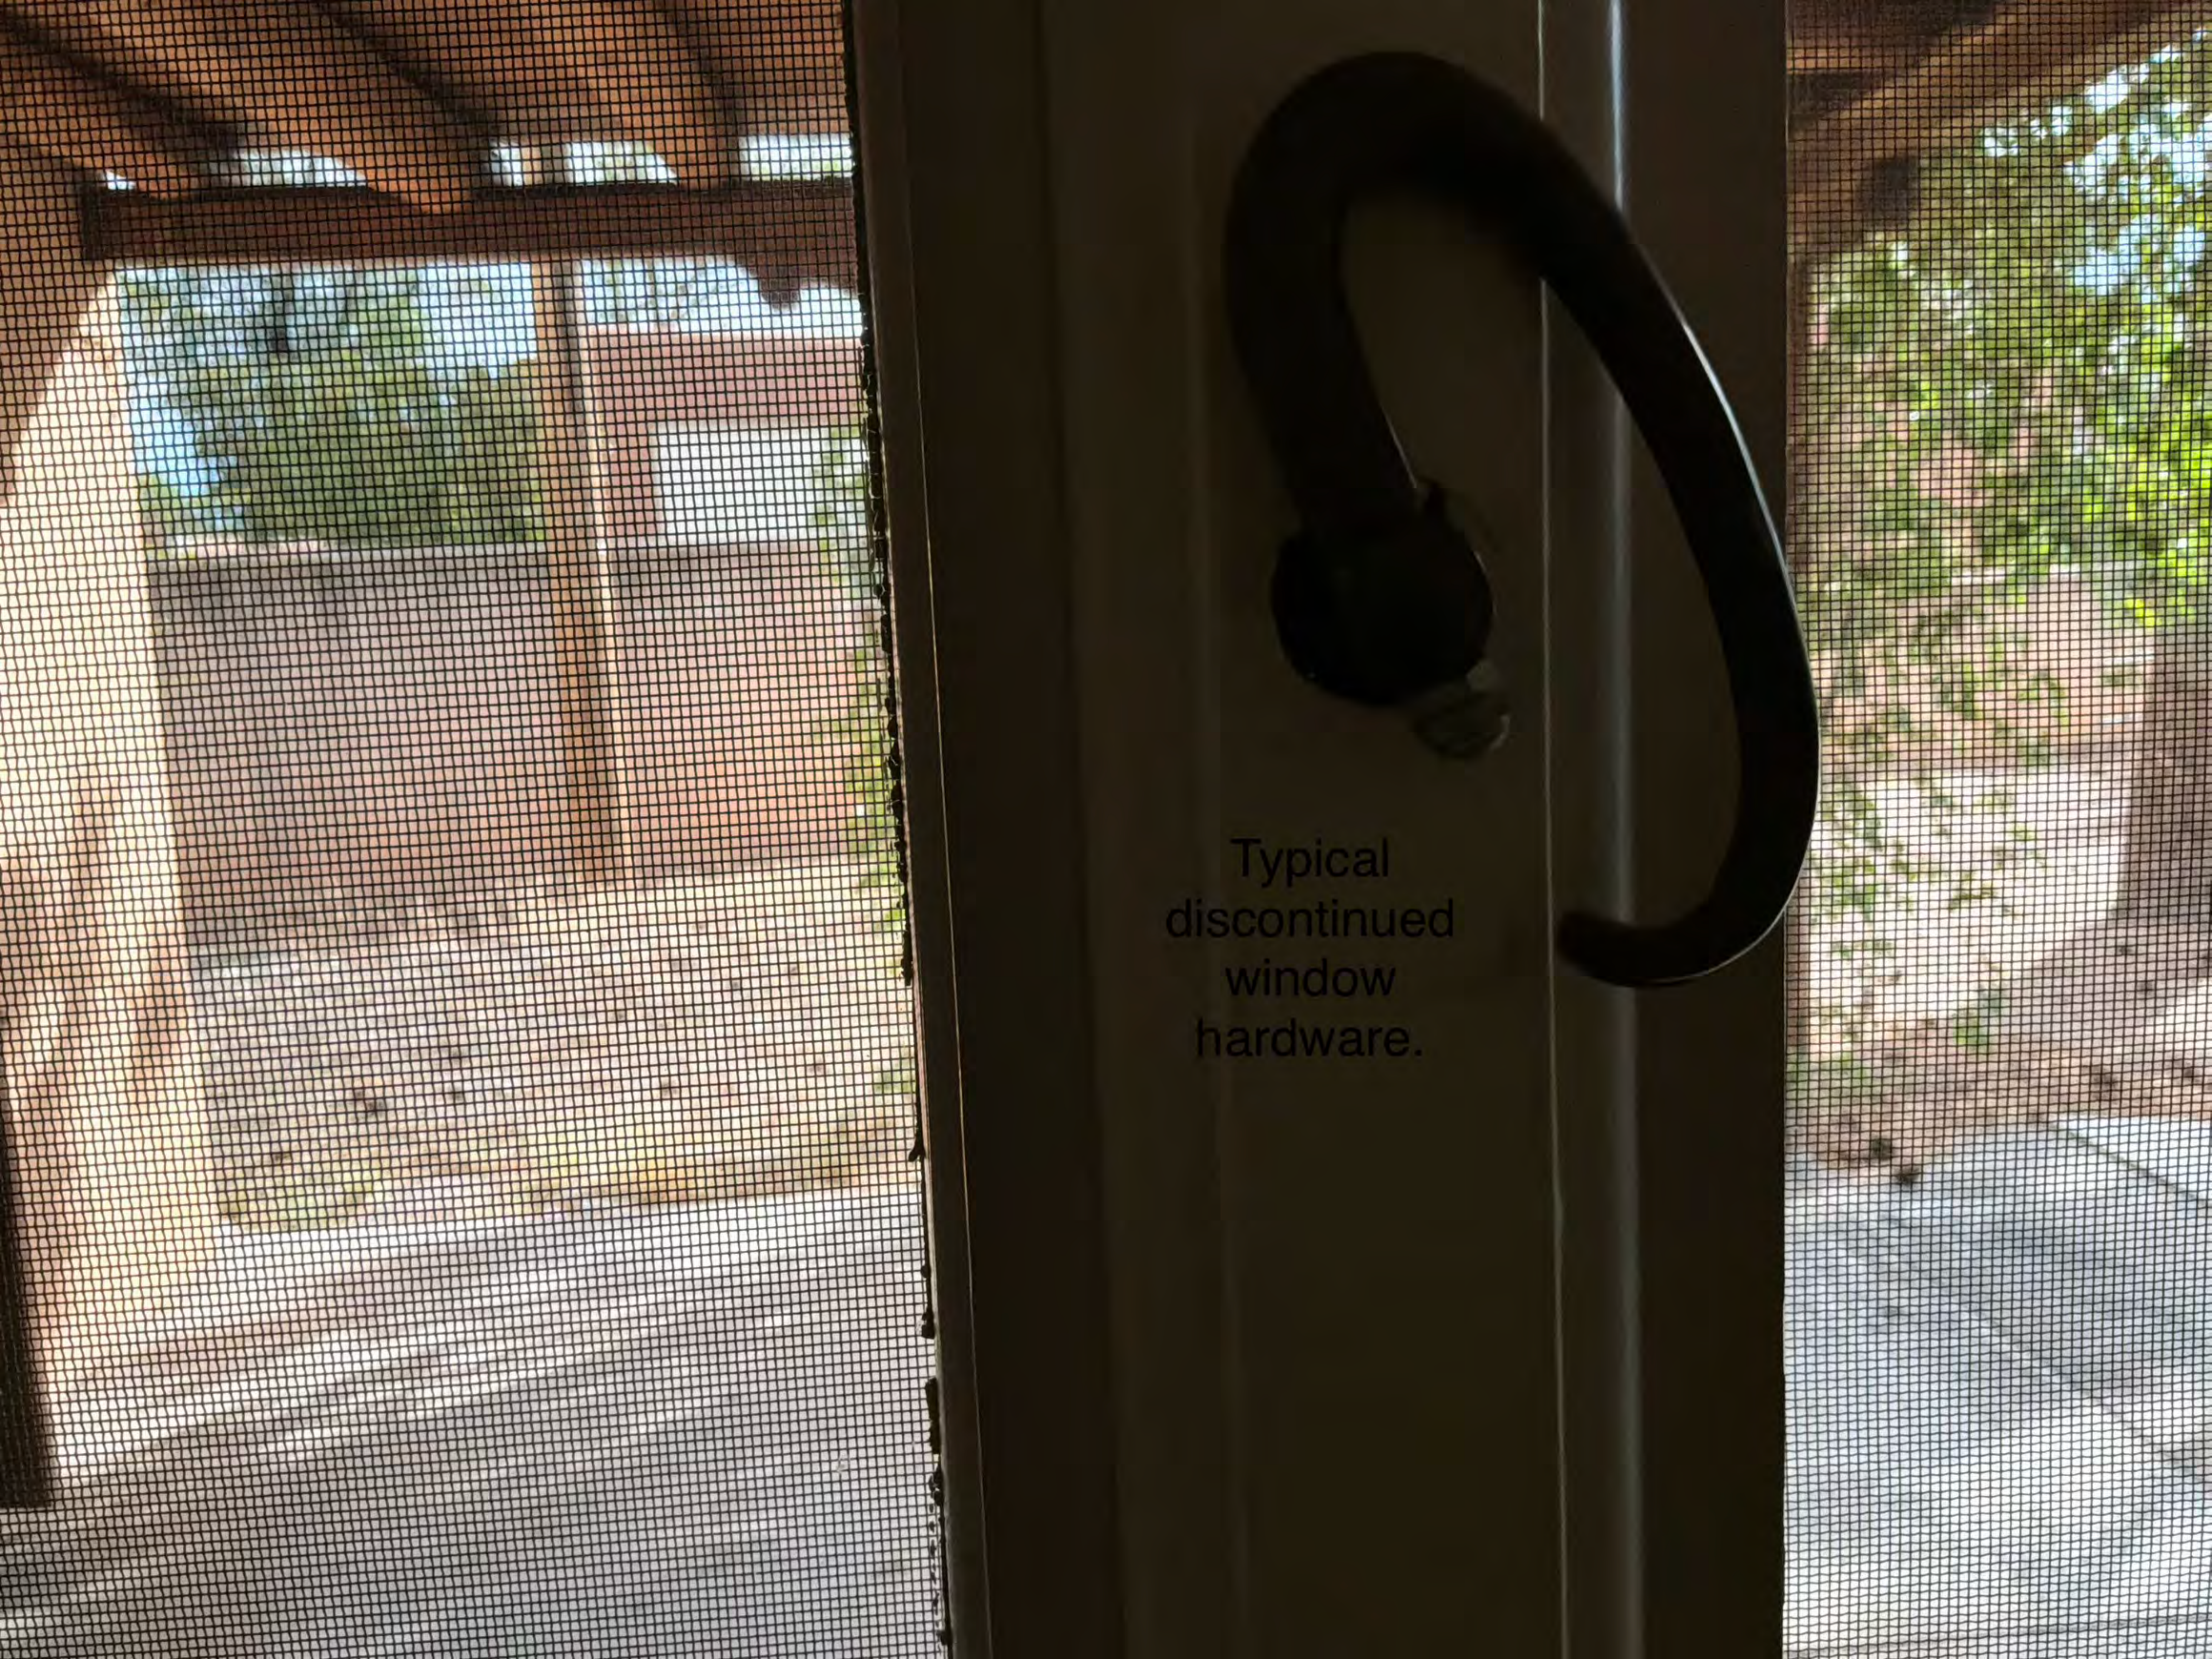
Typical  
discontinued  
window  
hardware.
