On behalf of the applicant Anita Alarid, I am submitting a **Request for Status Review** for 338 Orchard Drive. The property is located within the Downtown and Eastside Historic District.

Re: 338 Orchard Drive, Santa Fe NM 87501  
Historic Narrative of Single-Family Residence

# Historic Cultural Properties Inventory (HCPI) Base Form (FORM 1)

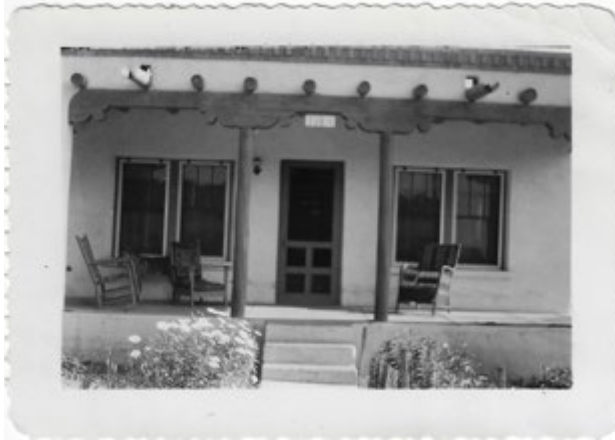
Original North Façade, circa early 1940's

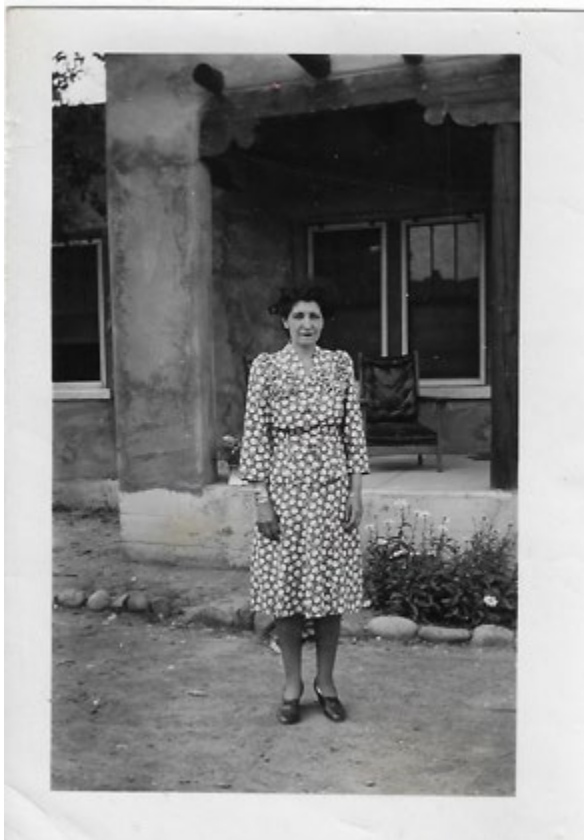
North Façade Entry Portal after stucco work circa 1930's  
Ruby Gonzales Chapman

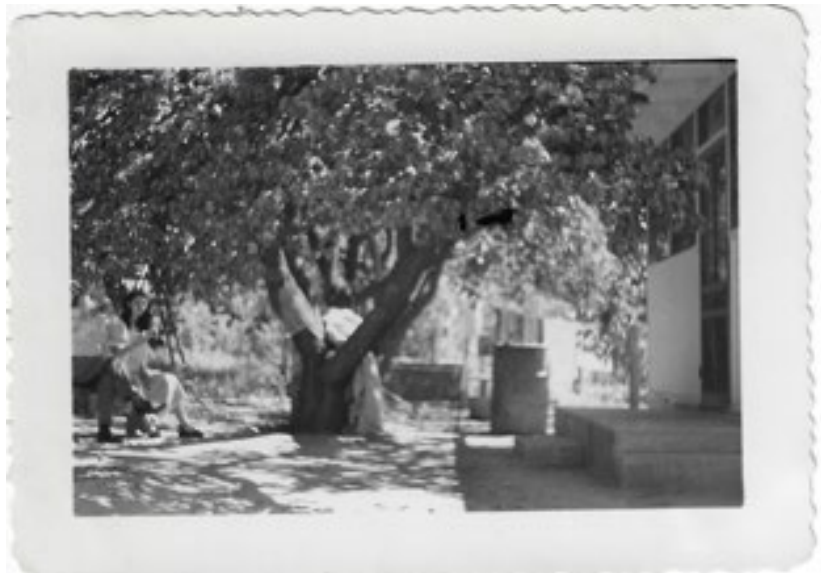
Anita Chapman Alarid, circa early 1940's  
East façade showing original porch

A screened porch is located on the east façade, southeast corner. Historic photos show that a porch was located here. The construction date is unknown but likely 15 years or less of the house construction. Based on the photo, it appears that the original porch has been significantly altered in size and materials at an unknown date. The existing porch would likely be considered "historic" due to its age but not original to the house. The current porch sits on a badly deteriorated concrete foundation, has vertical wood siding with framed fixed screen windows, and a shallow single slope shed roof with exposed galvanized metal drip edge. Based on the deteriorated slab, it is recommended that the structure be replaced as the foundation cannot be easily repaired without removal of the structure.

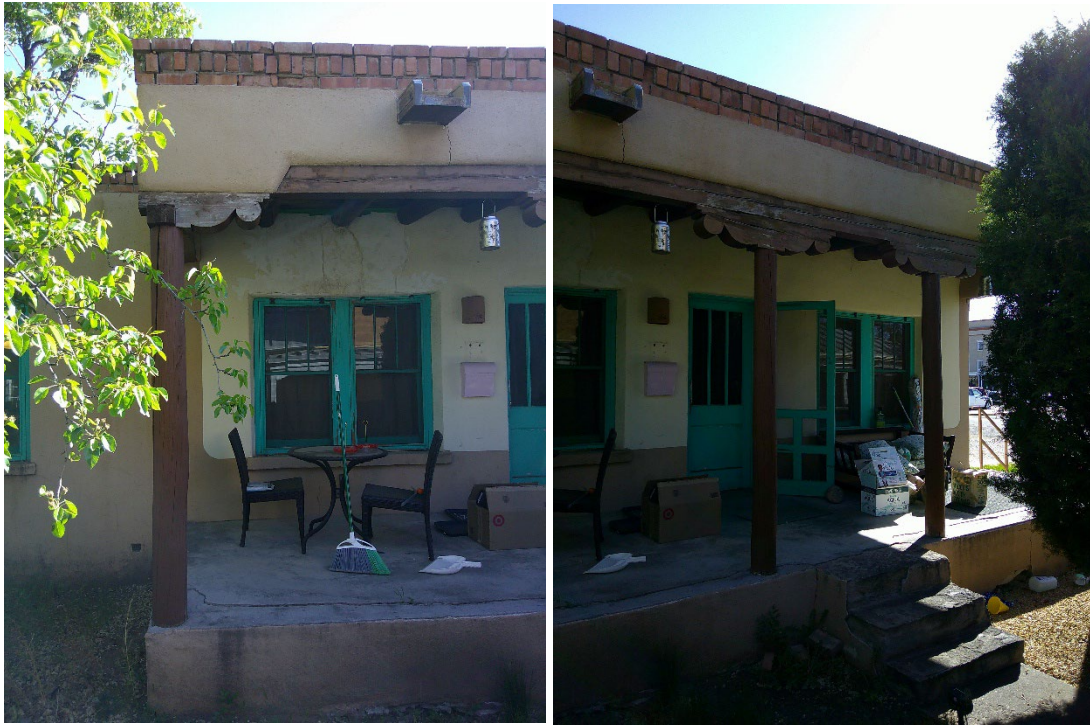
North Façade Entry Portal

The north portal has the same parapet height. It is supported with painted wood columns, corbels, primary wood header beam, and vigas exposed as the portal ceiling. The raised portal floor has deteriorating stucco on the face of the portal edge and a deteriorating concrete flooring. It is accessed with two sets of deteriorating concrete steps at the north and west. The roof line is noticeably dipping toward the north façade. The owners had a structural engineer assessment approximately 5 years ago (Vince Dimmer, GB and Jim Hands PE, retired). The assessment determined that the portal slab has likely settled, producing the dip in the parapet. Otherwise, the portal appears to be structurally sound.

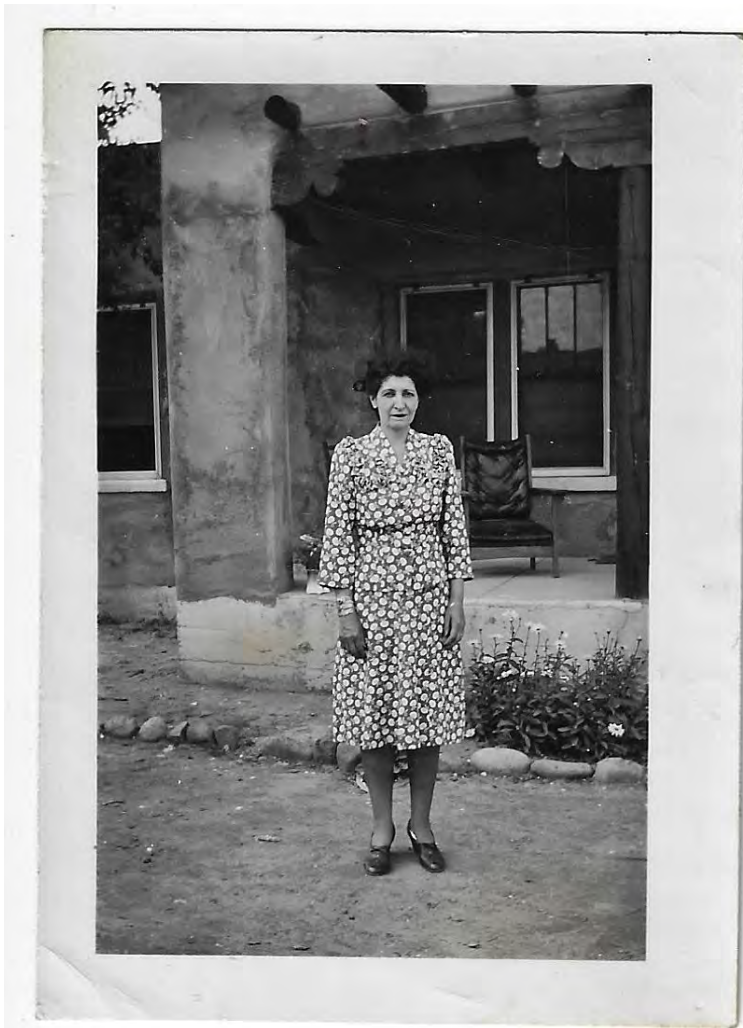
**Figure 2: c.1944-46 photograph of Ruby G. Chapman. Note east stuccoed column of portal. Courtesy of the Alarid family.**

Period photographs indicate that the portal was originally framed by stout masonry columns that formed closed end walls (Fig. 2). Historically, it featured 10 projecting vigas and round galvanized-steel or sheet-metal canales (Fig. 3). The masonry columns and end walls remained in place through at least 1985 (Fig. 9) but were subsequently removed and replaced with smaller wood posts, leaving the ends of the portal open. Around the same time, the projecting viga ends were also cut flush with the wall plane, and the original metal canales were replaced with wider modern wood trough drains (Photo 5).

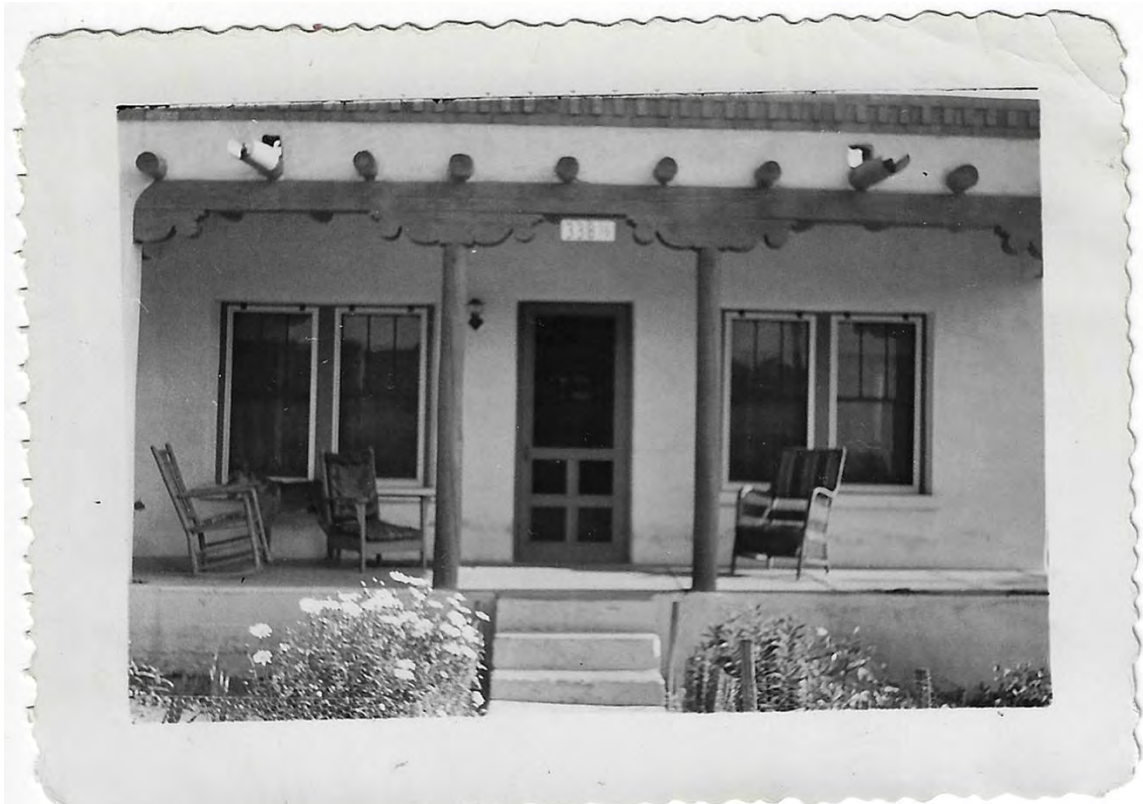
**Figure 3: Undated photograph. Note presence of viga ends and rounded galvanized canales. Courtesy of the Alarid family.**

The roof is drained with a combination of painted metal canales on the main house and metal lined stained wood canales on the portal. Historic photos indicate that the portal was originally drained with half round metal canales. These were replaced with the wood canales at an unknown date. Thus, it is likely that all the canales have been replaced at an unknown date.

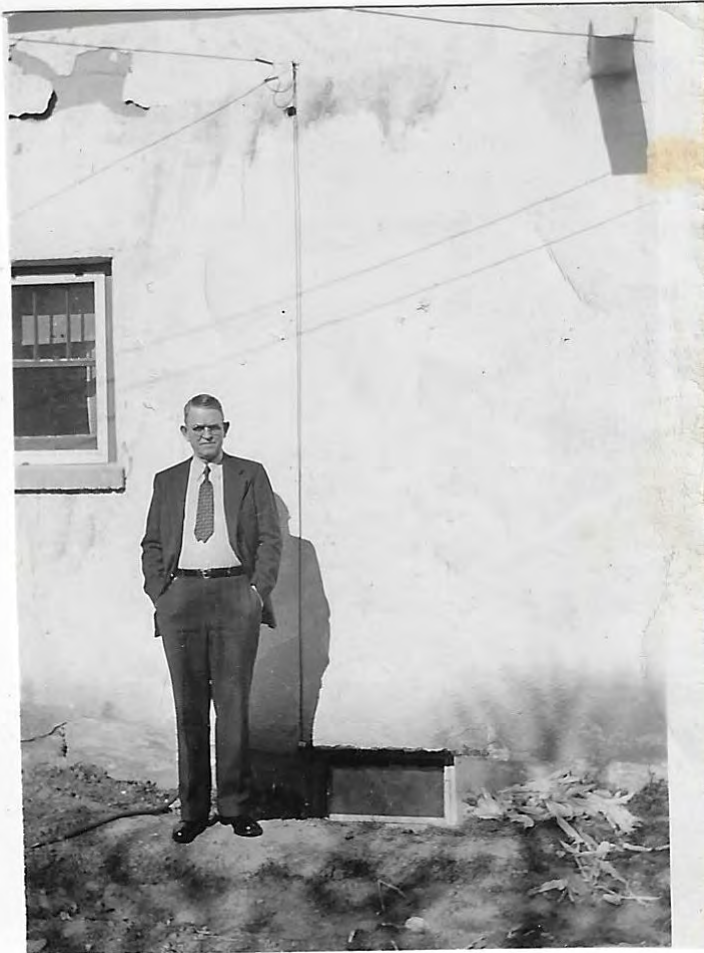
**Figure 4: c. 1944-46 photograph of south elevation. Note wood multi-light window at bathroom. Courtesy of the Alarid family.**

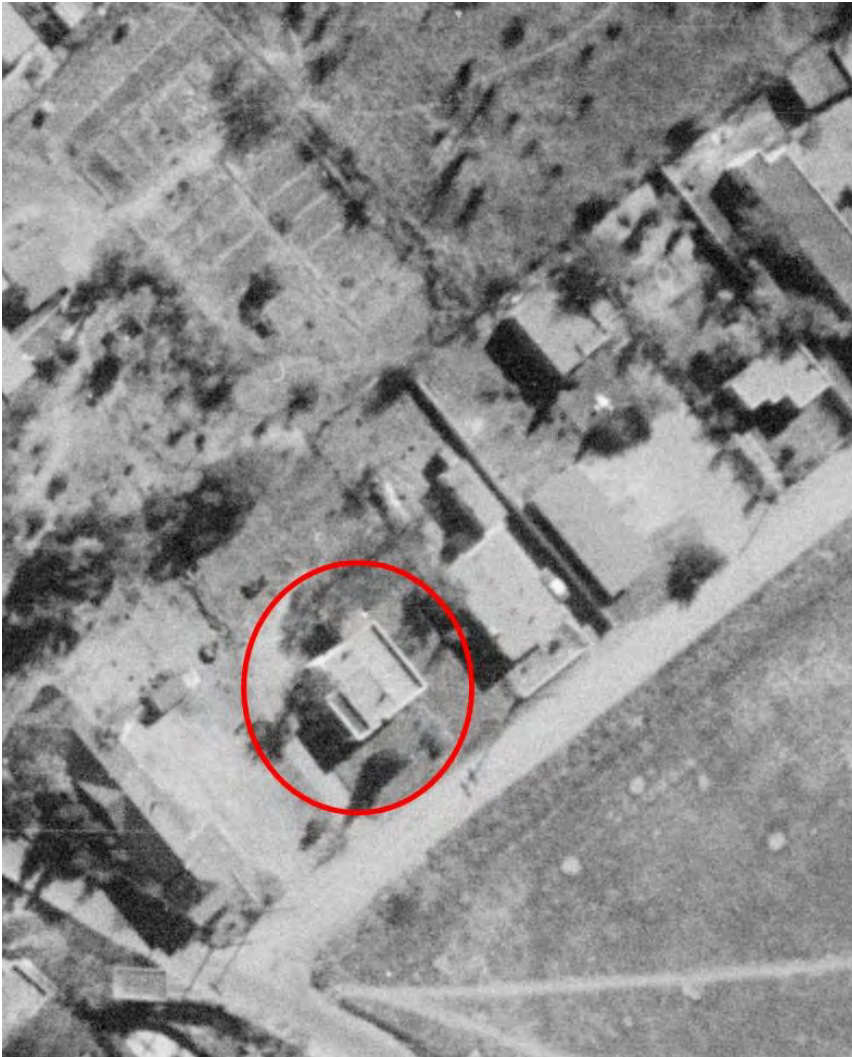
**Figure 6: November 10, 1958, aerial photograph. Note presence of screened porch.**

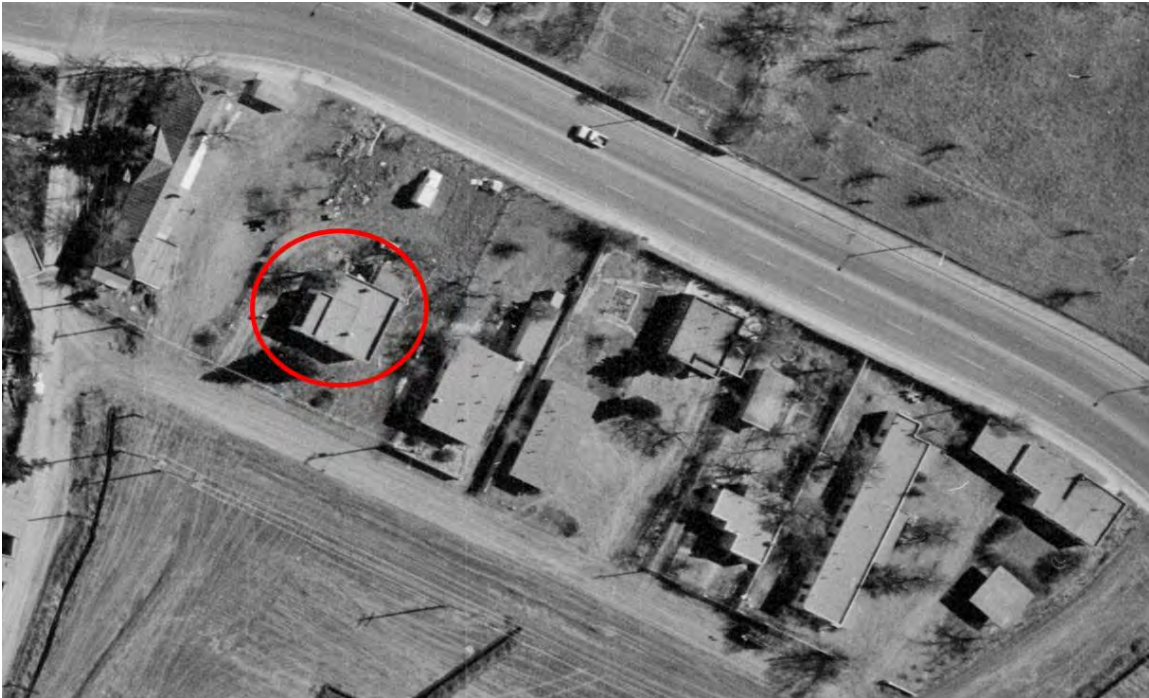
**Figure 7: February 2, 1968, aerial photograph.**

At nearly the same time, the PERA Building was completed in 1968, and its expansive parking lot occupied much of the former St. Michael's Cemetery. The new government complex replaced the open landscape west of the house and largely eliminated its views toward the Jemez Mountains.<sup>31</sup> An aerial photograph from the same period illustrates the extent of these changes (Fig. 7).

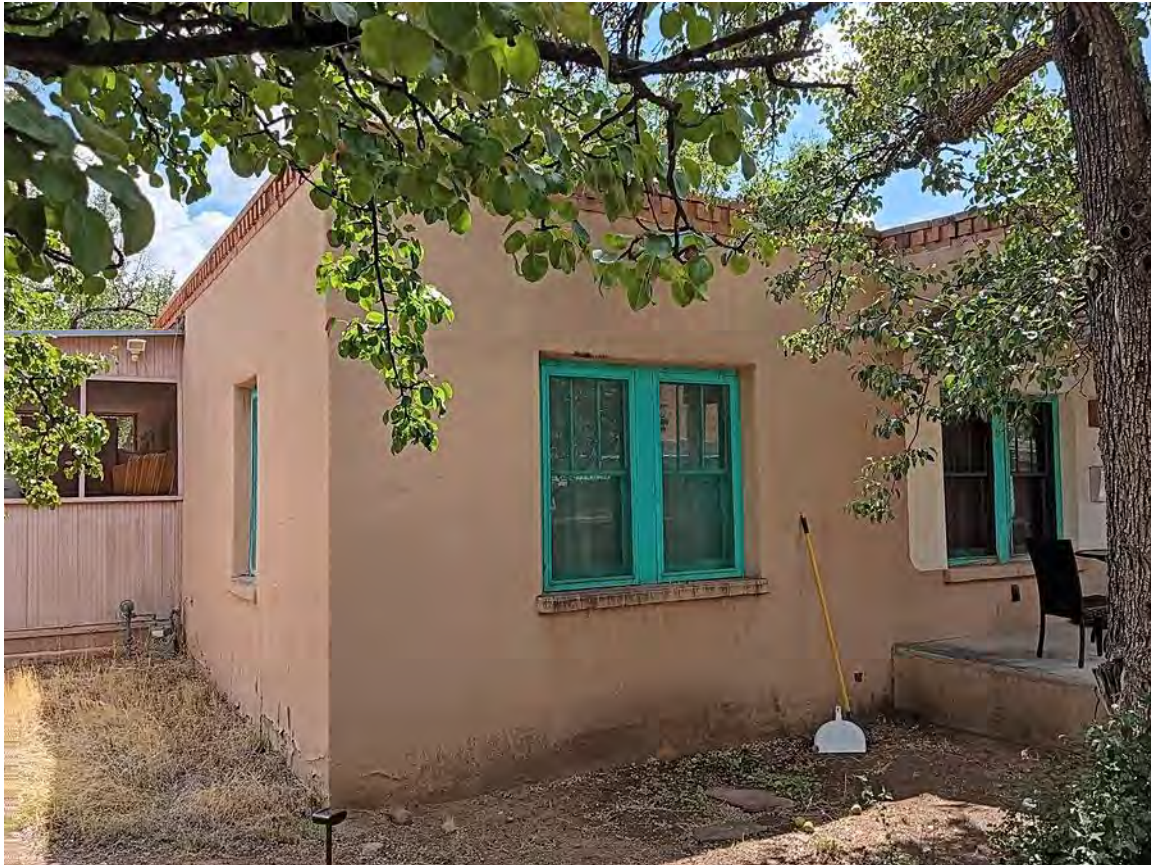
**Photo 3: East section of north elevation. Camera facing southwest.**

*The north elevation cannot be photographed as a full façade because of the shallow side yard and the presence of a mature pear tree in front of the portal.*

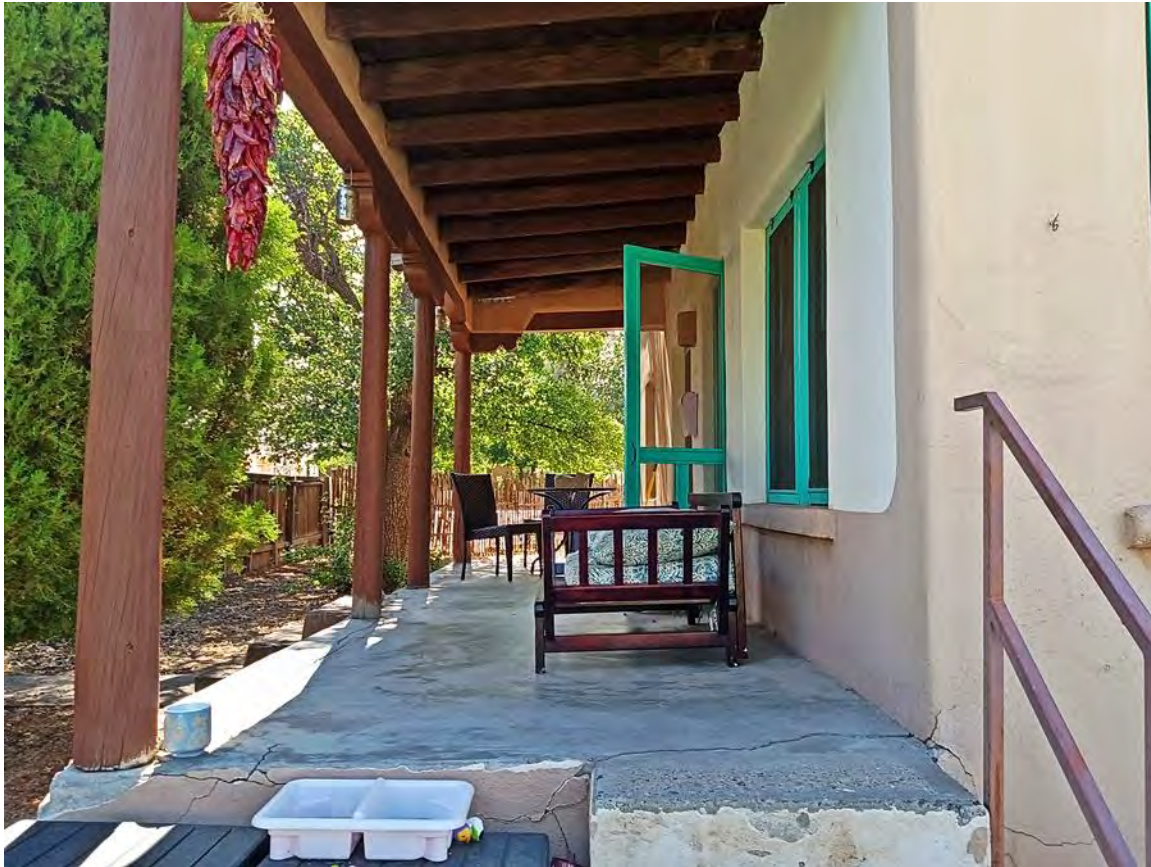
**Photo 4: Portal. Camera facing east.**

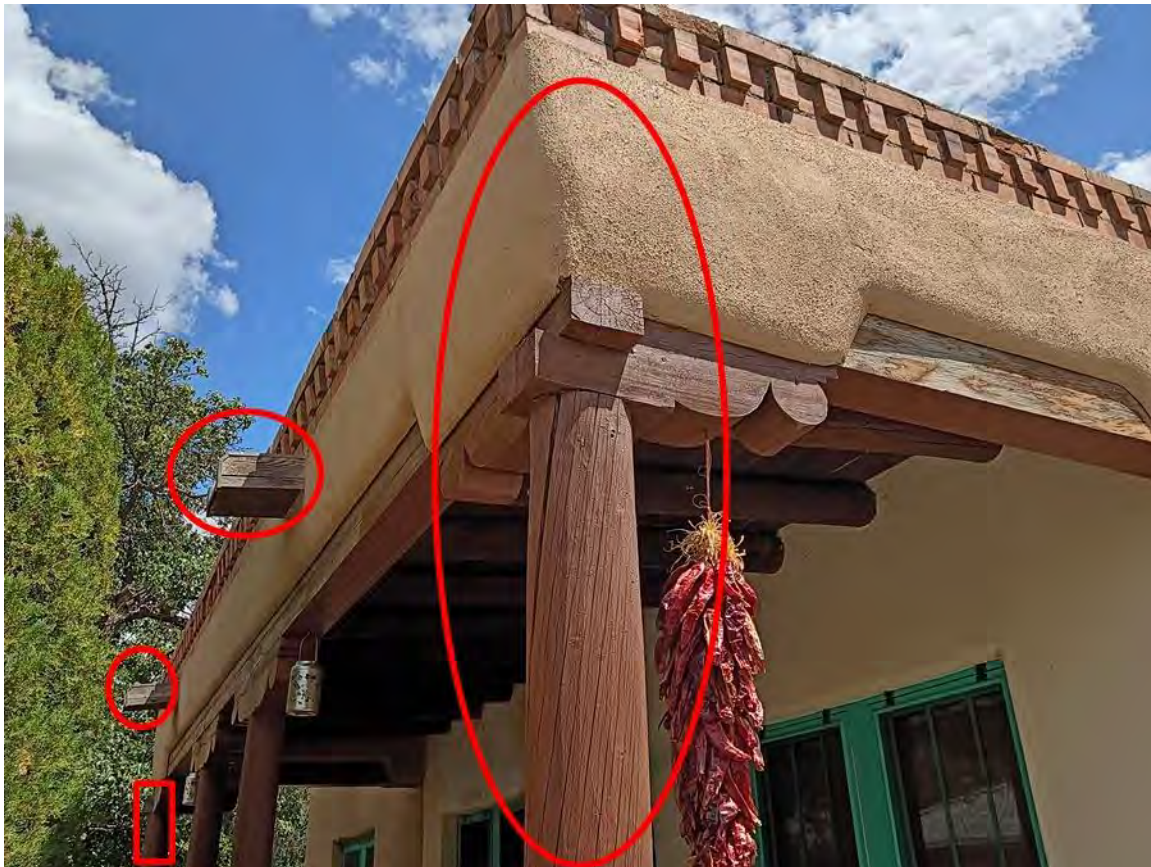
Photo 5: Elements that have been altered across the portal. Camera facing up.

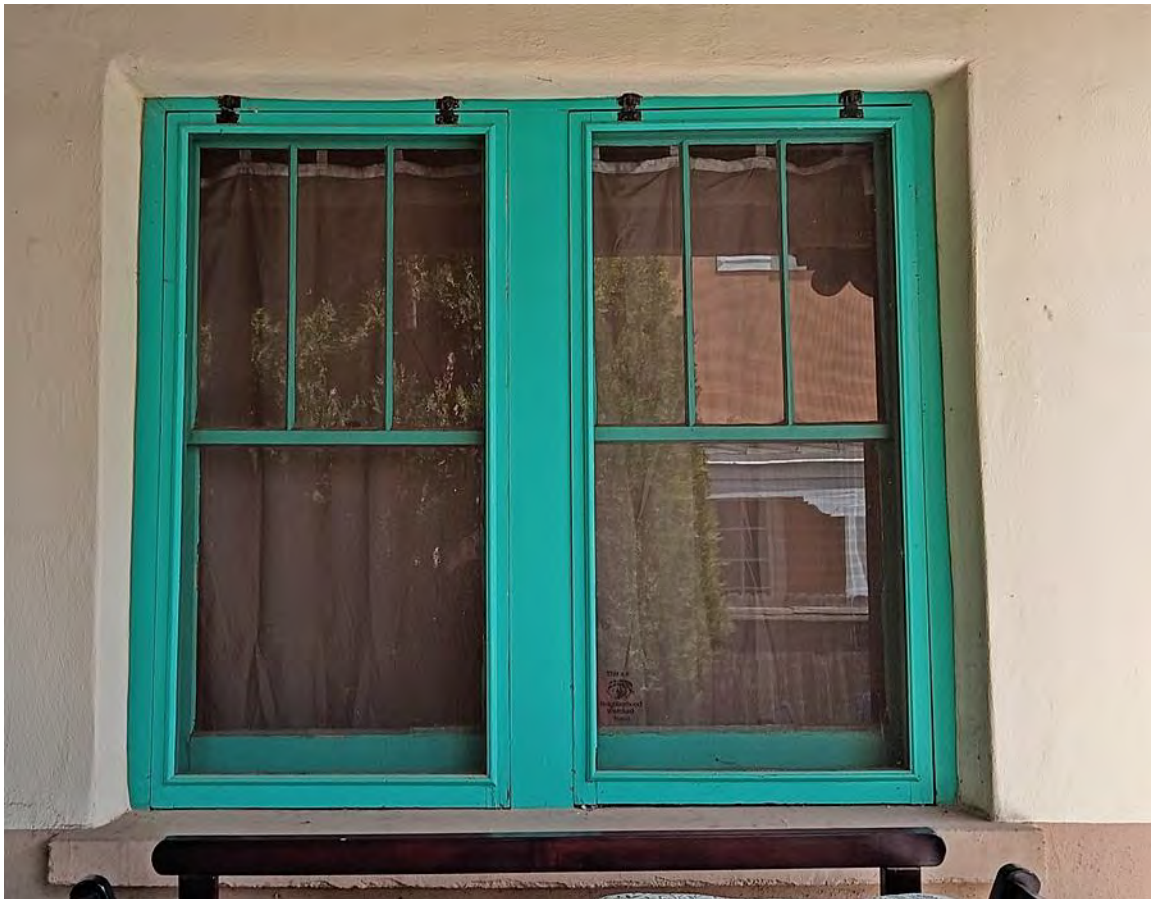
**Photo 7: North elevation. Window detail. Camera facing south.**

The existing windows are primarily double hung with a three lite upper sash (3/1) over a single lite lower sash (1/1) with separate window screens. The windows are painted turquoise. A least one window on the south façade has been replaced at an unknown date with a non-historic composite window unit. The typical window unit appears original, historic at the minimum. The windows are not fully functional

and are not weather tight. However, it appears that the windows can be restored. The majority of the window frames and mutins appear to be intact without significant rot damage.

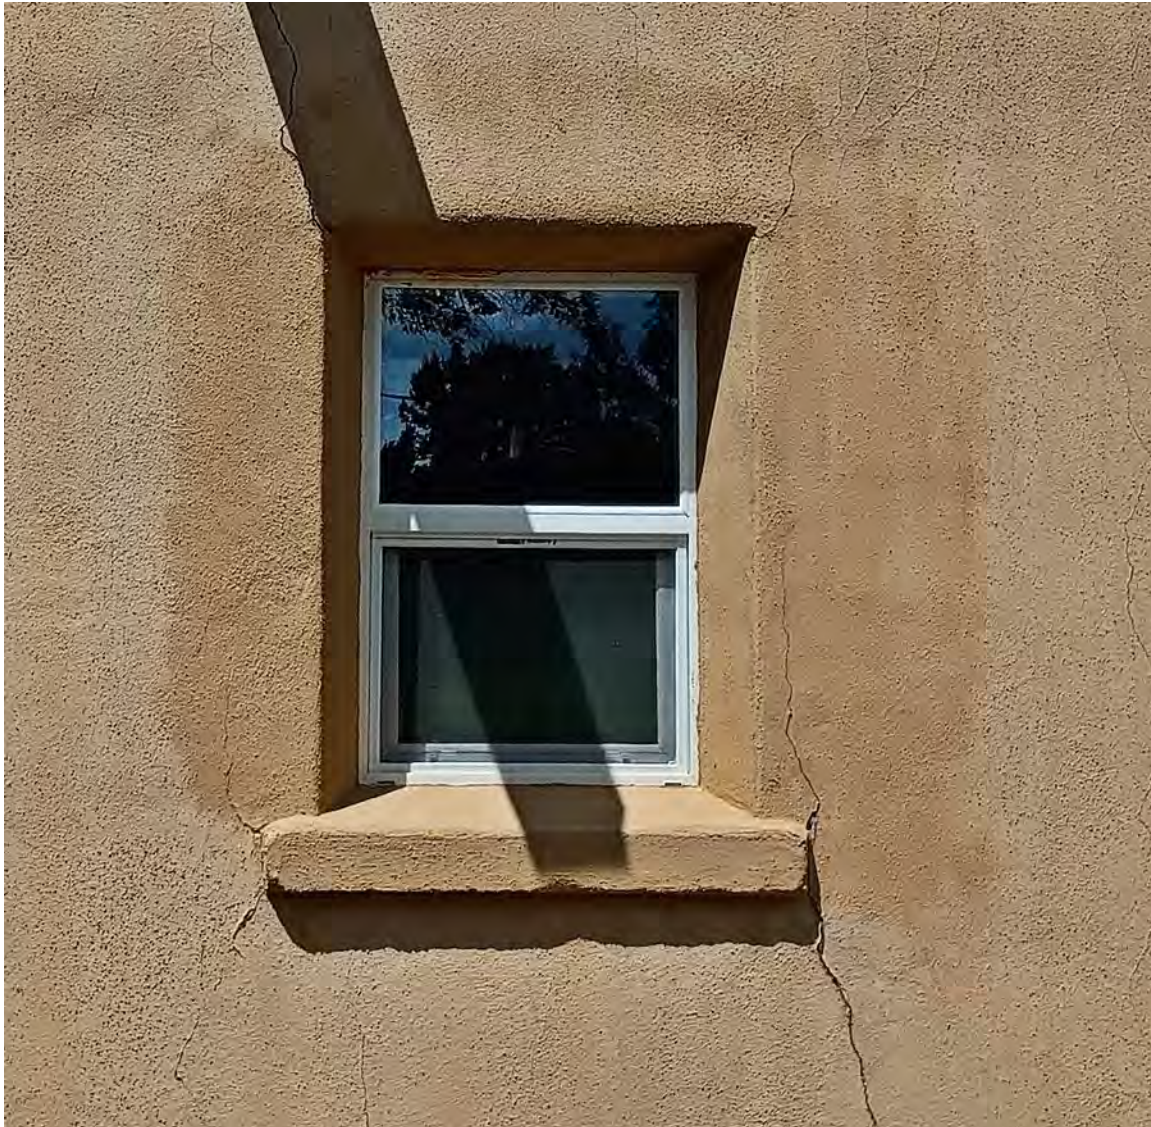
**Photo 10: South elevation. Detail of replacement window.**

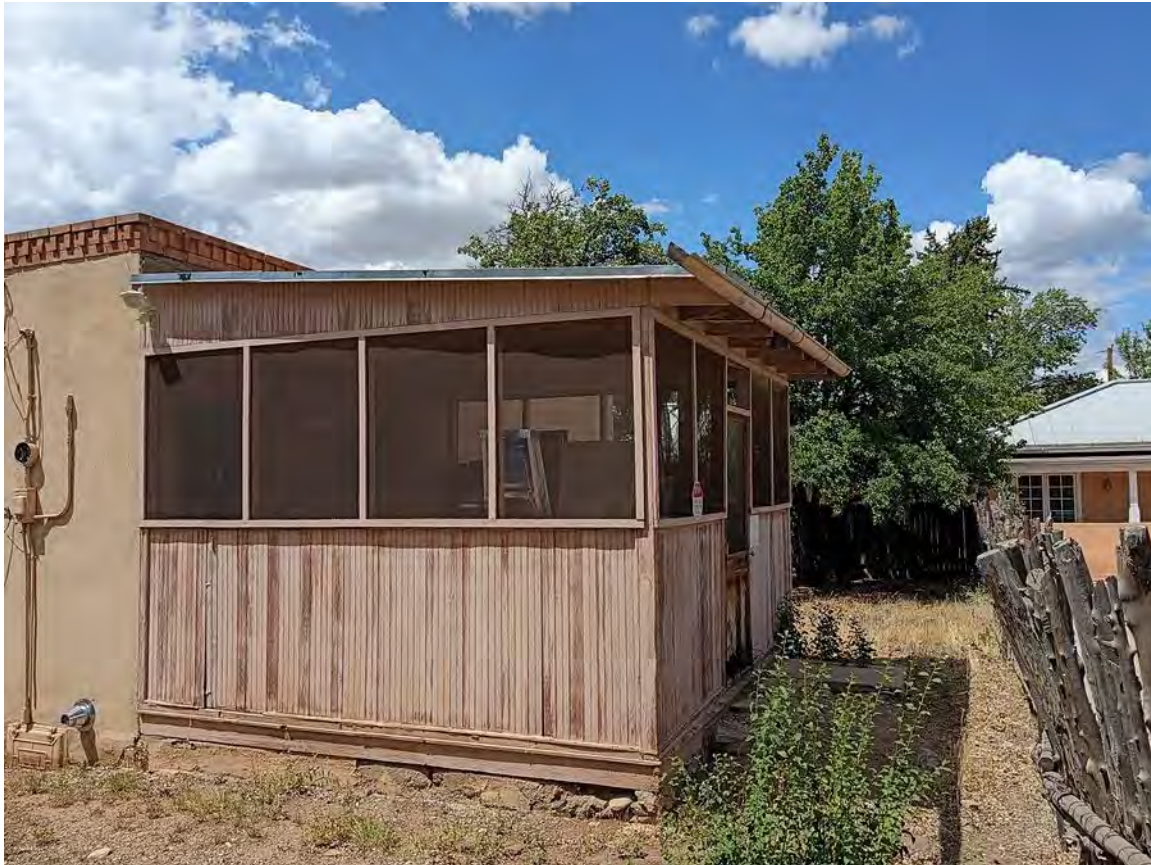
**Photo 11: South elevation. Frame screen porch. Camera facing northwest.**
