# Historic Cultural Properties Inventory (HCPI) Base Form (FORM 1)

| For HPD Office use only: | | | | | | | | |
|---|---|---|---|---|---|---|---|---|
| 1. Name of property:<br><br>Vicente and Petrita Brito House | | 2. Location:<br><br>320 Camino Delora<br>Downtown and Eastside Historic District –<br>Santa Fe | | 3. Local Reference Number:<br>Santa Fe ID: H-778 | | | | |
| 8. Name of Project:<br>HDRB Status Evaluation | | | | | | | | |

John W. Murphey  
Architectural Historian  
Architectural History Services  
w/ Jim Rodman

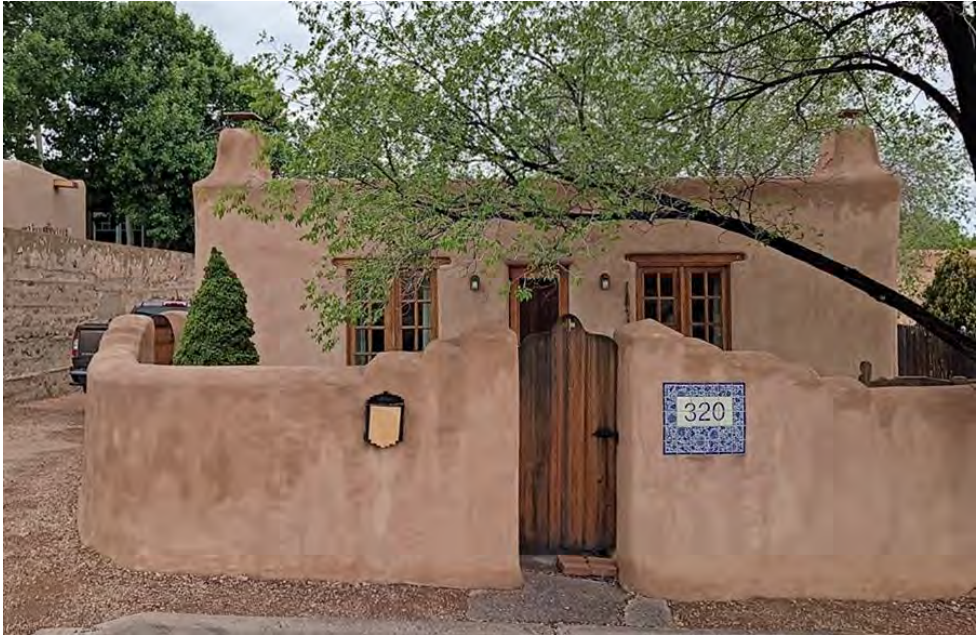
| For HPD Office use only: | | | | | | | | |
|---|---|---|---|---|---|---|---|---|
| 10. Photo Information: Jim Rodman, photographer. Photo 1: View of east (front) elevation. Camera facing west. May 19, 2026. | | | | | | | | |

| For HPD Office use only: | | | | | | | | |
|---|---|---|---|---|---|---|---|---|
| 11. Brief Description of the Property:<br>Located at the corner of Camino Delora and Cristo Rey Street, the former Vicente and Petrita Brito House faces east toward the Sangre de Cristo Mountains (Photo 1). The house likely originated in the late 1930s as a modest two-room dwelling. Over time, several additions were constructed to the rear, all of which appear to be adobe. Following its departure from family ownership in the early 2000s, the vernacular dwelling underwent a substantial renovation, transforming it into a residence more closely resembling a Santa Fe Style house of the 1920s. The property also includes a guesthouse (casita), constructed in the early 2000s, along with several walls and fences, most of which date from the same period. The primary house is designated Non-contributing and the guesthouse has no status.<br><br><i>Continued on Page 5.</i> | | | | | | | | |

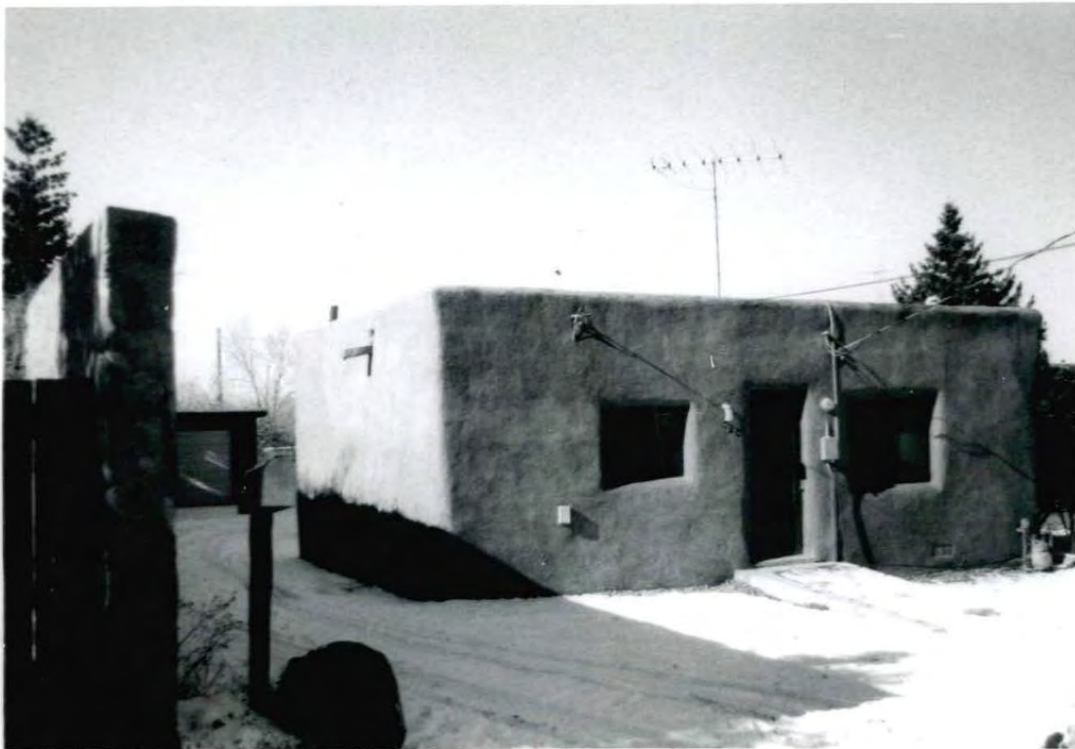
**Figure 1: October 30, 1984, Historic Building Inventory form photograph. East (front) and south elevations, looking northwest. Michael Belshaw.**

The house faces Camino Delora with a substantially altered composition. As documented in the 1984 Historic Building Inventory survey, the façade consisted of a centered entry flanked by closely spaced rectangular window openings (Fig. 1). During the early-2000s renovation, Steve Marlens, the owner and an historic house renovator, retained this basic symmetrical arrangement but relocated the window openings farther from the entrance while narrowing them and extending them to floor level (Photo 3). In place of the original windows, he installed paired ten-light wood French windows,<sup>1</sup> a motif repeated on other elevations of both the primary house and the casita. Each opening is finished with a metal threshold and exposed wood header, a detail recalling

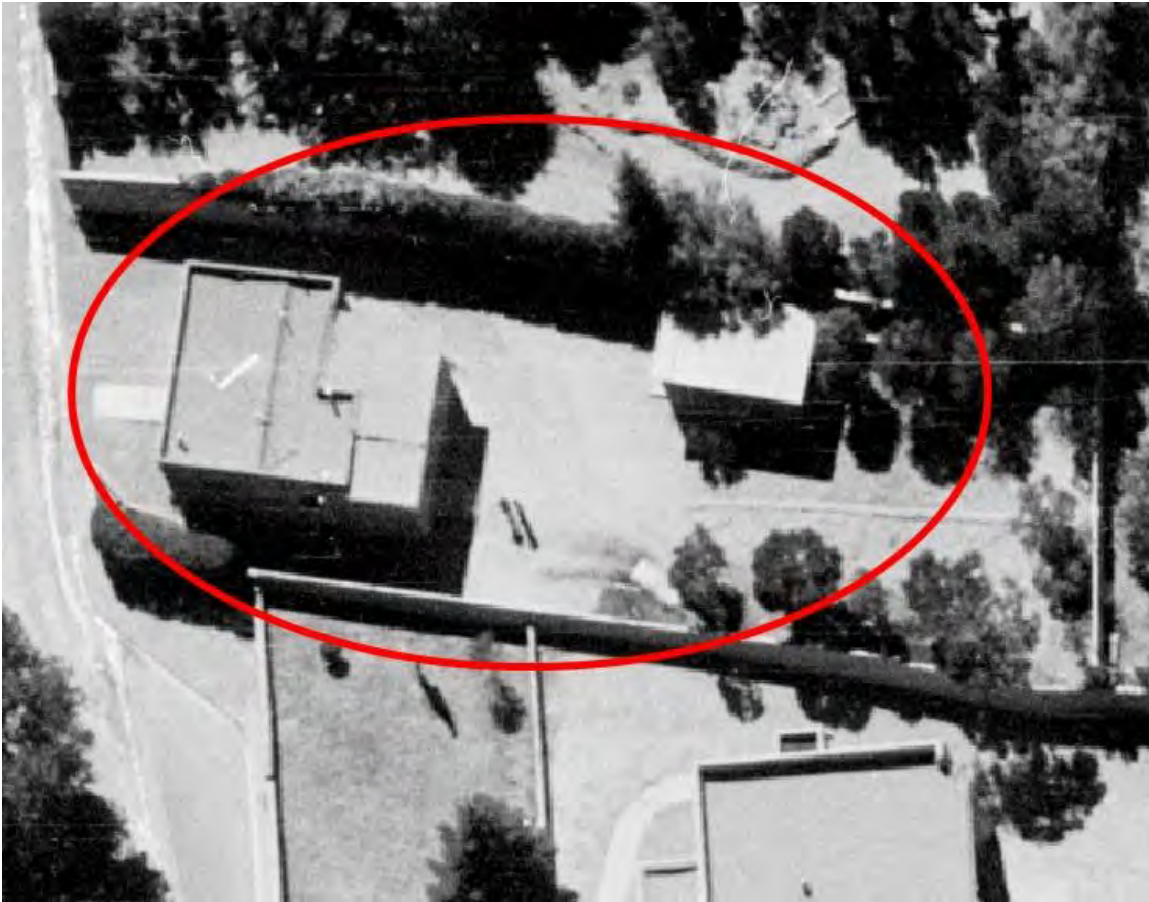
**Figure 5: September 11, 1978, aerial photograph. Note addition made to the northwest corner of the primary house.**

The west elevation opens onto the patio and backyard. Comparison with a 1978 aerial photograph indicates that the fenestration was simplified and repositioned to a more centralized arrangement (Fig. 6). Today, the elevation consists of a single ten-light wood door to the left (north) and a paired ten-light wood French window to the right (south) that originally gave access to a wooden deck (Photo 6). The brick-faced steps leading to the door postdate Marlens' renovation.

The north elevation overlooks the former Cristo Rey Parochial School and presents a minimal amount of fenestration (Photo 7). Comparison with a 1978 aerial photograph indicates that the west end of the elevation formerly included a projecting, lower-roofed section (Fig. 6). As discussed above, this projection has since been removed or simplified, creating a more uniform west end of the house. The remaining two window openings, based on their depth within the wall, appear to be older. Both contain non-historic sliding vinyl windows (Photo 8).

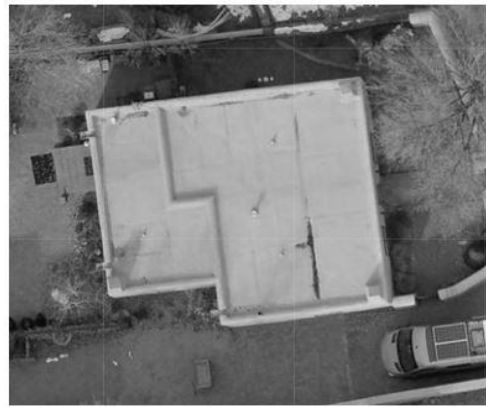
Figure 6: 1978 aerial photograph, left; 2023 satellite imagery, right.

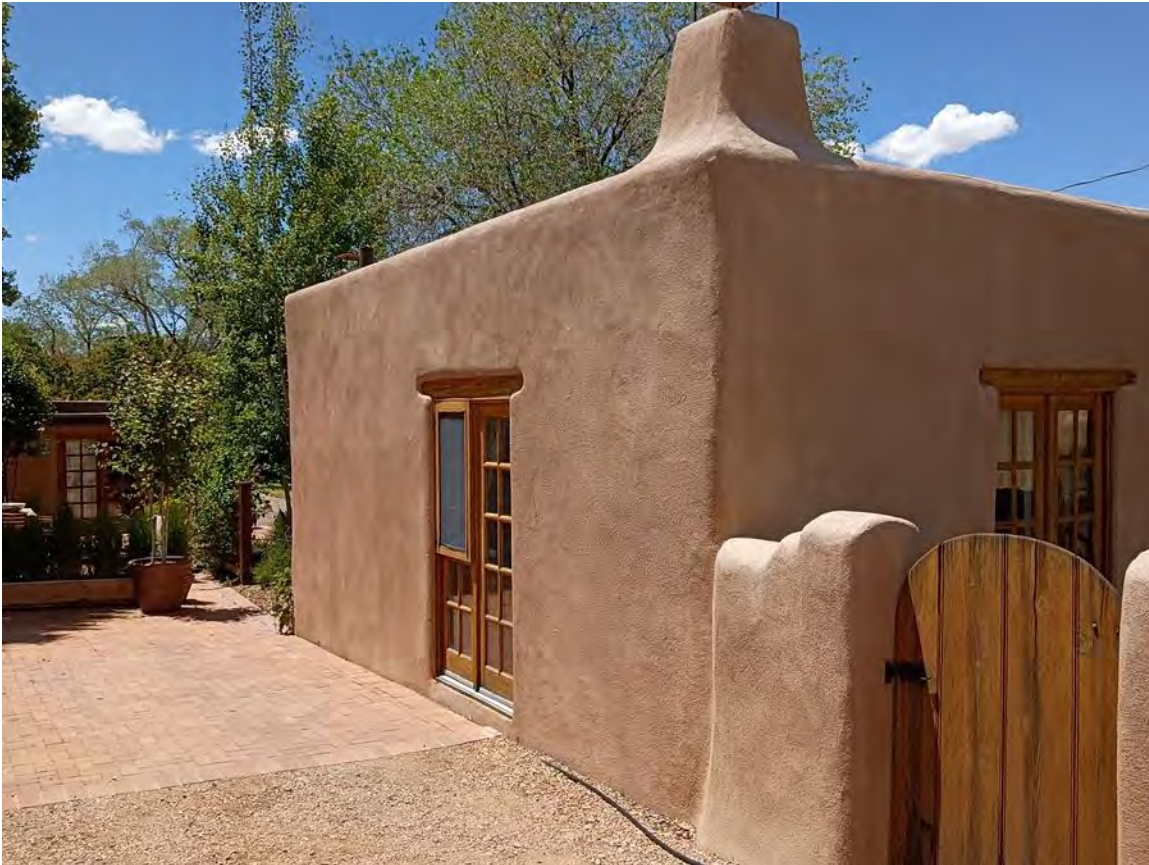
**Photo 4: South elevation, east end. Camera facing northwest.**

The south elevation faces a tall stone wall that originally separated the property from an adjoining parcel later acquired by artist and designer Alexander Girard. As documented in the 1984 Historic Building Inventory survey, this short elevation was originally devoid of fenestration. During the early-2000s renovation, Marlens introduced a ten-light wood French window with a lowered threshold, providing direct access to a brick-paved patio (Photo 4).

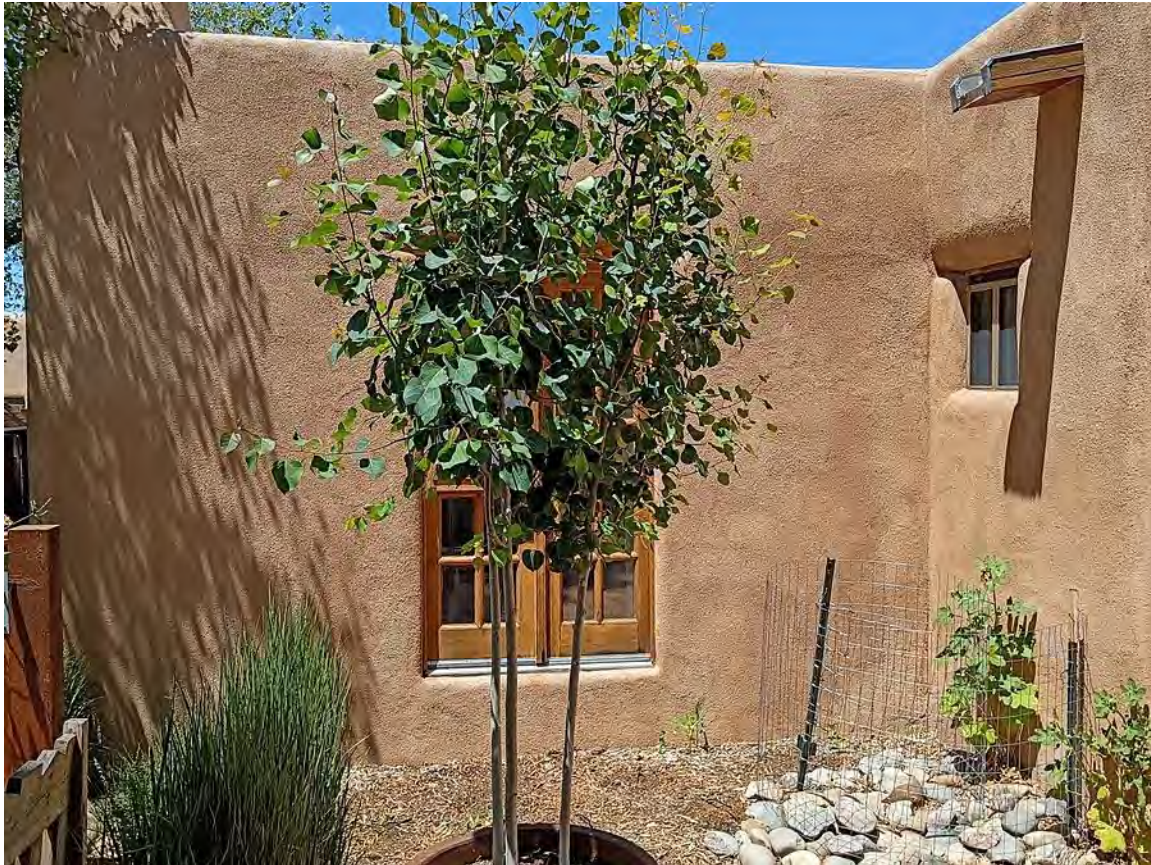
**Photo 5: South elevation, west end. Camera facing north.**

West of the original façade, the elevation steps back to an addition constructed between 1960 and 1966, based on aerial photographic evidence (Figs. 3 & 4). Like the original portion of the house, the addition was remodeled with a French window; however, this opening retains a higher sill above grade (Photo 5).

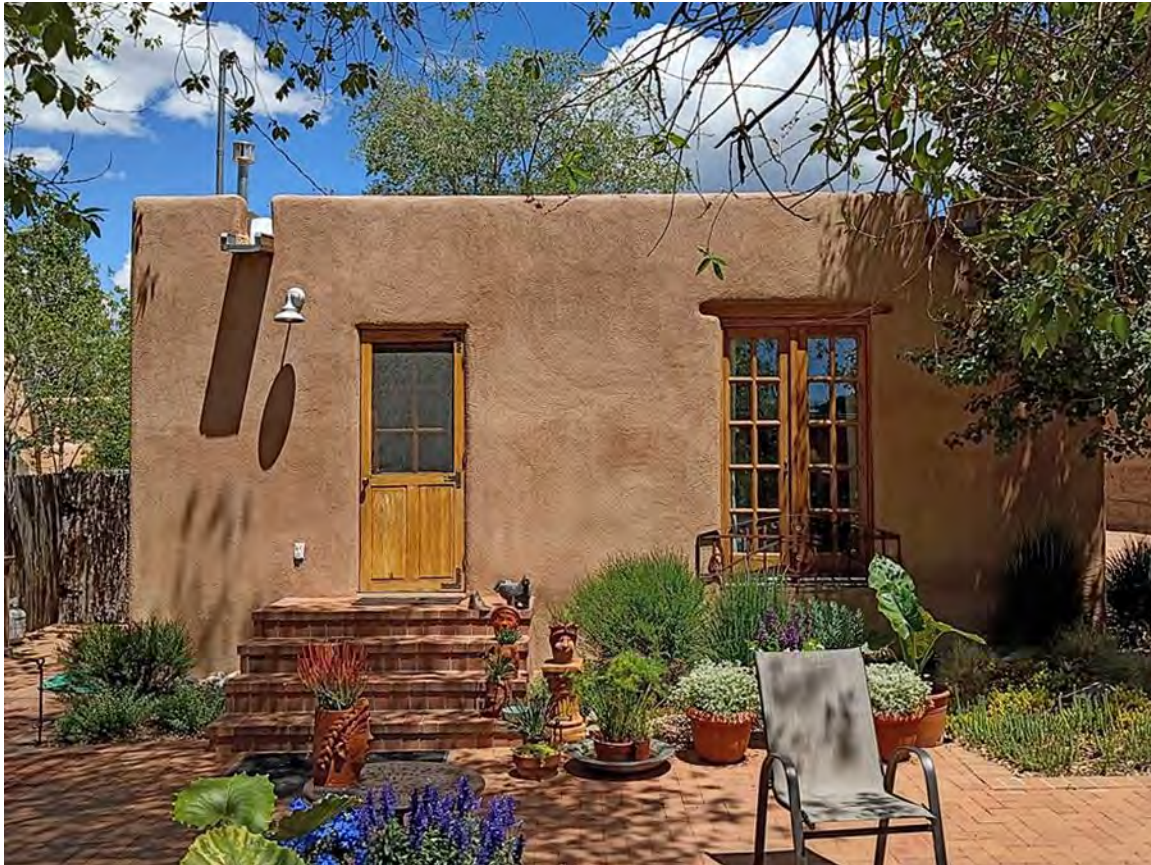
**Photo 6: West elevation. Camera facing east.**

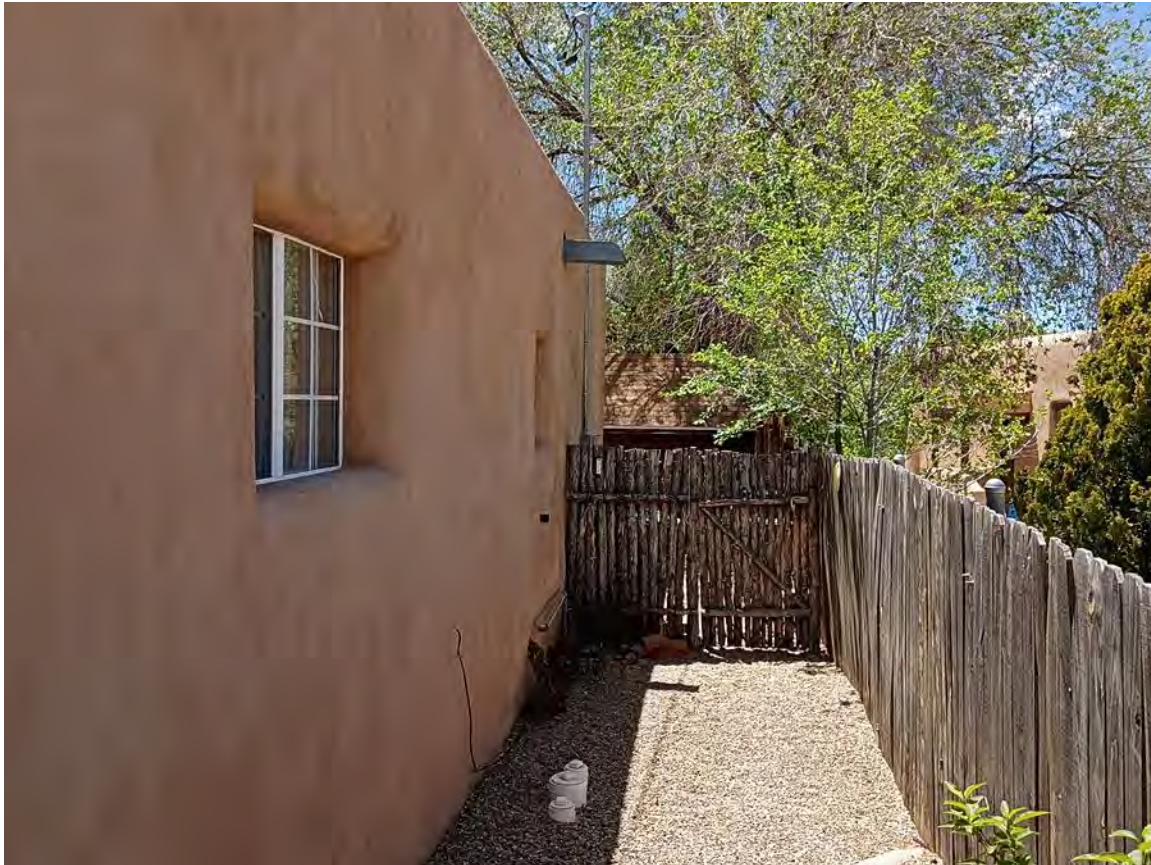
**Photo 7: North elevation. Camera facing west.**

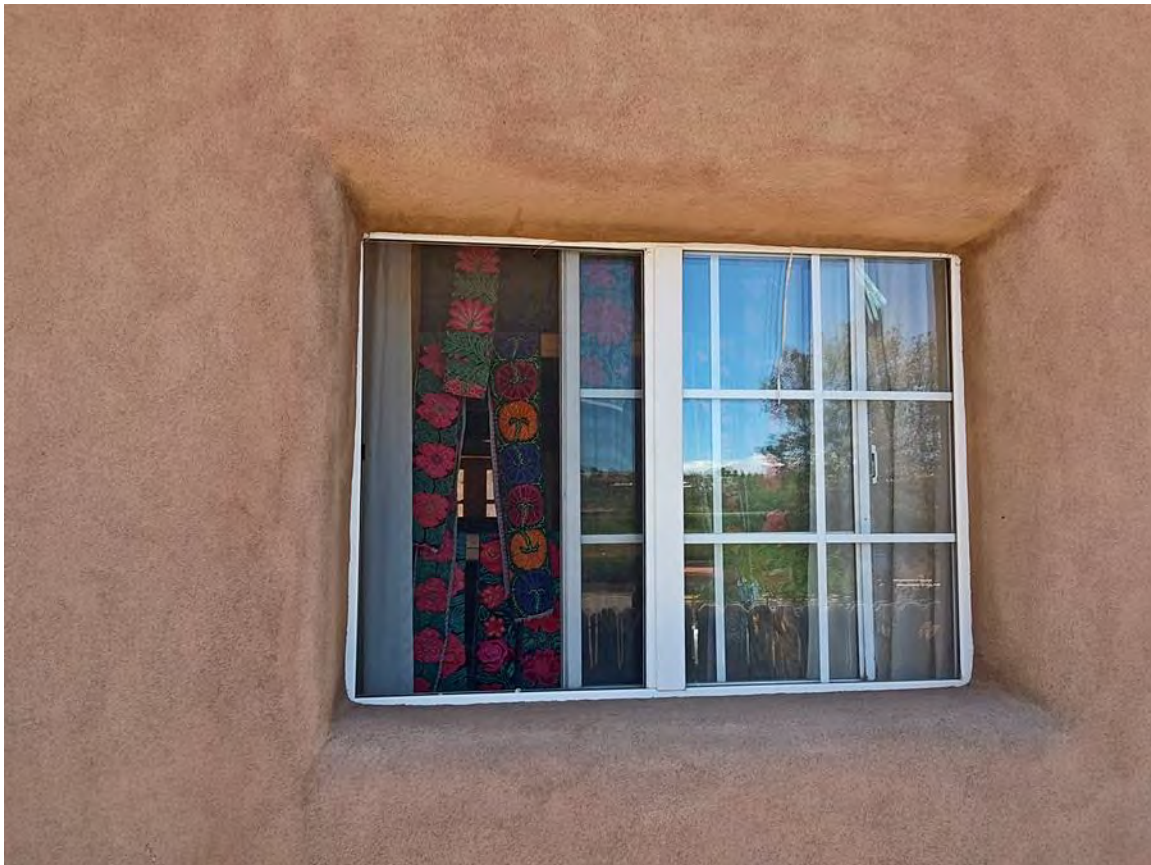
Photo 8: North elevation. Window detail. Camera facing south.
