# Historic Cultural Properties Inventory (HCPI) Base Form (FORM 1)

| For HPD Office use only:<br>HCPI No. _____ District No. _____ NRHP _____ SRCP _____ Criteria <u>  A  </u> <u>  B  </u> <u>  C  </u> <u>  D  </u> | | |
|---|---|---|
| 1. Name of property:<br><br>Juanita Compound Apartments –<br>Parcel A: Units A & B*<br><i>Letter designations were<br/>assigned as part of this survey</i> | 2. Location:<br><br>405 A & B Juanita Street<br>Westside-Guadalupe Historic District –<br>Santa Fe | 3. Local Reference Number:<br>Santa Fe ID: 2507<br><br>4. County: Santa Fe<br>Parcel # 19100777 |
| 8. Name of Project:<br>HDRB Status Evaluation | | |

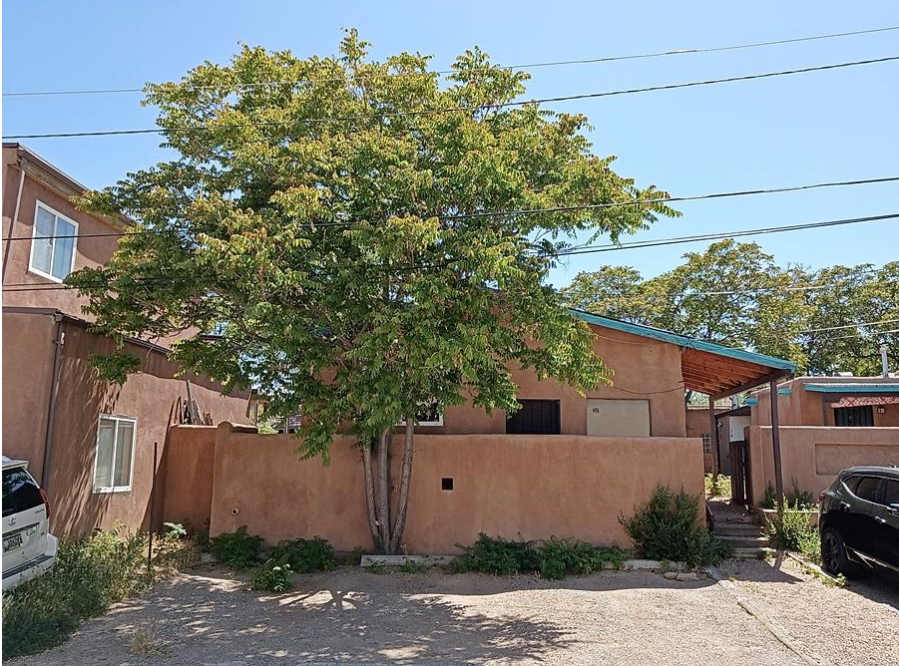
| For HPD Office use only:<br>HCPI No. _____ District No. _____ NRHP _____ SRCP _____ Criteria <u>  A  </u> <u>  B  </u> <u>  C  </u> <u>  D  </u> | | |
|---|---|---|
| 10. Photo Information: Jim Rodman, photographer. Photo 1: View of west (front) elevation. Camera facing east. | | |

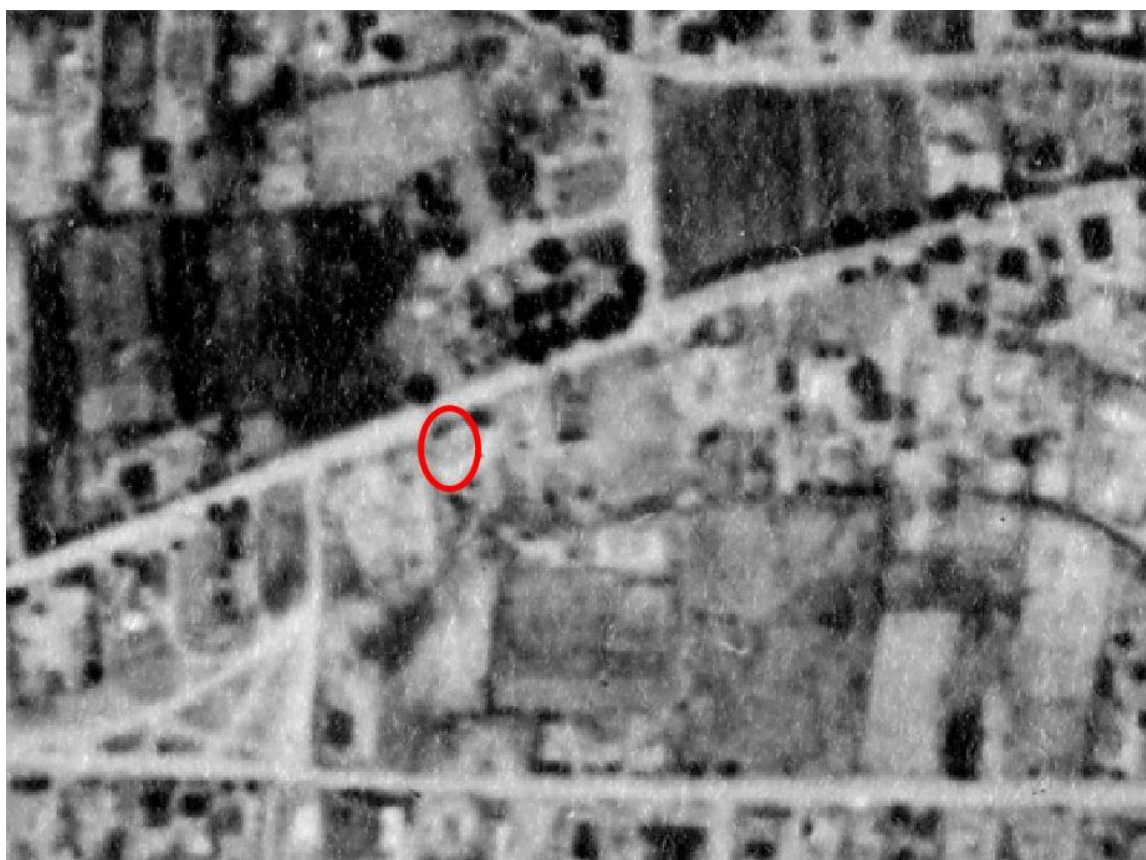
**Figure 3: 1935 aerial photograph showing primary dwelling at 826 Agua Fria Street.**  
 Source: 1935 aerial photograph, Image # 1261.

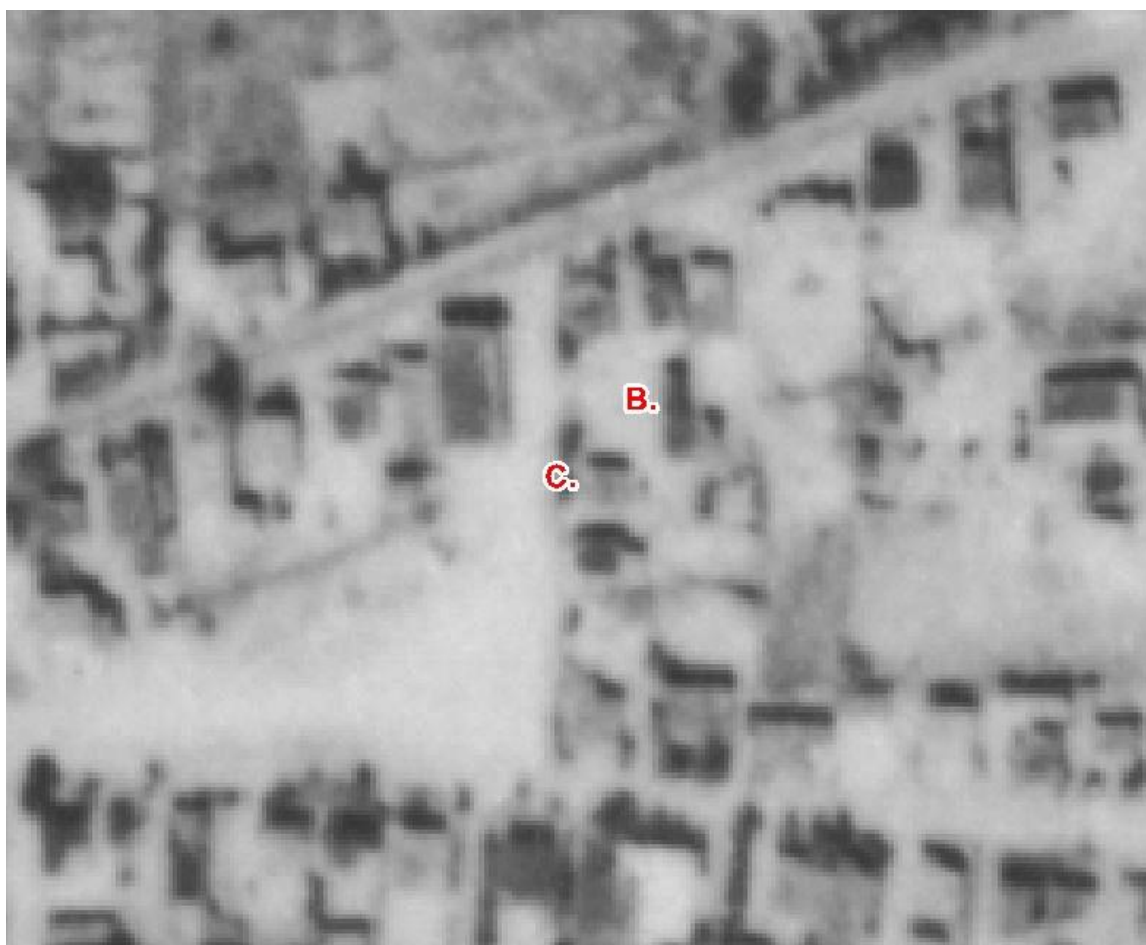
**Figure 4: 1948 aerial photograph showing Units B and C on the site. Source: October 25, 1948, aerial photograph.**

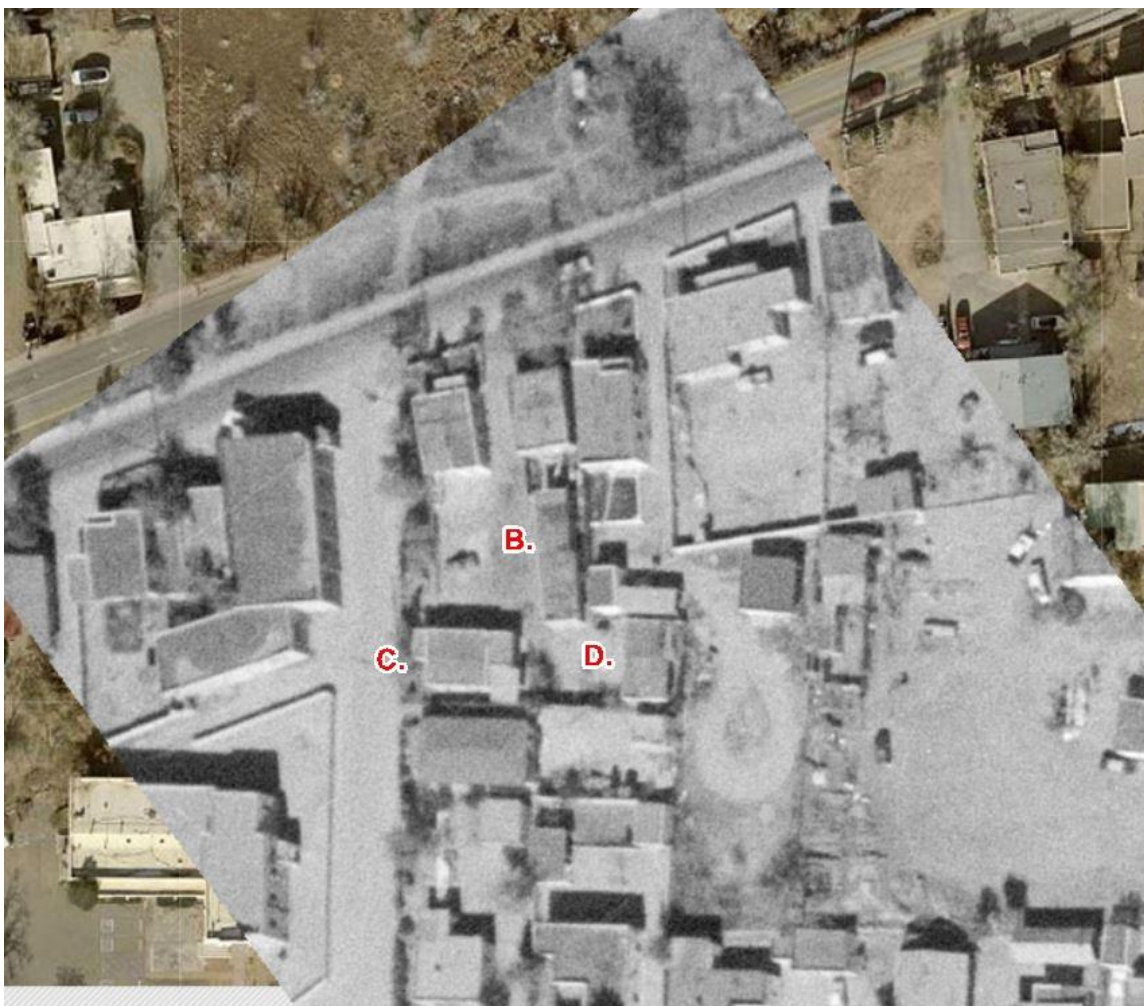
Figure 6: 1958 aerial photograph laid over current satellite image showing Units B, C, and D on the site. Source: November 10, 1958, aerial photograph.

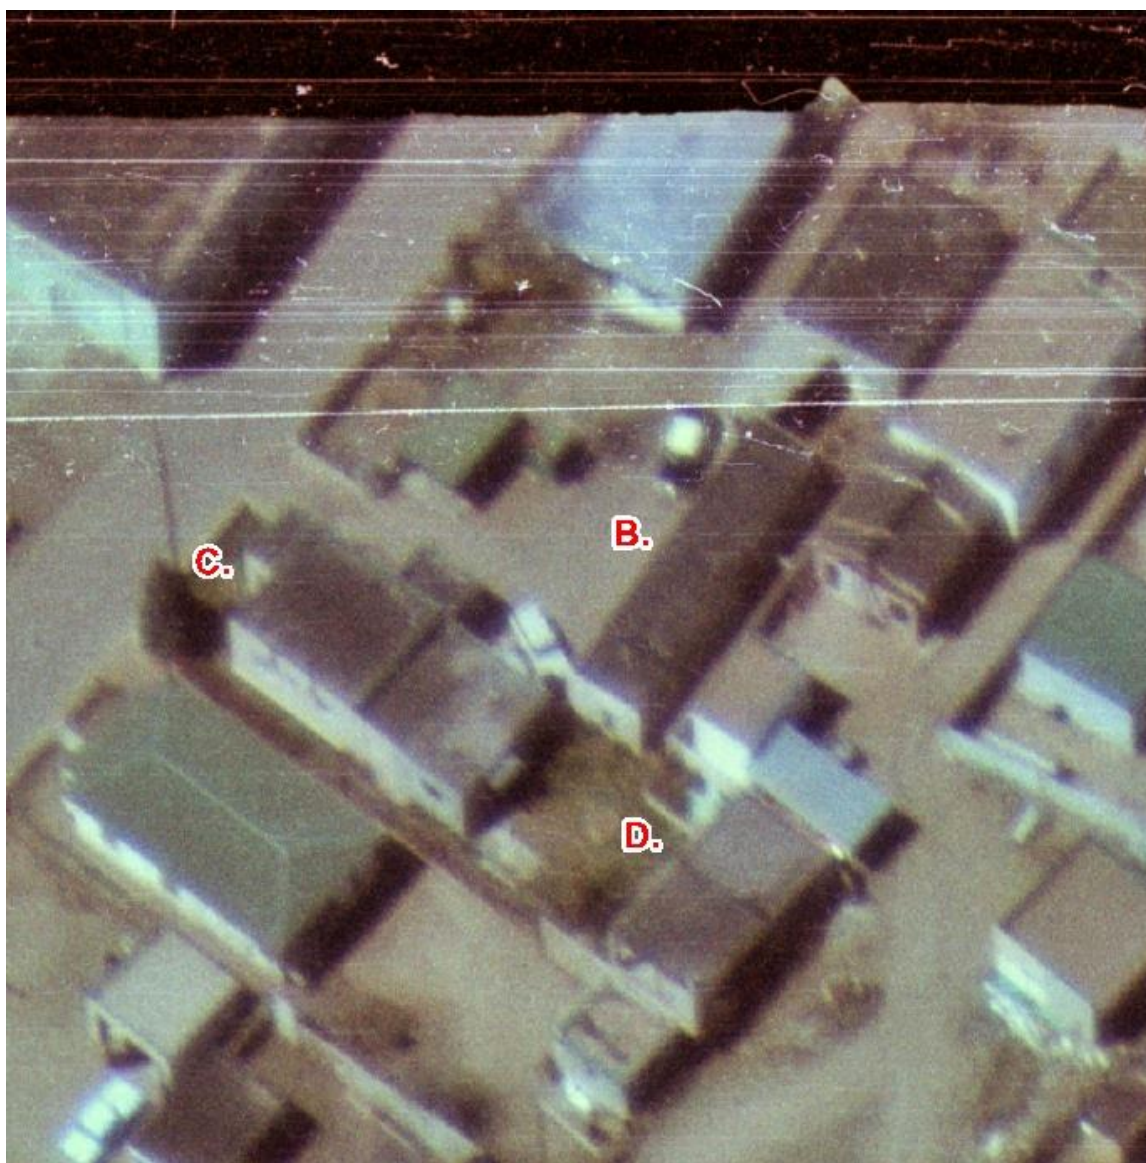
**Figure 7: 1969 aerial photograph showing Units B, C, and D on the site. Source: February 27, 1969, aerial photograph.**

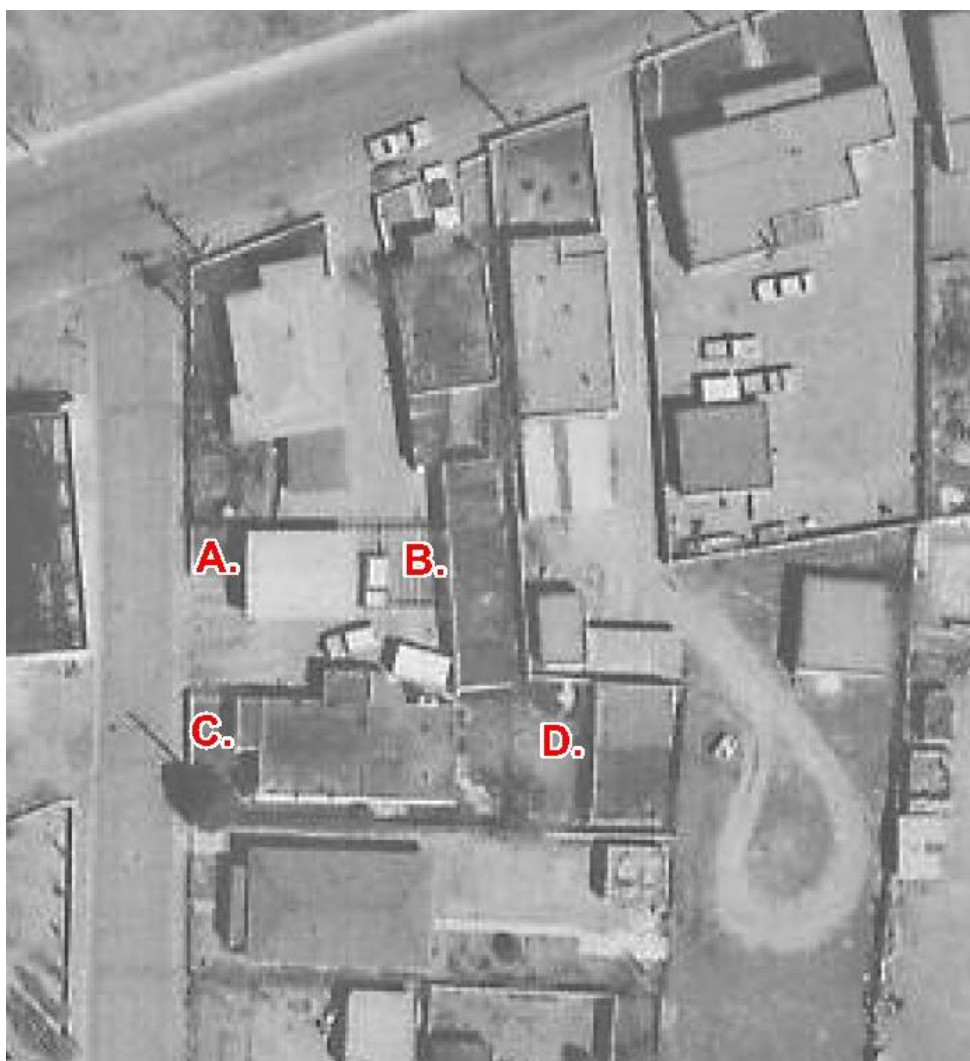
The west-facing façade retains the general form of the original dwelling while reflecting several post-construction modifications (Photo 2). The south portion of the façade contains a modern entry door and a large fixed-glass window (Photo 3). Prior to 1985, this portion of the façade functioned as an integrated carport (Fig. 8). The north side contains a vinyl sliding window that replaces an original aluminum unit.

Facing the interior courtyard, the west elevation has been substantially altered, based on comparison with the 1985 Historic Building Inventory photograph and surviving material evidence. The current entry occupies the location of a pair of wood double-hung sash windows visible in 1985 (Photo 7; Fig. 8). Elsewhere, the elevation contains few openings, several of which are filled in with glass block.

**Figure 8: 1975 aerial photograph showing Units A, B, C, and D on the site.**  
**Source: April 19, 1975, aerial photograph.**

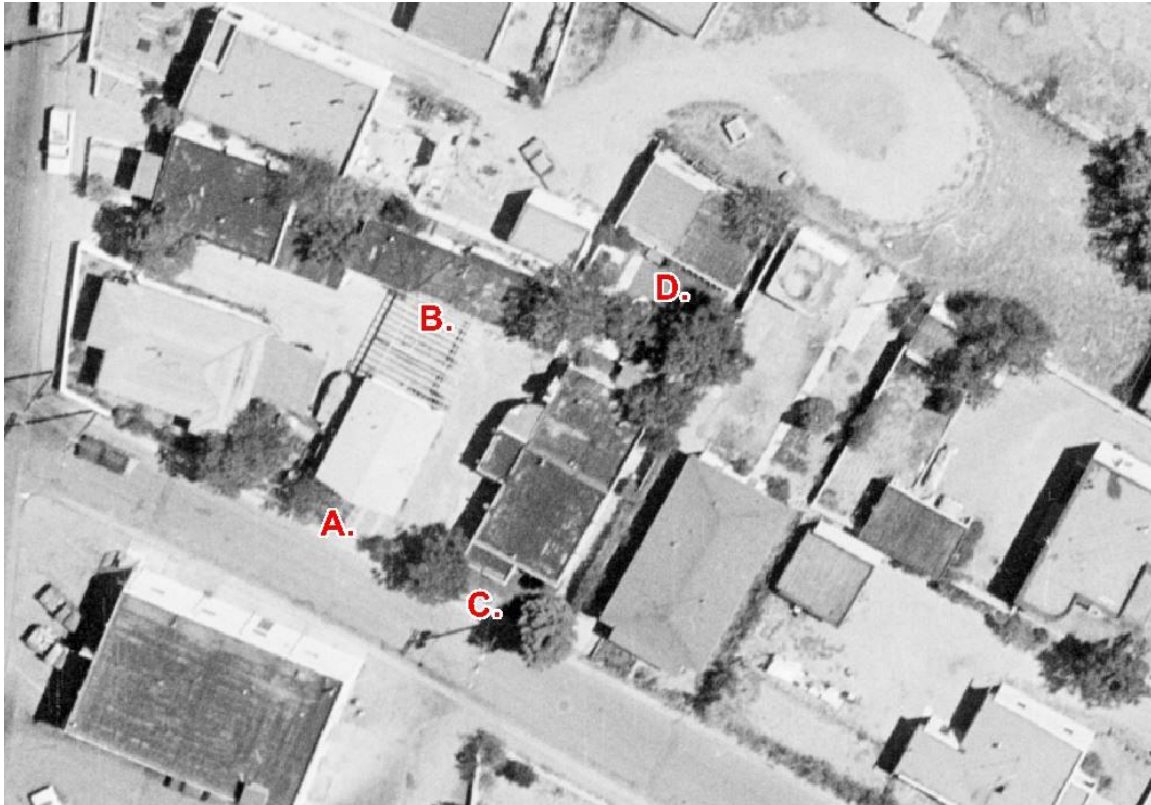
The front house at 405 Juanita Street is a relatively recent addition to the development history of the larger property, having been constructed in the early 1970s. The dwelling was subsequently expanded to the east and, sometime after 1985, its integrated carport at the front was enclosed (Fig. 9). Attached to the rear of the house is an older rectangular dwelling that, based on aerial photography, dates to at least the 1940s. It has long been used as an apartment. A portion of this building extends onto the adjoining parcel. By the early 2000s, both units were operating as a small apartment complex under the name Juanita Compound.

The house was surveyed in 1985. The survey photograph depicts 405 Juanita Street in its original configuration, with the open carport approached by a concrete ribbon driveway (Fig. 9).

**Figure 9: 1978 aerial photograph Units A, B, C, and D on the site. Source: September 11, 1978, aerial photograph.**

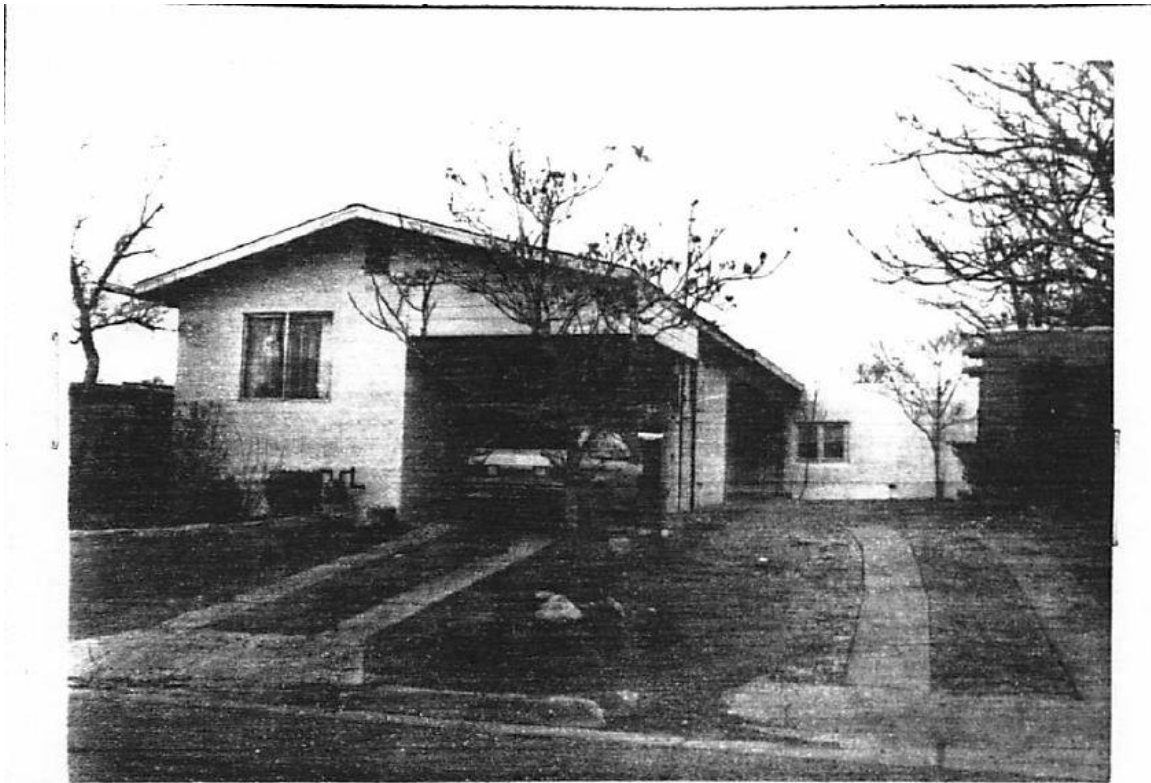
At some point after 1985, the carport was enclosed, a porch was added along the south elevation, and the original windows and doors were replaced. Although not acknowledged in the 1985 survey, a portion of the rear apartment building is visible in the background of the photograph. The visible section has a pair of double-hung sash windows at that time. Since then, the fenestration has been substantially altered, with openings modified, filled in, or replaced with glass block. The opening shown in the 1985 photograph was turned into a door.

**Figure 10: August 1985 HBI survey photograph showing original design to front and back buildings. Creator: Harry Weiss.**

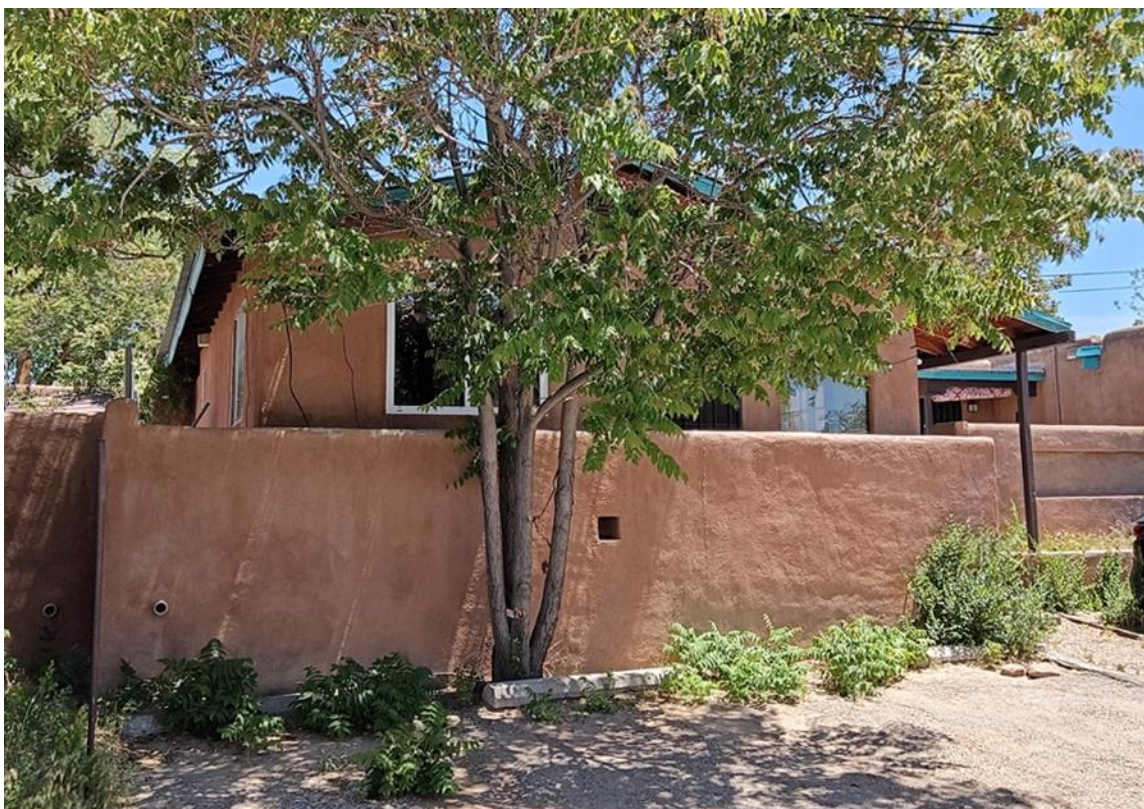
**Photo 2: West (front) elevation. Non-historic infill of carport at right and non-historic wall at center. Camera facing Southeast.**

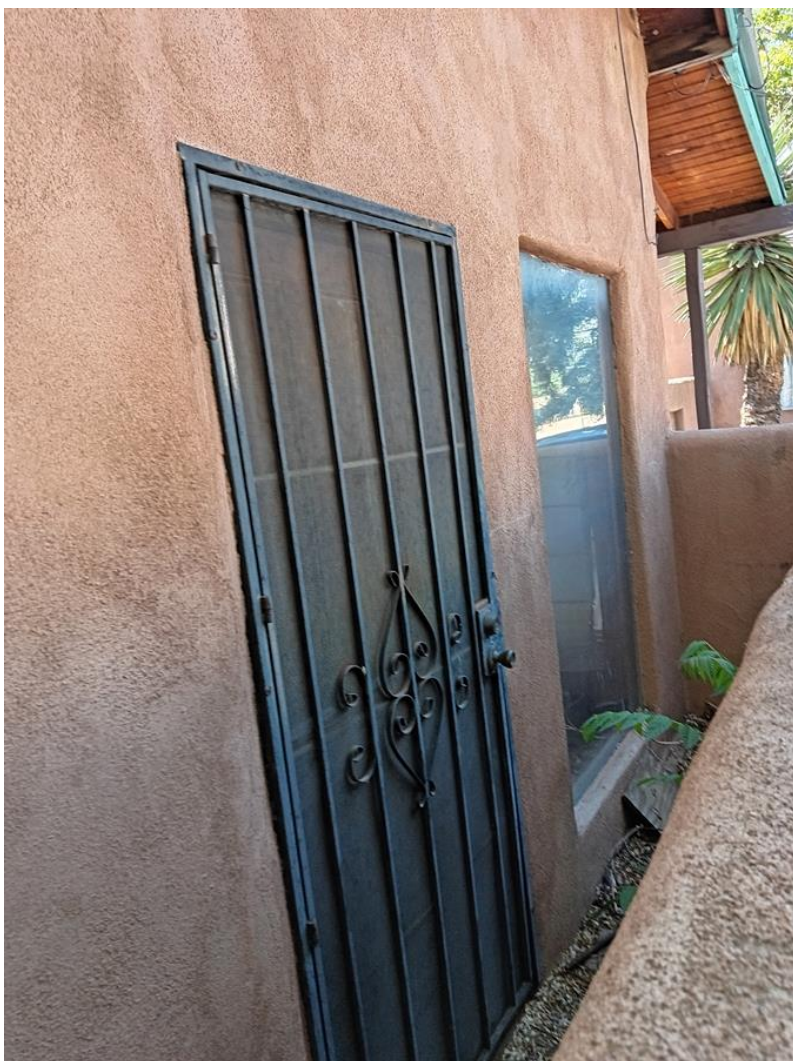
**Photo 3: West (front) elevation. Fenestration of non-historic infill of carport.  
Camera facing southeast.**

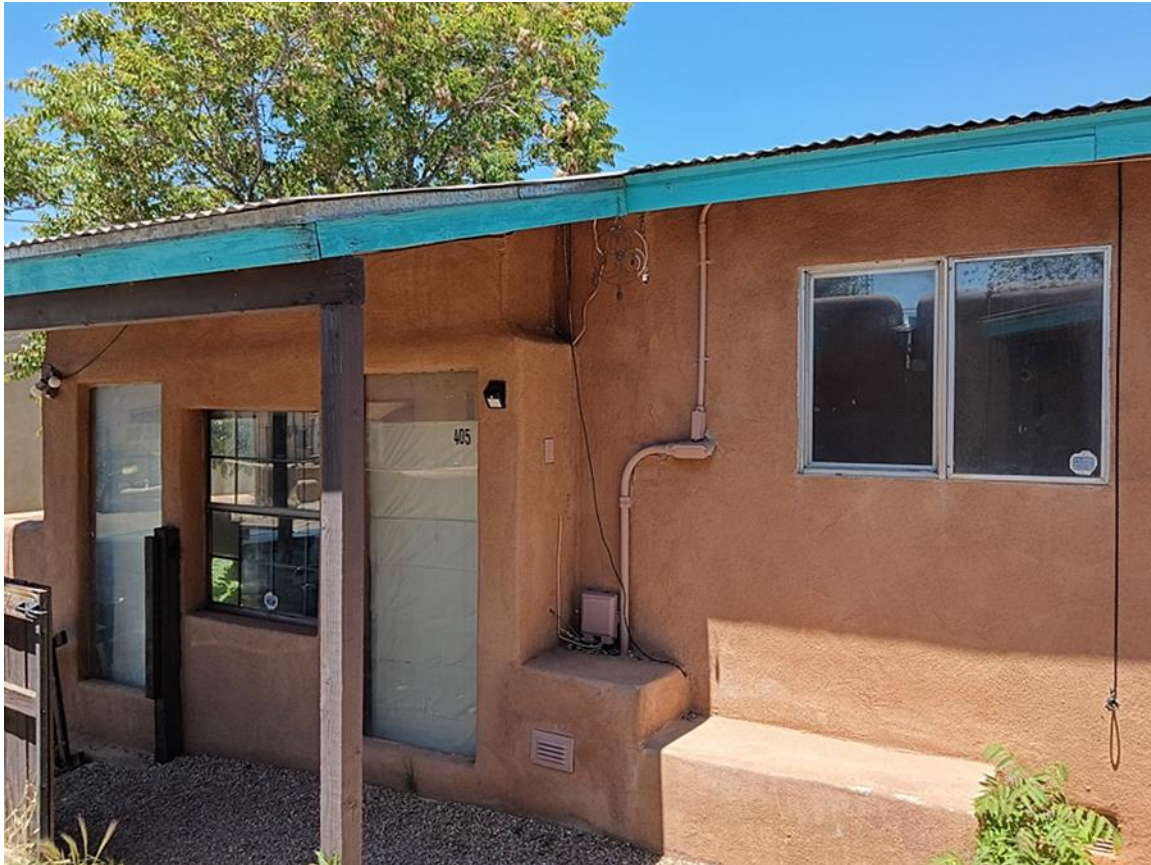
The south elevation faces a courtyard and circulation area serving the various units of the rental complex. The enclosed former carport contains two tall fixed-glass windows and an aluminum hung-sash window. It is sheltered by a non-historic porch (Photo 4). East of this enclosure is an original aluminum sliding window. Beyond are two storage bays, or former carports, that originally featured open slatted roofs (Photo 5). These have been modified with a solid gabled roof structure. The east end of the building connects to the older adobe dwelling.

**Photo 4: South elevation, west end. Non-historic infill of carport at right. Camera facing northwest.**

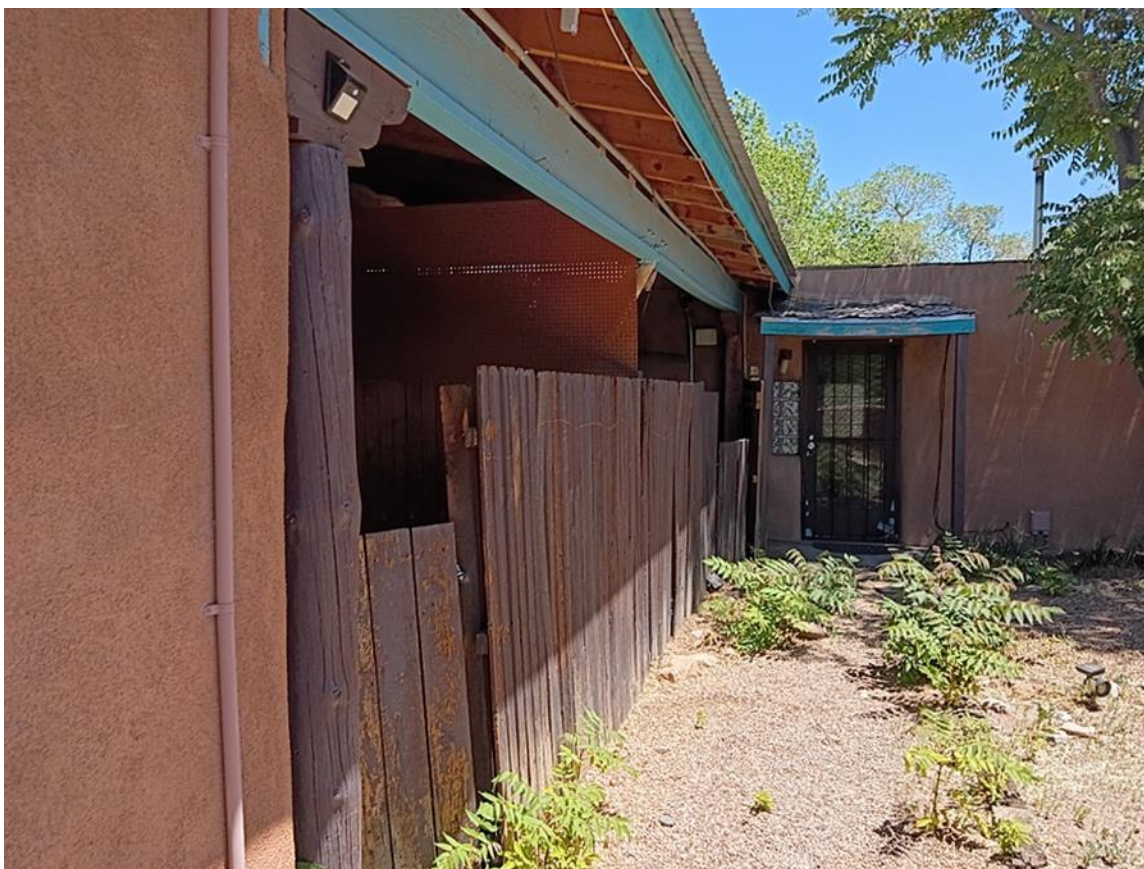
**Photo 5: South elevation, east end. Nonfunctional carports, left; altered fenestration of earlier apartment, center. Camera facing east.**

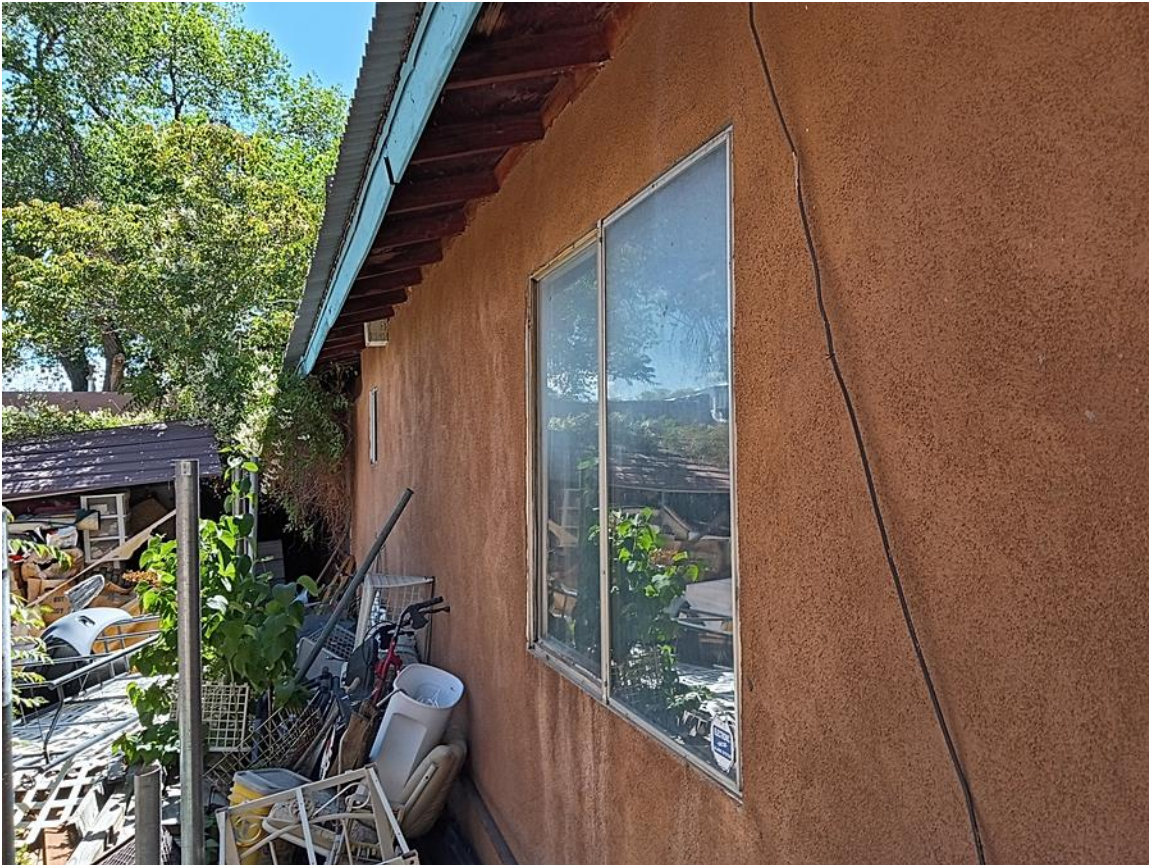
The north elevation faces an adjoining property and contains a single aluminum sliding window (Photo 6).

**Photo 6: North elevation. Camera facing southeast.**

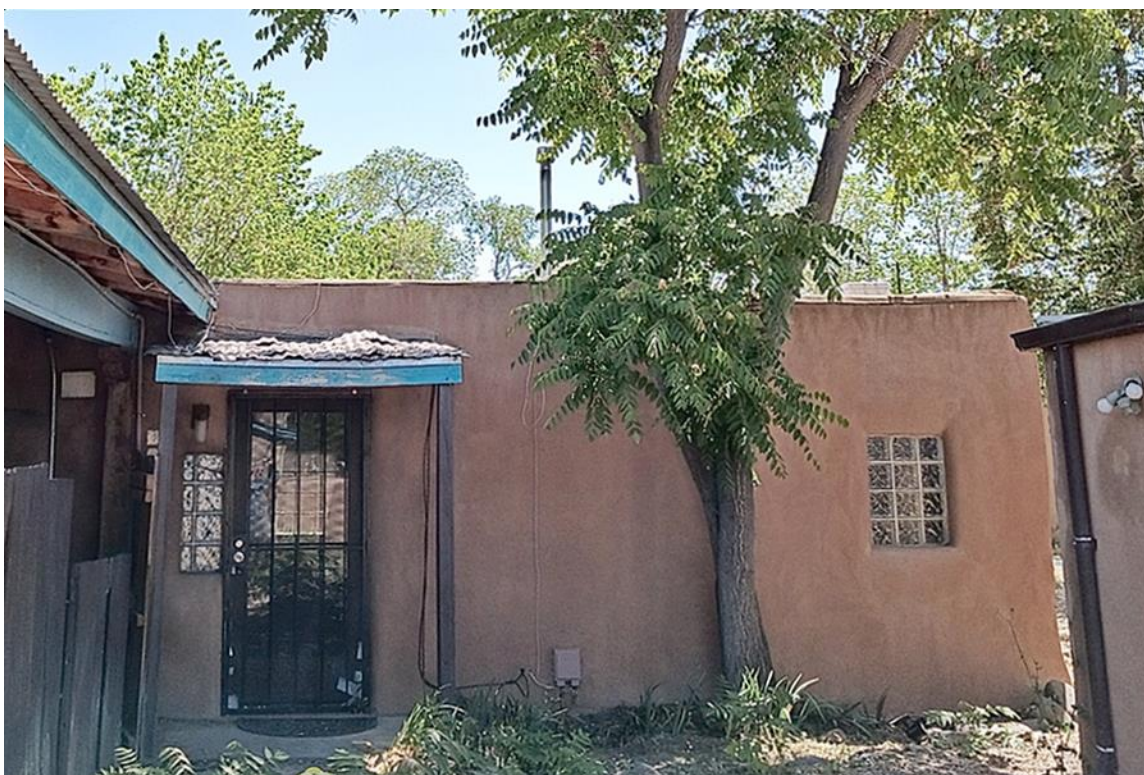
**Photo 7: West elevation, south end. Camera facing east.**

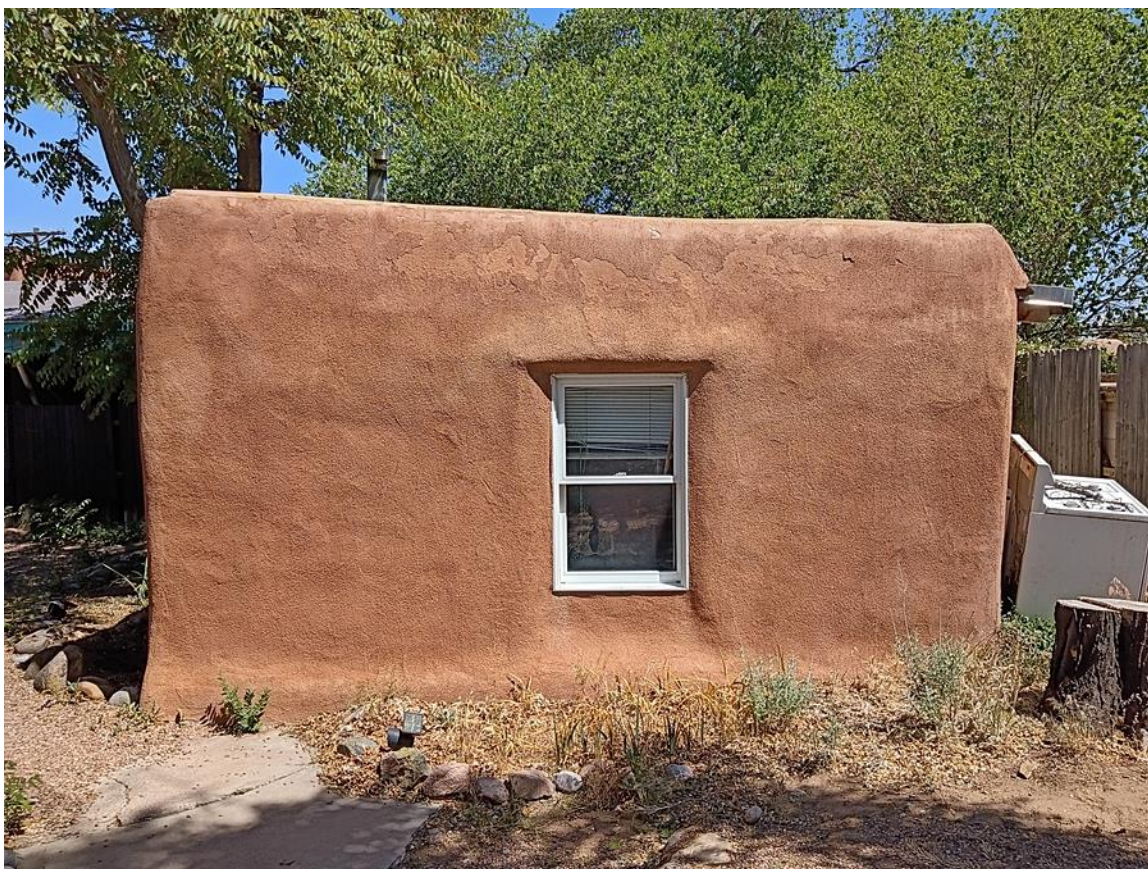
The short south elevation has a single vinyl one-over-one hung-sash window (Photo 8).

Photo 8: South elevation. Camera facing north.

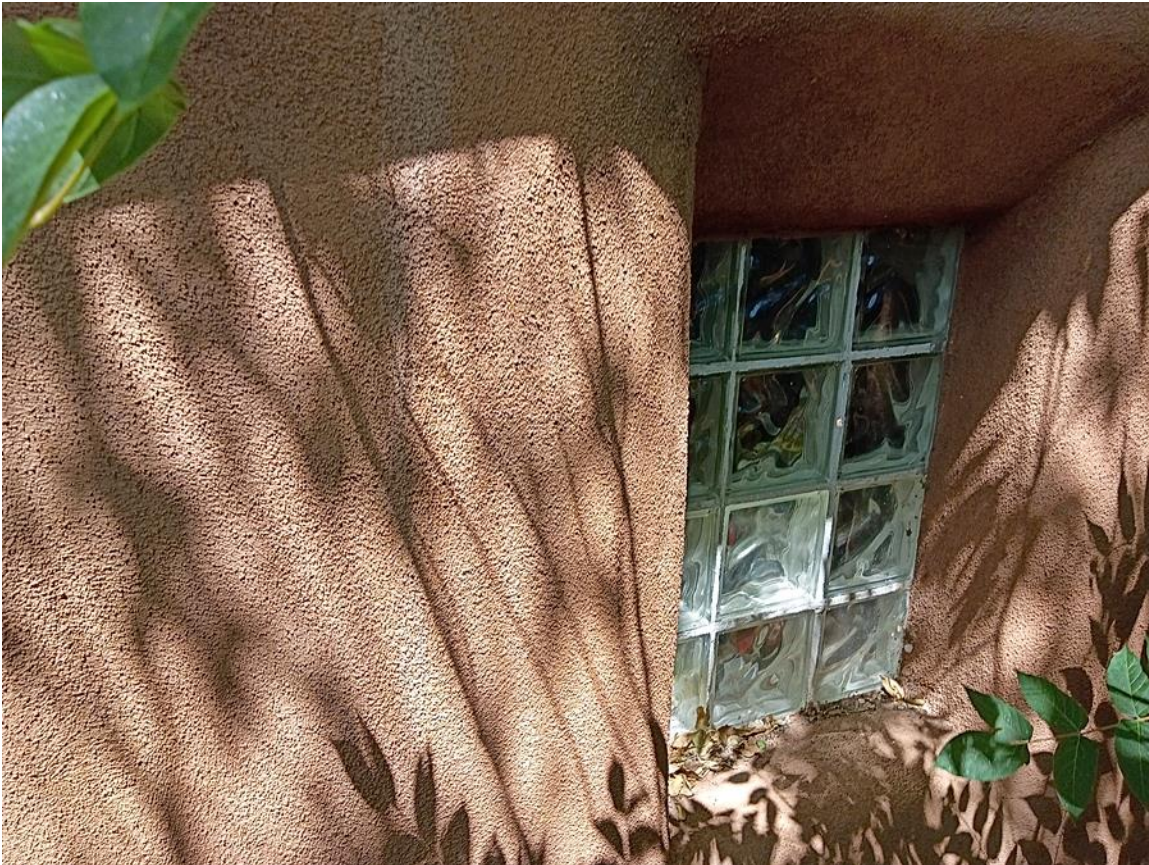
The east elevation is situated close to the east property wall. It is fenestrated with two openings infilled with glass block (Photos 9 and 10). To the north, the building extends across the property line onto a separately owned parcel.

**Photo 10: East elevation opening infilled with glass block. Camera facing down.**
