NEW MEXICO HISTORIC BUILDING INVENTORY - SANTA FE RESURVEY

ADDRESS: *826 AGUA FRIA STREET*

NEW MEXICO HISTORIC BUILDING INVENTORY FORM

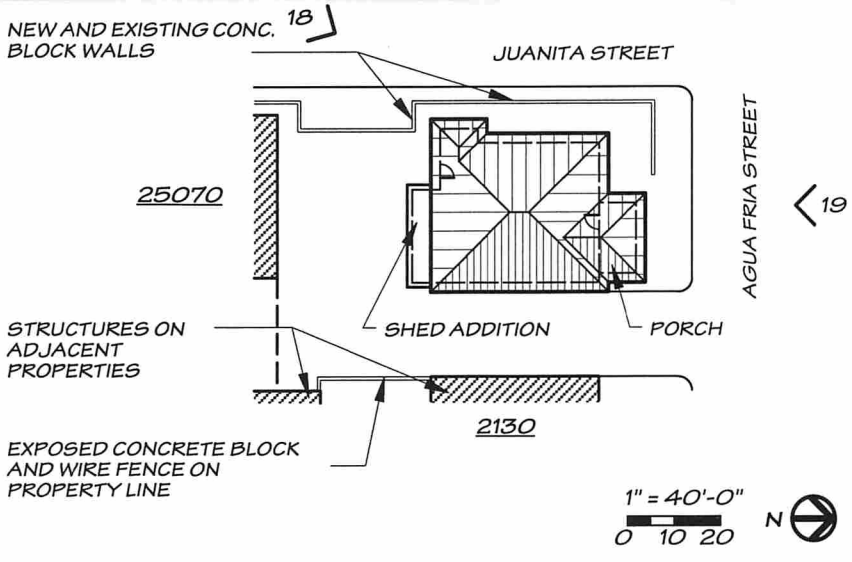
PHOTO

EXPLAIN: *SHED ADDITION; CHANGE DOORS AND WINDOWS*

X FAIR ____ DETERIORATED

ROOFS & DRAINS	WOOD FRAMED, SHALLOW SLOPED HIP ROOF; WIDE EAVES (24" ±); GREEN, ROLL ASPHALT ROOFING; DETERIORATING PLYWOOD SOFFITS; SOME GALVANIZED METAL GUTTERS	
BUILDING WALLS	WHITE FLOATED STUCCO FINISH; SHED ADDITION ON SOUTHEAST CORNER OF STRUCTURE HAS PAINTED T-111 PLYWOOD FINISH	
FOUNDATIONS	ORIGINAL: UNDETERMINED WITH CONT. STUCCO BUTTRESS; ADDITION: CMU	APPROX. HEIGHT (FT.) 14'-0" ±
DOORS	3/5 TRUE DIVIDED LITE WOOD FRENCH FRONT DOOR; PLAIN WOOD REAR DOOR	
WINDOWS	MIXTURE OF WINDOW TYPES: MANY ORIGINAL PAINTED 3/1 WOOD DHW; A FRONT WINDOW HAS BEEN REPLACED WITH A LARGE FIXED SINGLE PANE WINDOW; THE SHED ADDITION HAS SMALL ALUMINUM FRAMED WINDOWS; A WEST WINDOW HAS A 1960'S ± ALUMINUM AWNING	
PORCHES OR PORTALES	ORIGINAL PORCH ON FRONT OF HOUSE WITH "L" SHAPED STUCCO COLUMNS, BEADED BOARD CEILING, EXPOSED CONCRETE FLOOR, AND DETERIORATING PLYWOOD SOFFITS; A DECORATIVE METAL COLUMN HAS BEEN ADDED TO THE SOUTHWEST CORNER OF THE STRUCTURE; THIS FEATURE MAY HAVE BEEN ADDED OR ENCLOSED IN THE 50'S OR 60'S

ARCHITECTURAL DETAILS	THE HOUSE HAS MINIMAL DETAILS WITH THE EXCEPTION OF THE EXTENDED EAVES AND ORIGINAL WINDOWS	
FENCES/WALLS	THE SOLAR SCREEN CONC. BLOCK WALL (1985 SURVEY) HAS BEEN STUCCOED OVER; A WOOD FENCE HAS BEEN ADDED ON TOP OF THE WEST WALL; EAST NEIGHBOR HAS A NEWLY STUCCOED WALL	
SITE FEATURES	NOTHING OF NOTE	
OTHER/ COMMENTS	A LOW SLOPED SHED ROOF ADDITION HAS BEEN PLACED ON THE SOUTHEAST CORNER OF THE ORIGINAL STRUCTURE; THE AGE IS UNDETERMINED EXCEPT THAT IT WAS NOT NOTED ON THE 1985 SURVEY; A CARPORT IN THIS LOCATION NOTED ON THE 1985 SURVEY HAS BEEN REMOVED; THE PROPERTY SHOWS SIGNS OF NEGLECT ALTHOUGH THE STRUCTURE DOES NOT SHOW SIGNS OF BEING THREATENED; THE HOUSE WAS SOLD APPROXIMATELY A YEAR AND A HALF AGO WHEN THE ORIGINAL OWNER DIED; SOME INTERIOR REMODELING HAS OCCURRED SINCE ACCORDING TO A NEIGHBOR (ALFONSO LARRAGOITE), DURING THE 1930'S, THE ENTIRE ROOF STRUCTURE WAS LIFTED FROM THE BUILDING DURING A WINDSTORM AND LANDED UNDAMAGED IN A FIELD ACROSS AGUA FRIA STREET. A GROUP OF NEIGHBORS LIFTED THE ROOF BACK ON THE HOUSE.
