Re: Status review of structures at 1545 Upper Canyon Rd.

Historic Cultural Properties Inventory (HCPI) Base Form (FORM 1)

Lynch Family Property
Former Lynch Fence Company

8. Name of Project:
HDRB Status Evaluation

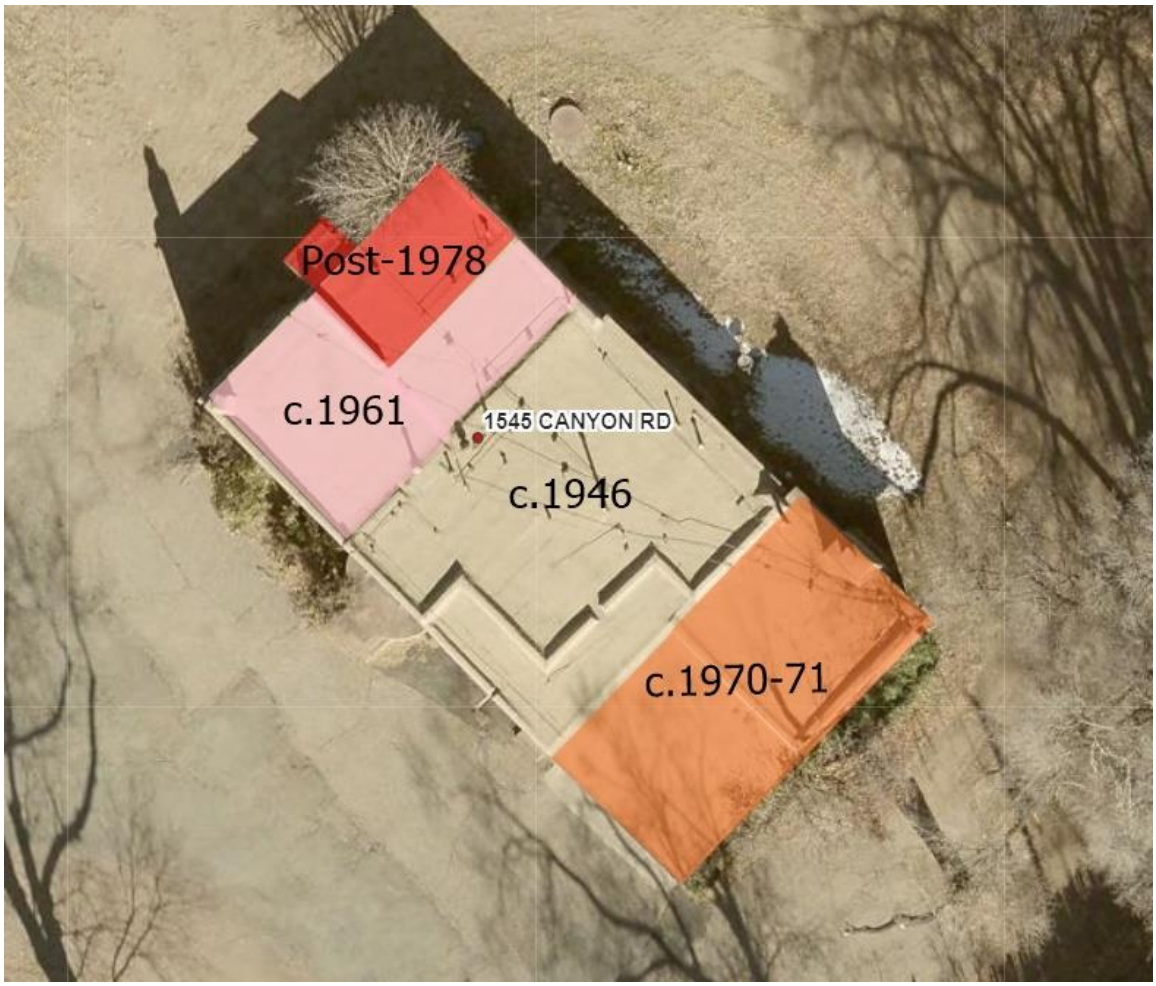
Figure 1: Building expansion based on aerial photographs and family memory.

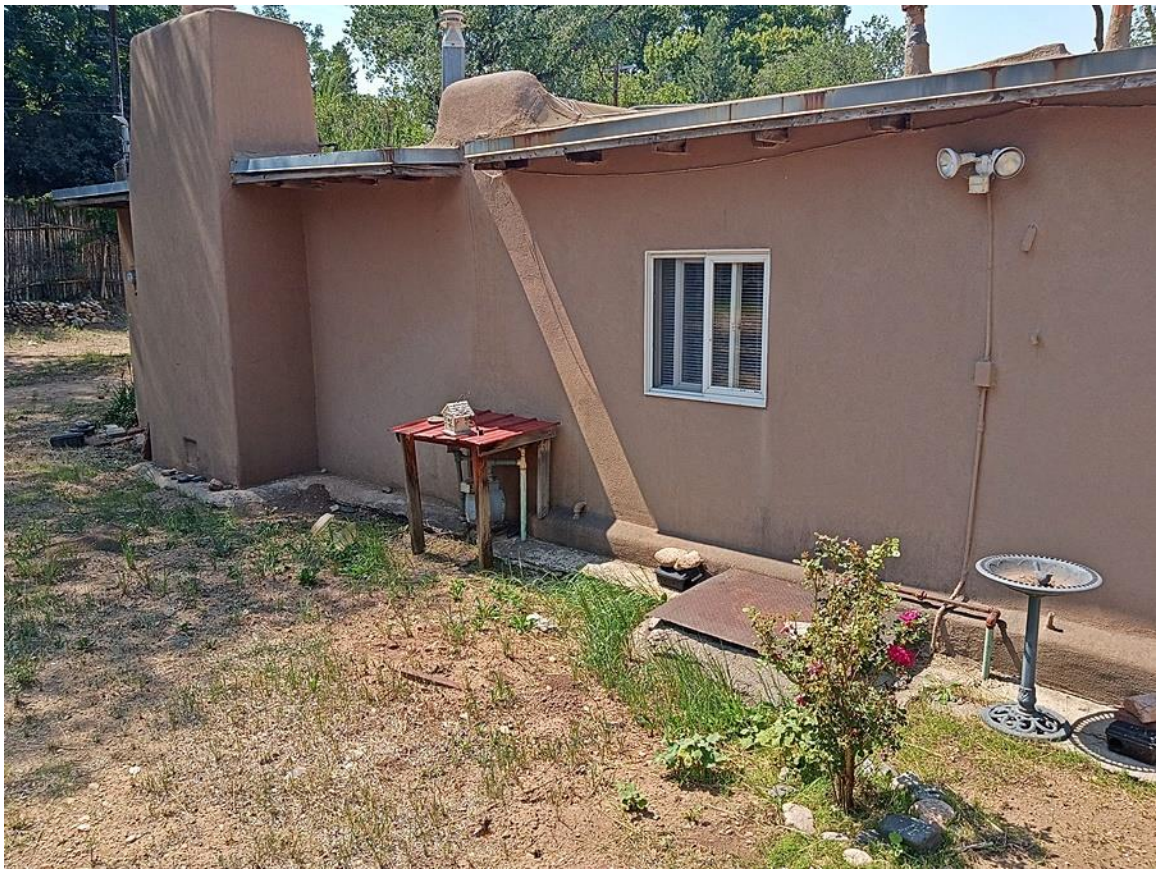
The southernmost section represents the early 1970s addition (Photo 15). It is marked by a stout exterior stuccoed chimney and a metal-fascia-clad overhang.

Photo 15: East elevation, south end. Camera facing southwest.

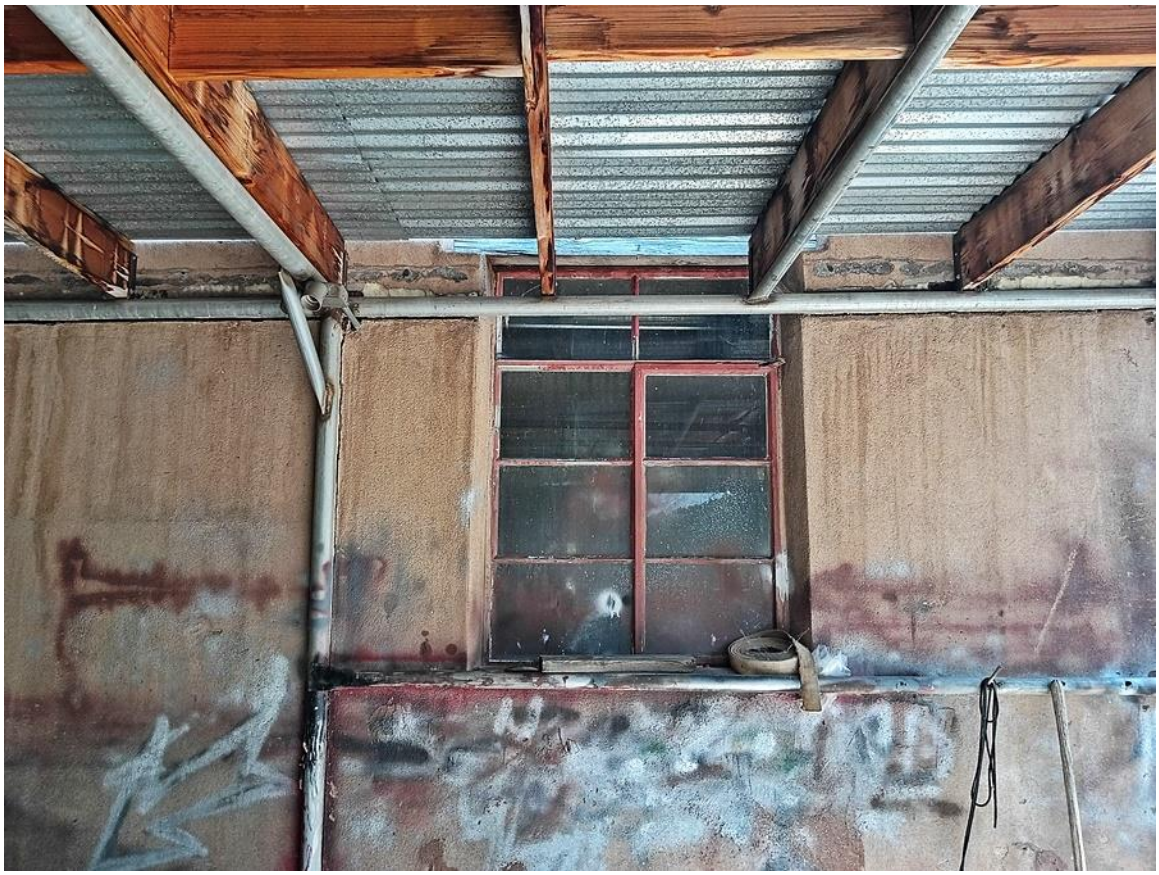
The carport shelters the west elevation (Photo 19), which includes an older steel casement window (Photo 20) and a wood pedestrian door with its openings covered by painted plywood (Photo 21). This older fenestration, along with an older door and

window on the north elevation, was reportedly salvaged from a rental owned by William Lynch.[2]

Photo 20: West elevation, window. Camera facing northeast.
