NEW MEXICO HISTORIC BUILDING INVENTORY - SANTA FE RESURVEY 1996

ADDRESS: 610 Agua Fria

SANTA FE ID NUMBER: H 169.0

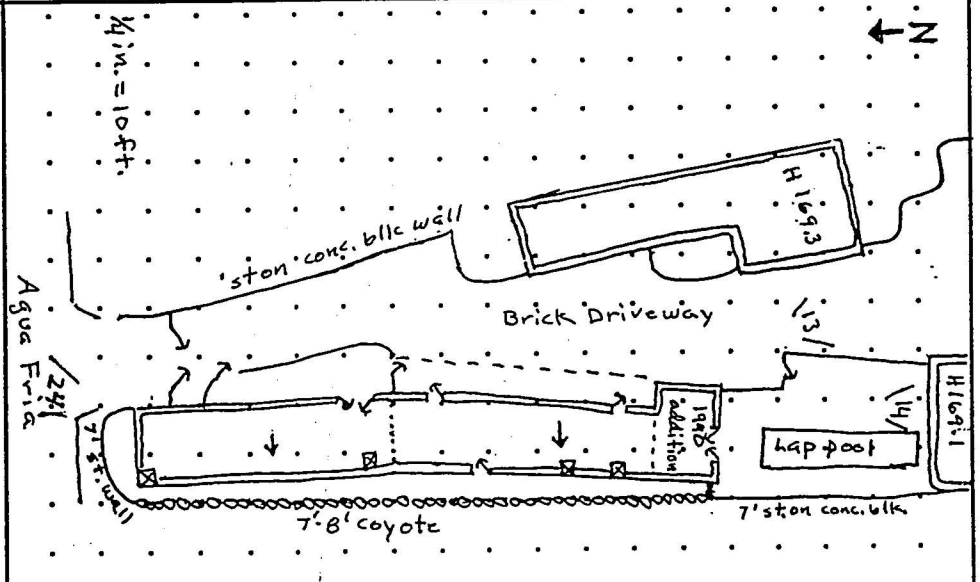
#24 North Elevation

EXPLAIN: New portal, stucco, windows, doors 1990.

X EXCELLENT ____ GOOD

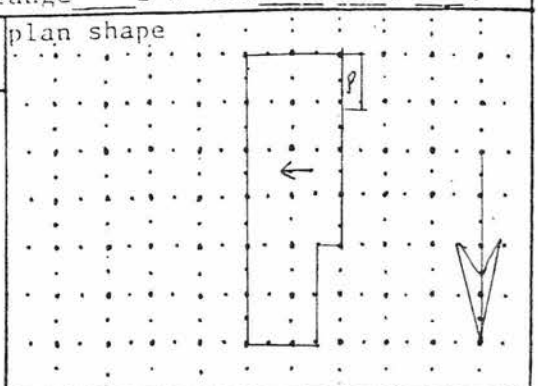
location description: 610 1/2 AGUA FRIA

condition
___ excellent ✓ good
___ fair ___ deteriorating

degree of remodeling
✓ minor ___ moderate ___ major
describe:

architectural features
SIDED RF TO E. BOXED WD EAVE.
12 LIGHT WD CASM'TS.
1 TRIP 3/1 WD CASM'T 1 TRIP 4/1 WD CASM'T.
1 FLANKED IS LIGHT SGL LF DOOR.
1 8 LIGHT SGL LF DOOR.
1 3 LIGHT SGL LF DOOR
SIMPLE FRAME PORCH ON REAR END.

comments
NOT ON KING'S, SF DIR UNCLEAR.
APPEARS TO HAVE GROWN N → S.
