NEW MEXICO HISTORIC BUILDING INVENTORY - SANTA FE RESURVEY 1996

ADDRESS: 613 W. San Francisco (NW corner at Candelario)

NEW MEXICO HISTORIC BUILDING INVENTORY FORM

613 W. SAN FRANCISCO

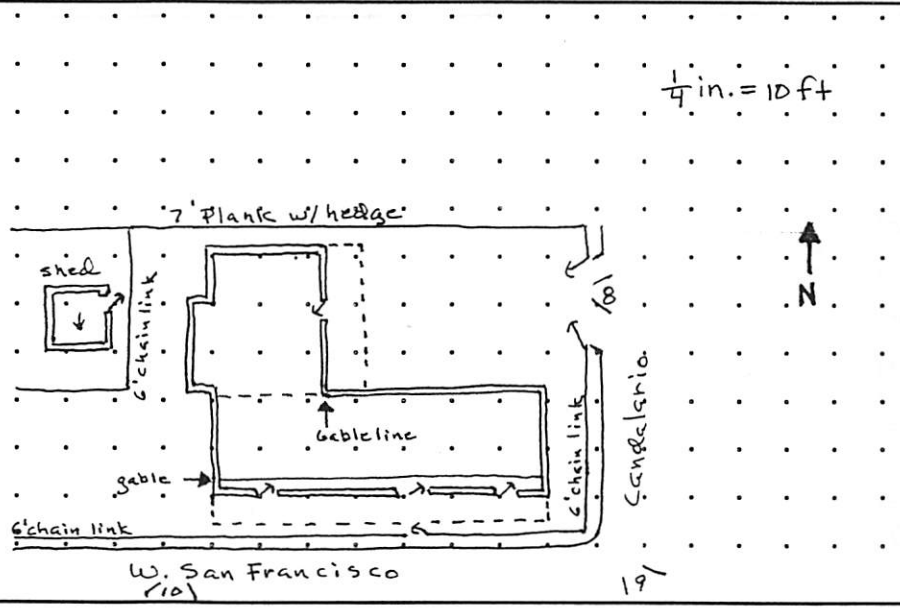
#9 South Elevation & South end of East Elevation

EXPLAIN: roof not original but owner (60yrs plus) says it has been like that all his lifetime

___ EXCELLENT X GOOD

ROOFS & DRAINS	Offset gable of corrugated metal, propanel at rear.
BUILDING WALLS	Stucco, painted white, on adobe, front portion double adobe walls.
FOUNDATIONS	not visible — APPROX. HEIGHT (FT.) 14 ft
DOORS	Wood 3 lights 4 panels; Wood 1 light 4 panels; Wood 13 panel; Solid wood 3 lights. Wrought iron screen doors.
WINDOWS	Recessed aluminum sliding units flanked by wood shutters painted turquoise. 1 picture flanked w/sliding, as above. Wrought iron grilles.
PORCHES OR PORTALES	Gable roof extends out over front & rear porches, both have boxed ceilings, 4x4 posts, bancos extend the length of both, wrought iron balustrade, floor of concrete covered w/indoor-outdoor carpet.
ARCHITECTURAL DETAILS	Gable ends sheathed w/ seamed metal, recessed fenstration.
FENCES/WALLS	6' chain link fence & gates, covered w/vines. N. has 7' plank & hedge.
SITE FEATURES	
OTHER/ COMMENTS	At w. side is a storage shed of stucco on adobe, shed roof of corrugated metal pr. wd. 6 light casmt. windows. Sanborn maps do not cover this area.
