- h. **2025-011230-HDRB, 527 Agua Fria Street, Units 1, 2, and 3, Westlake-Guadalupe Historic District, contributing**, Osage Design Studio, agent for Neirika, LLC, owner, proposes to construct a 36 square foot addition, replace windows and doors, raise two sections of roofing, re-roof, stucco, and other repairs. Exceptions are requested to 14-5.2(D)(5)(a)(i)(ii)(iii) for the replacement of windows on primary facades, and to 14-5.2(D)(3)(a) for raising the roof of a contributing structure.

Renovation of an Existing Residential Structure

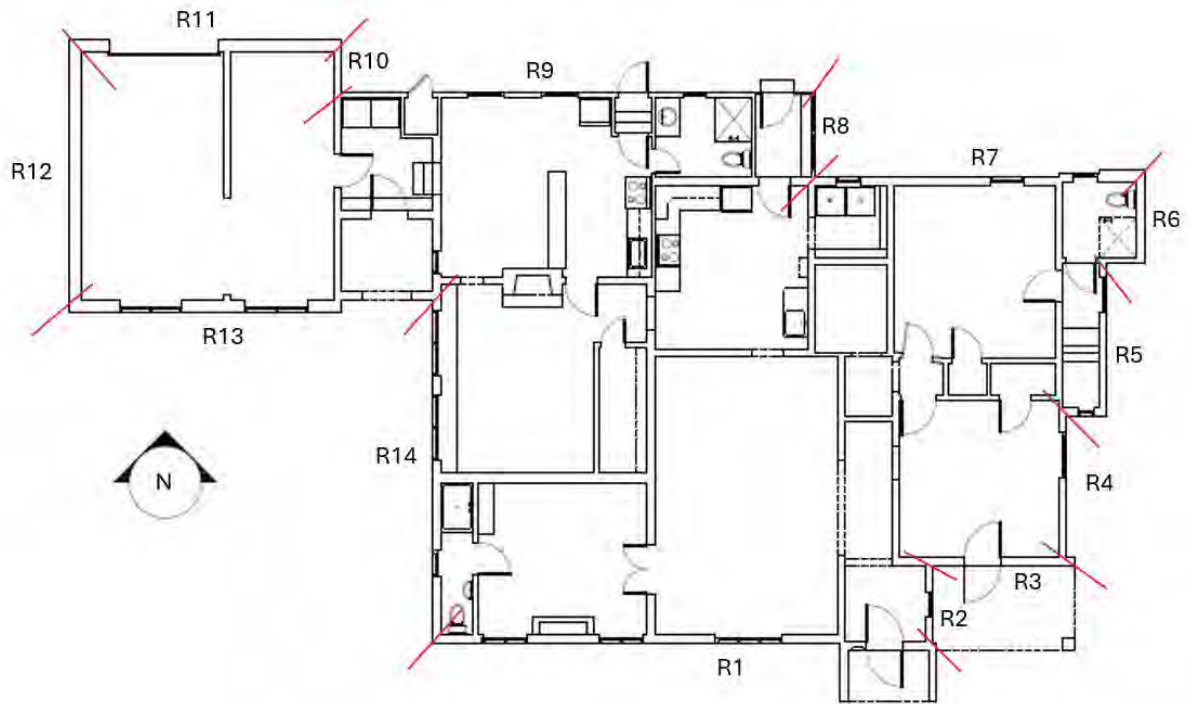
Figure 3: Façade Diagram

The 3,017 sq. ft. multi-family residence at 527 Agua Fria units 1, 2, and 3 sits on a 0.418-acre lot and was constructed by 1908 and is listed as contributing to the Westside-Guadalupe Historic District with the south and east elevations designated as the primary facades.

Ms. McCulley responded that they are the south elevation, larger sections and the entire east elevation.

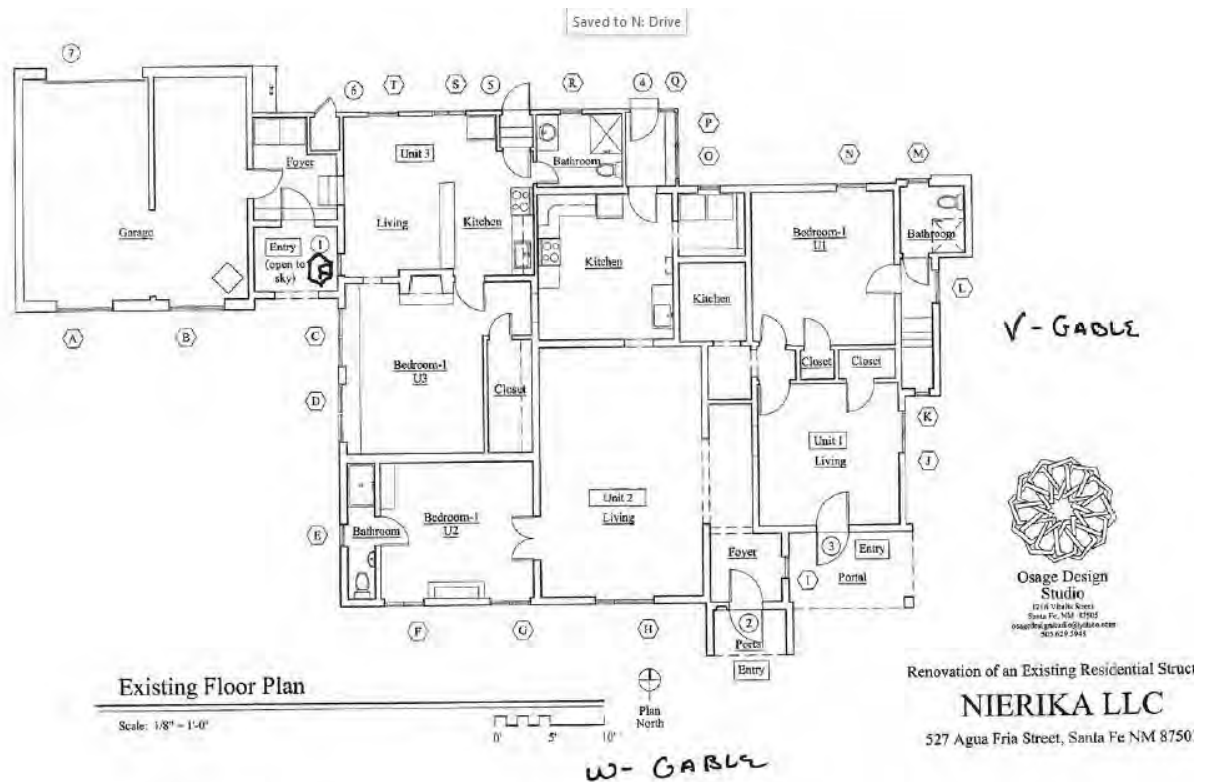
Figure 3: Window Schedule

- a. Window replacement in the same size opening at F, G, H, I, J, L, M, O, P, R, S, T, and V. Windows F, G, H, I, and J are historic and restorable. Window O is historic; however, unrestorable. Windows L, M, P, R, S, T, and V are non-historic. Windows F, G, H, I, J, and L are all located on primary facades.

- b. Window replacement with a new size at window E, which is a non-historic window, and not located on a primary facade.
  - c. Window Q will be infilled as part of the structural changes on the north elevation. This window is non-historic, and not located on a primary facade.

- l. The east and south gable diamond vents are to be replaced with metal louvered vents for attic exhaust, painted white to match the fascia. The east and south gable vents should open for venting; however, they have glass on the inside and do not vent to facilitate attic airflow.

**Exception to section 14-5-2(D)(5)(a):** The applicant requests an exception to replace historic windows F, G, H, I, J, and L, and doors 2 and 3 on primary facades.

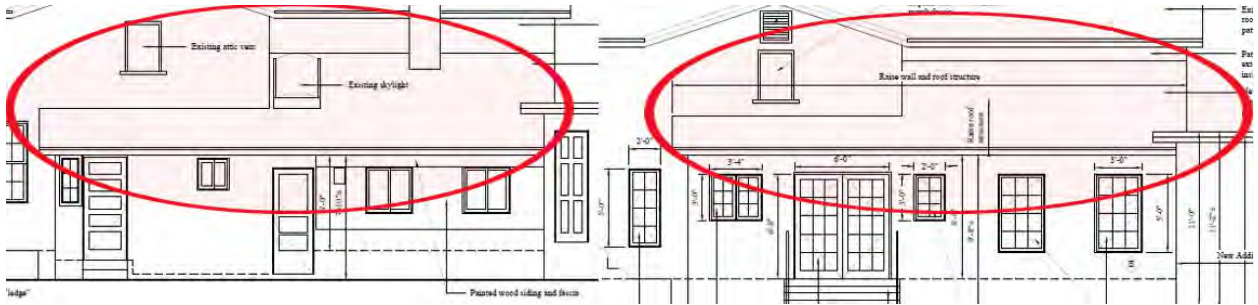
Figure 4: Area of Roof to be Raised on North Elevation

- 2) Raise the roof of the lower section of the north elevation, currently at 7'-10", to a height of 9'-8" and reroof to match the existing. The slope of the roof will be lessened to minimize the overall height change. This portion of the roof is not located on a primary façade.

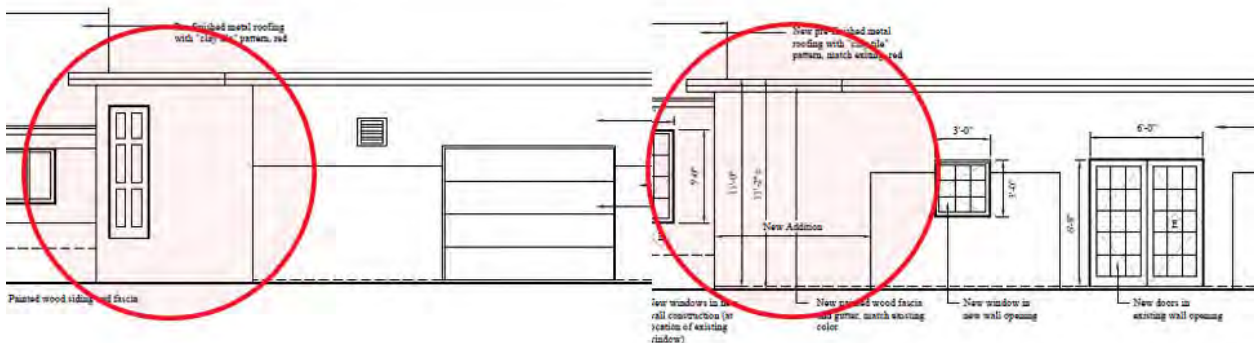
Figure 5: Area of Addition on North Elevation

- 3) Construct a 36. sq. ft. addition to a height of 11'-2", where the maximum allowable height is 17'-8" on the north elevation. The addition will have a pre-finished metal gutter, downspout, and rain barrel. The addition is not on a primary façade nor is it within 10' of a primary façade.

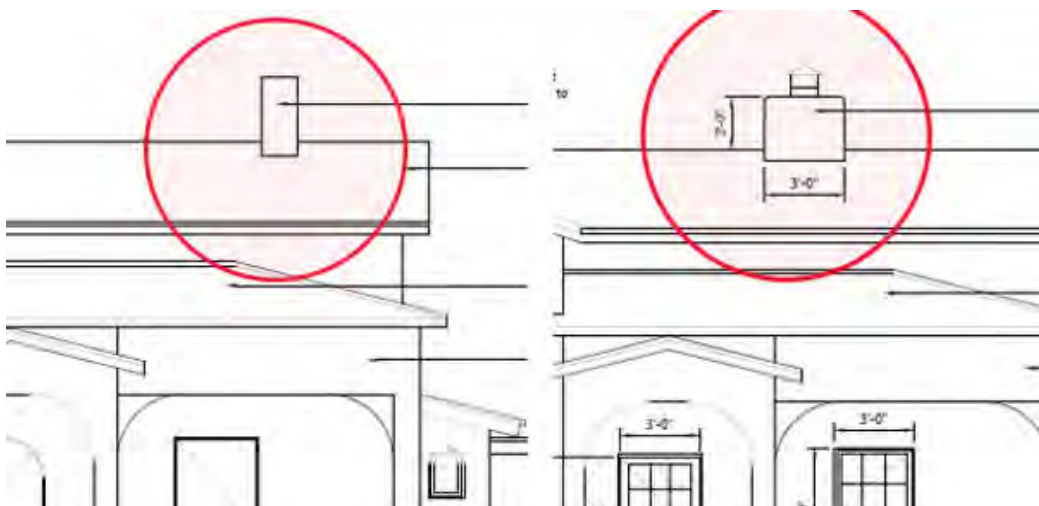
Figure 6: Area of Chimney on North Elevation

- 4) Replace a chimney to meet current fire code and remove the metal flue for the wood stove that is currently on the northwest roof area. The chimney and flue are not located on primary facades.

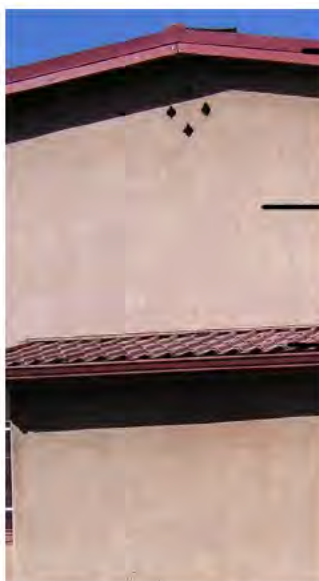
Existing wood and pre-finished metal fascia

Existing stucco

Existing pre-finished metal roofing with "clay tile" profile

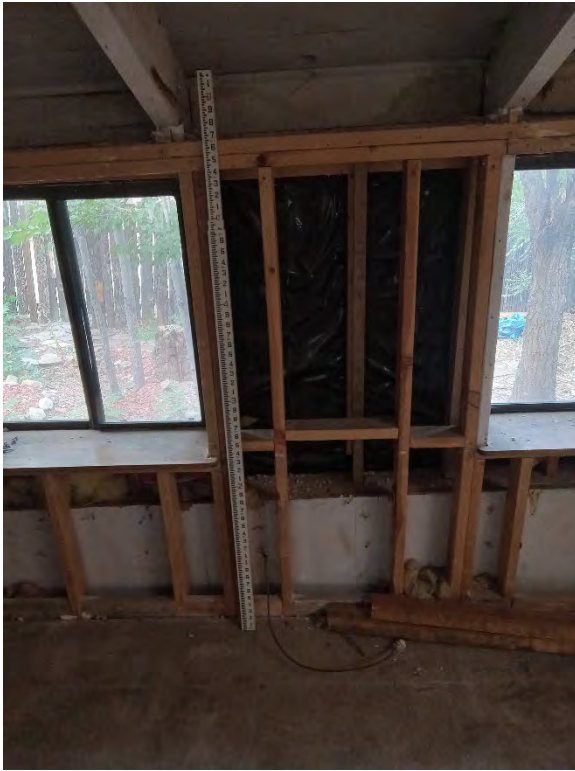
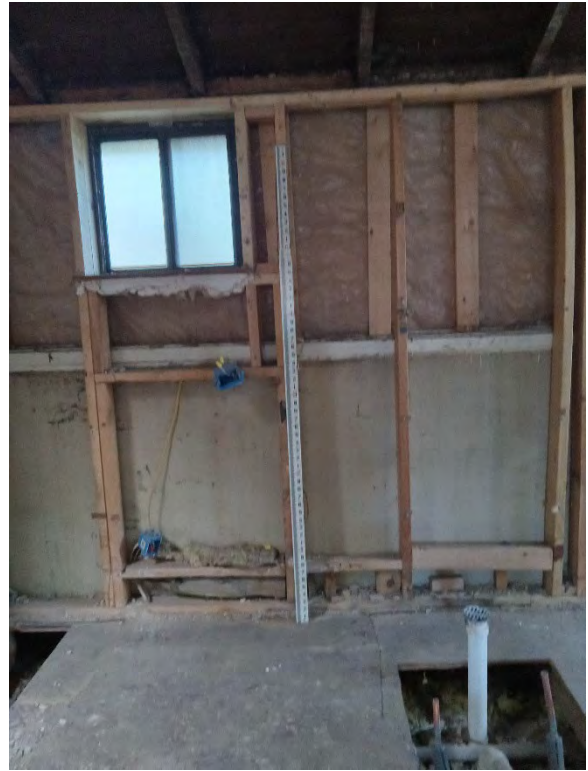
Photographs of interior along rear façade (north wall). White pole set at 6'-0" (disregard numbers on pole). Per code, minimum ceiling height of a habitable space is 7'-0"

Photo on left in area of proposed Bedroom-2. Approximate bearing to beams 5'-8".

Photo on right in area of proposed rear hallway. Approximate bearing is 6'-10". However, finish floor will be raised approximately 6" to match floor level of remainder of residence.

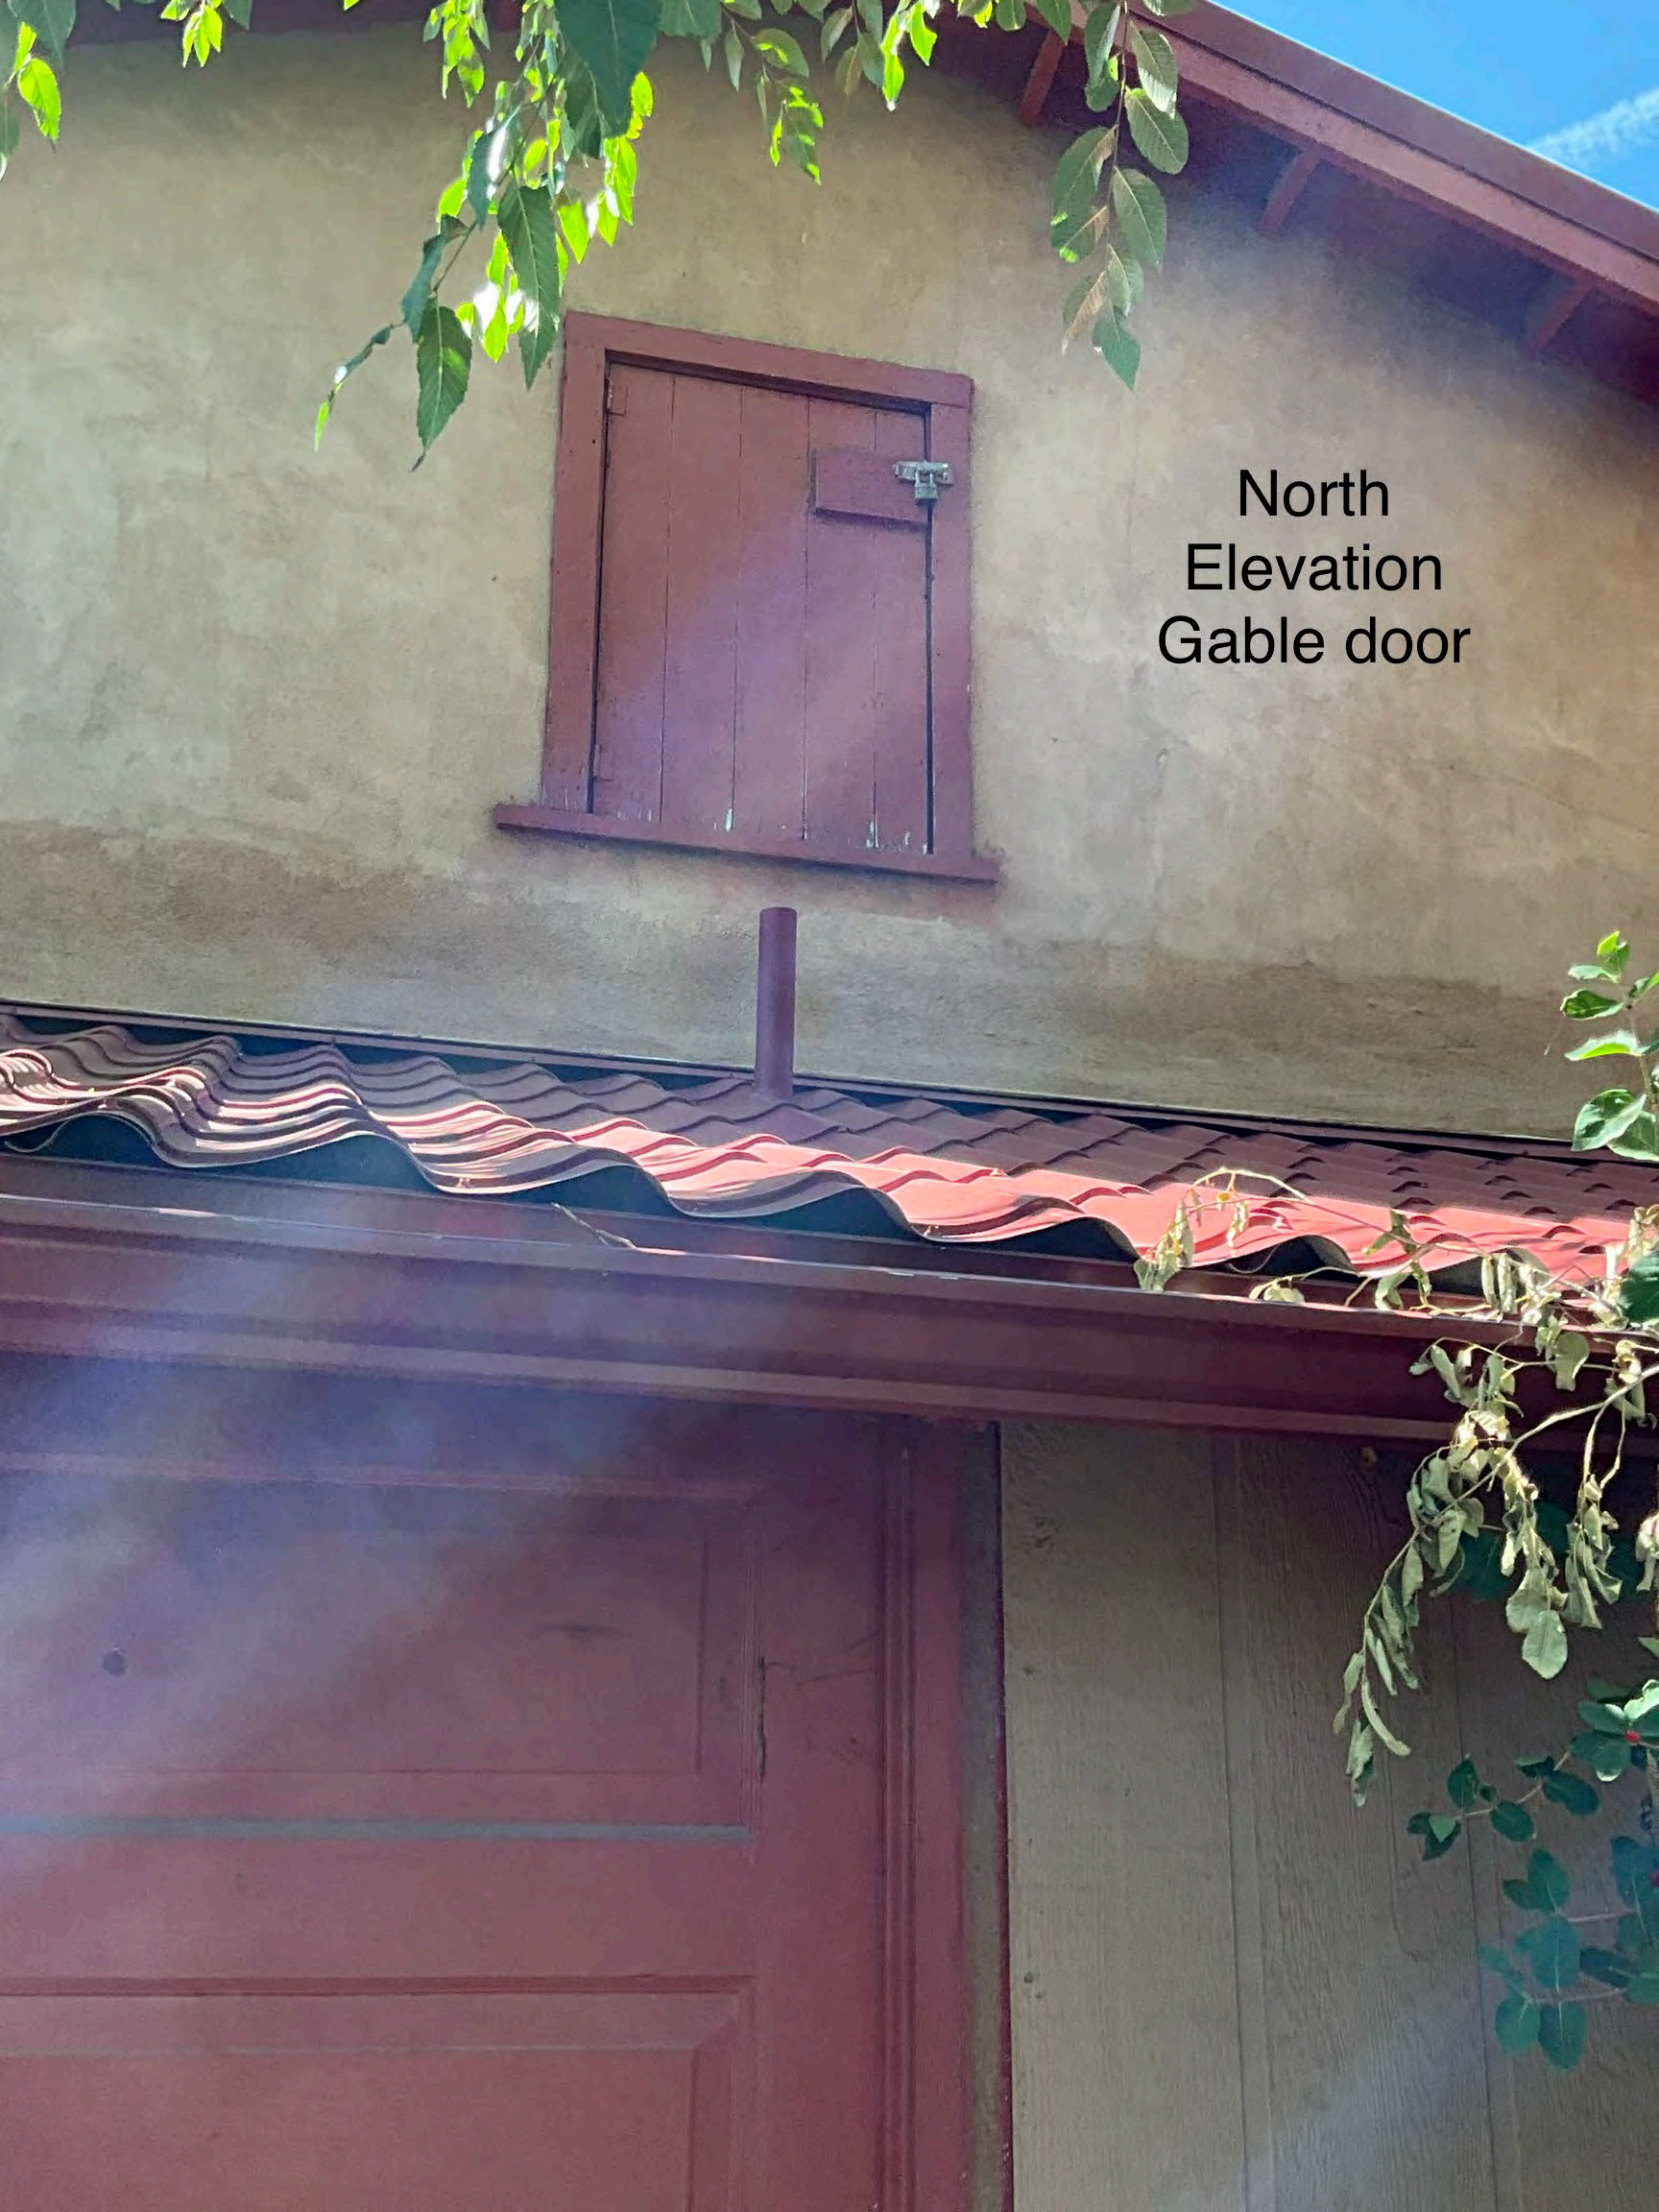
North  
Elevation  
Gable door

A photograph of the north elevation of a building. The upper portion features a light-colored, textured stucco wall. A dark brown wooden door is set into this wall, featuring a small window with a metal latch. Below the door is a dark brown metal roofline with a red, wavy corrugated metal roof. A dark brown downspout is visible on the roof. The lower portion of the image shows a dark brown wooden door with a panel design. Green foliage is visible in the upper left and lower right corners.

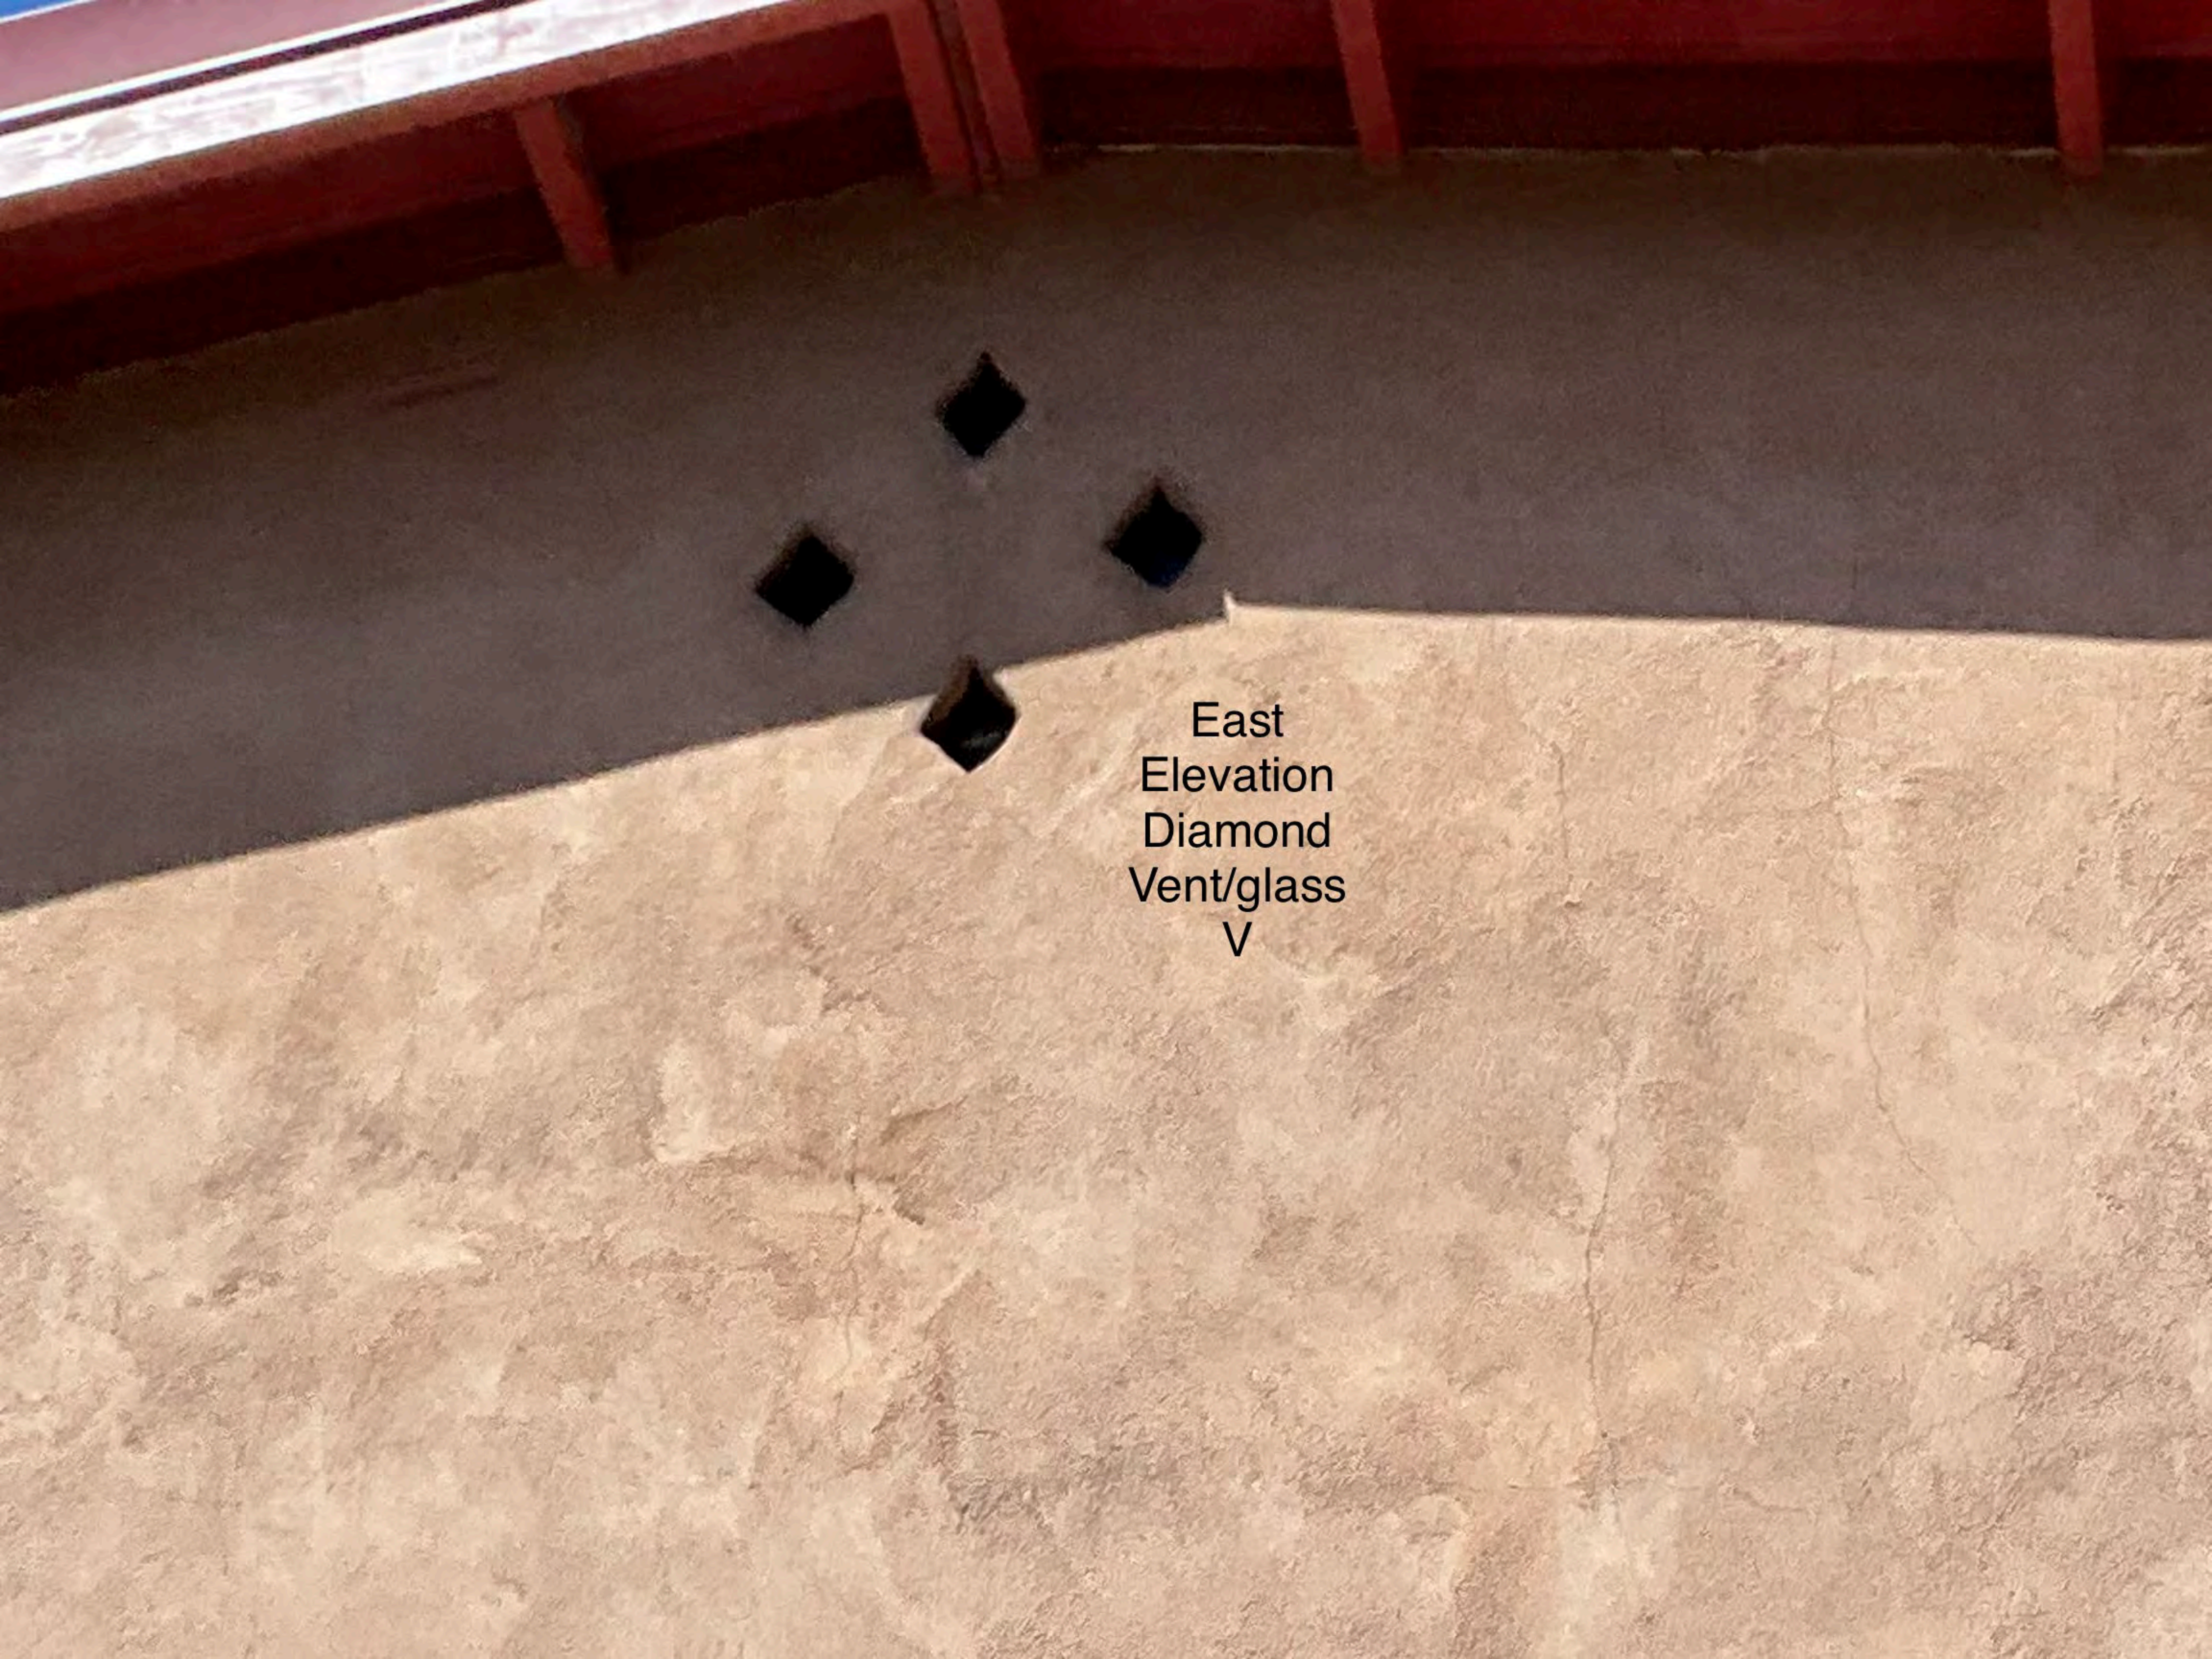
East  
Elevation  
Diamond  
Vent/glass  
V

The image shows a close-up of a curved, light-brown textured surface, likely a dome or vaulted ceiling. Four dark, diamond-shaped openings are visible, arranged in a cross pattern. The top of the image shows the underside of a wooden structure with reddish-brown beams. The text 'East Elevation Diamond Vent/glass V' is overlaid on the right side of the image.

1. Replace existing windows and selected exterior doors, including altering the size and location of fenestrations. The exception request includes removal of iron grilles on some of the windows and replacement of existing “diamond” gable vents. *14-5-2(D)(5)(a)(i)(ii)(iii): Historic windows shall be repaired or restored wherever possible. No new openings shall be made unless historic documentation supports its prior existence. No existing openings shall be closed.*
