## NEW MEXICO HISTORIC BUILDING INVENTORY FORM

building threatened? ☐ yes surveyed date \_\_\_\_\_ by HMW county SANTA FE ID no. 05161 0270

location description \_\_\_\_\_ city/town SANTA FE

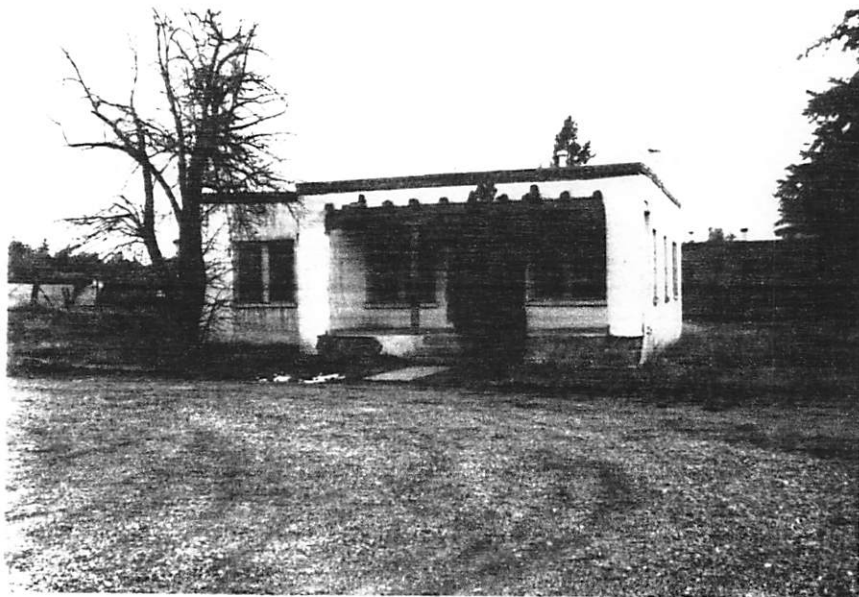
by HMW no. SFHD 21 31

date of construction 1930's estimate \_\_\_\_\_ actual \_\_\_\_\_

present residential

☒ excellent ☐ good

☒ minor ☐ moderate ☐ major

☒ similar ☐ not similar

RF DRAINS TO MTL. CANALES AT REAR.

STRAIGHT BRK COPING: S/DENDE. R.H. / S ↓.

3/1 D.H. WD WDWS, RECES'D W/ CONC. LUG SILLS, SOLS &

TANDEMS. FRONT DOOR: SOL-LEAF WD PANEL W/ 3 VERT.

TALL LIGHTS, W/ SCREEN.

FRONT PORCH: ROUND WD POSTS & CORNER PIERS CARRY EXT'D

WD LINTELS ON ZAPATAS & CORBELS W/ STRAIGHT-CUT PROJ.

comments VIGAS & TWO MTL & WD CANALES.

E PORCH: SCREENED - IN FRAME PORCH ON CONC. PAD,

T & G WD WALLS.

ALL WD IS AQUA PT'D.
